A METEOROLOGICAL ANALYSIS OF THE AMERICAN AIRLINES FLIGHT 1420 ACCIDENT *

Erik A. Proseus
Massachusetts Institute of Technology
Lincoln Laboratory
Lexington, Massachusetts 02420-9185

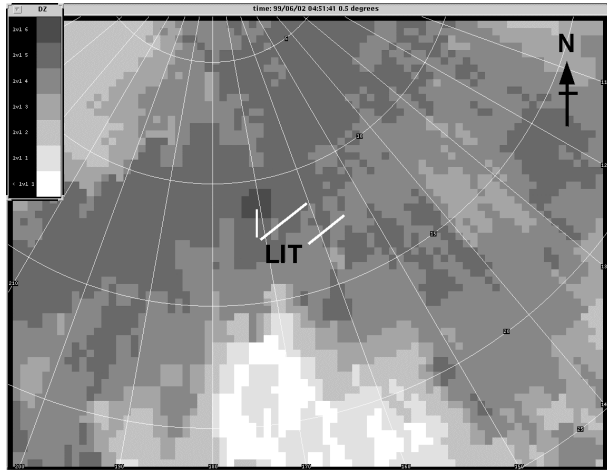
Figure 2. KLZK NEXRAD Reflectivity - 04:51:41 UTC.

The KLZK NEXRAD reflectivity confirms the ASOS reports shown above. Figure 2 shows the near-surface reflectivity values one minute after the accident occurred. In most of the following images, the three bold white (or black) lines in the center are the runways at LIT, azimuthal spacing is set to 10 degrees, and range rings are at 5-km intervals. Runway 4R, the runway on which the mishap occurred, is the right-most runway and the aircraft's final approach path was from the southwest. Level 6 precipitation is occurring over the approach end of the north-south runway

(northwest of runway 4R) and level 5 precipitation is occurring over runway 4R.

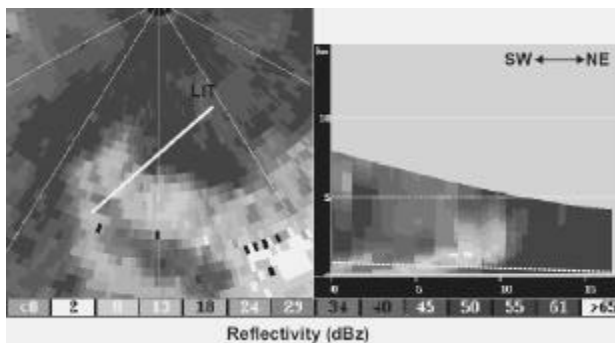
Figure 3. Reflectivity Cross-Section along the Flight Path (04:45:51-04:51:41 UTC).

A cross-section of reflectivity data was made along the final approach path of AAL 1420 and appears in Figure 3. The flight path is indicated by a solid white line in the left panel and by a dashed white line on the right. The right panel also incorporates the aircraft's approximate altitude. The cross-section ends at the runway threshold. From this image, it is possible to see that AAL 1420 encountered heavy precipitation about 9 km (5.6 mi) before reaching the runway threshold and flew through >50 dBz reflectivity for the last 7 km (4.3 mi) of flight.

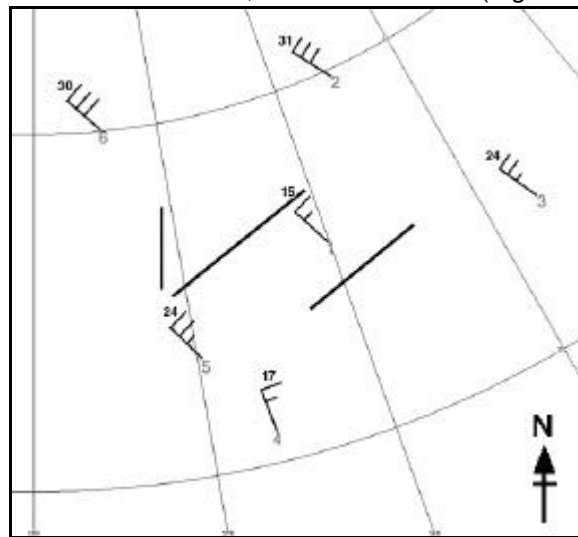
Figure 4. LLWAS Station Plot - 04:50:10 UTC.

At the time of the accident, all LLWAS sensors were reporting wind from the northwest at 15 to 31 knots (Figure 4) and the four sensors nearest runway 4R (numbers 1, 3, 4, and 5) all show wind speeds of less than 25 knots. Thus, there was no directional shear and very little speed shear present at this time. The Doppler velocity images shown in Figures 5 and 6 depict the surface wind field immediately following the accident. These images also have the nearest (in time) LLWAS surface winds overlaid. Wind at the airport prior to and at the time of the accident was from the northwest. However, at 04:52:13 UTC (Figure 5),

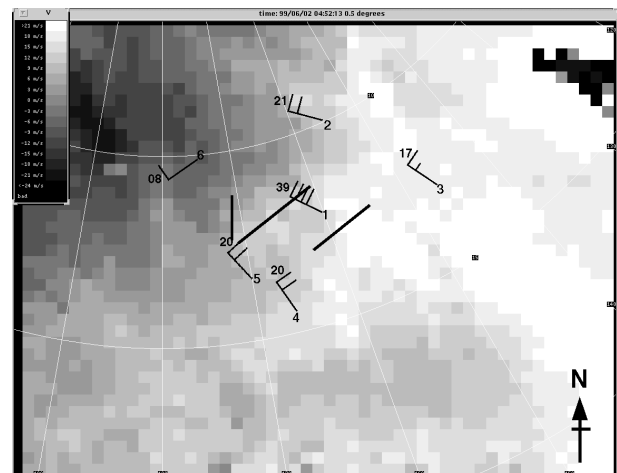
Figure 5. NEXRAD Velocity with LLWAS winds - 04:52:13 UTC.

an increasing southwesterly wind can be seen just west of the airport. This southwest wind is the result of an outflow created by a thunderstorm complex in the same area (see Figure 2). The western-most LLWAS sensor (# 6) depicts this southwesterly wind, while the other sensors continue to show a northwesterly wind. The image in Figure 6 is taken about eight minutes after the accident. By this time, the storms have moved directly over the runways and a microburst signature is present over the airport. The LLWAS sensors are more variable and indicate a definite divergent signature over the airport. The divergence is especially noticeable between sensors 5 and 6, where a 48-knot speed differential is observed. This signature was not present over the runways in Figure 5, so it is safe to assume that the microburst did not affect the airport until after the accident. It is quite likely that this divergent signature not only advected onto the airport with the storm complex, but also strengthened considerably, as the previous image does not show divergence of this magnitude. Thus, according to the NEXRAD and LLWAS data, the aircraft was experiencing a fairly significant crosswind (both in the final stages of flight and at touchdown), but there are no signs of significant wind shear until after the accident occurred.
