ANALYSIS OF THE 12 APRIL 1996 WIND SHEAR INCIDENT AT DFW AIRPORT**

Cynthia Meuse, Linda Galusha, Mark Isaminger, Michael Moore, Dale Rhoda, Frank Robasky, Marilyn Wolfson

MIT/Lincoln Laboratory Lexington, Massachusetts

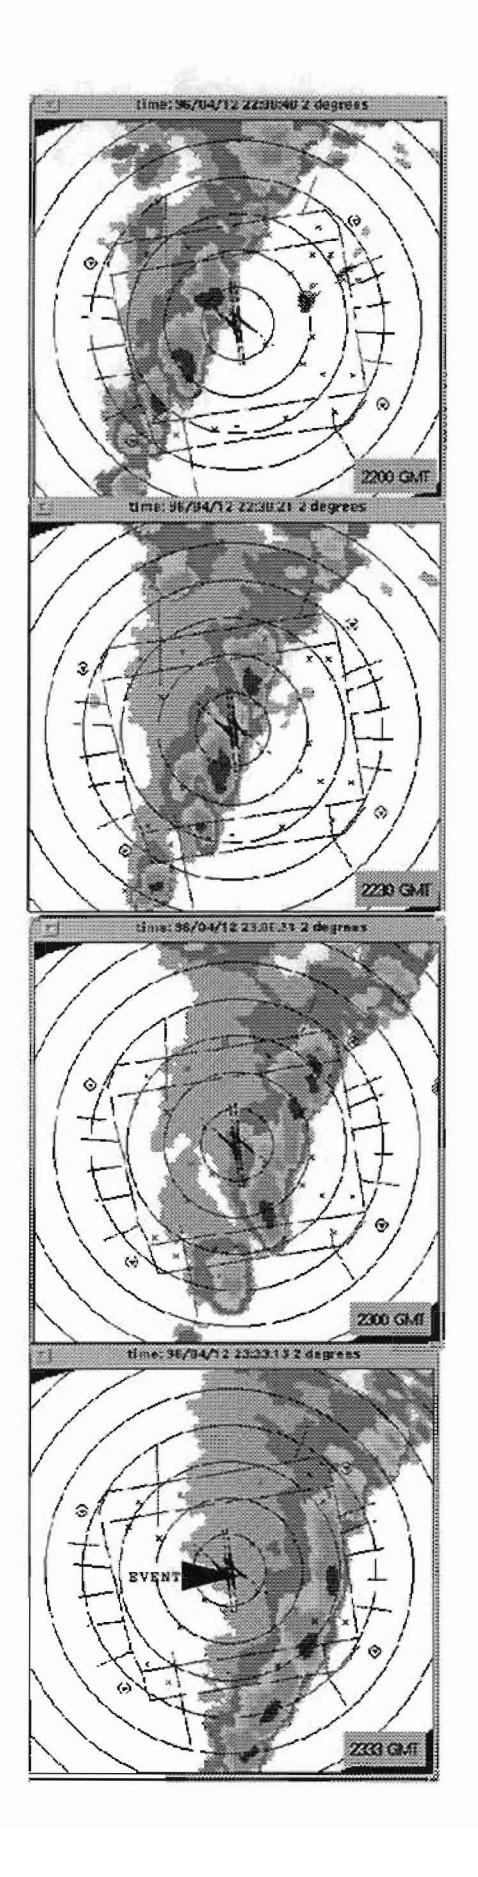
The airport was operating in a "south flow" (planes taking off and landing towards the south) before the storms reached the airport. The line of storms approached from the west and prevented arrivals starting at 2205 GMT (Fig. 2). Departures continued until 2227 GMT. The thunderstorms caused a wind shift at the airport which necessitated a change in runway configuration with nearly 100 aircraft on the ground waiting to depart. The first post-storm departure occurred at

By the time the departures resumed in earnest, precipitation at the airport had diminished to level 1 and the line of thunderstorms was approximately ten miles east of the airport moving eastward at 30 knots (Fig. 2). Approximately 15 aircraft took off to the north without incident before two aircraft on the west side of the airport reported wind shear encounters at approximately 2330 GMT. (Figure 3 shows a transcript of the weather-related transmissions on the west and east side tower frequencies for the period of reported wind shear.) Three minutes later the pilot of AA 1352 taking off on Runway 35L on the east side of the airport reported an encounter with severe wind shear. Reportedly, the winds gusted to 40 kts from the southwest (a tailwind), "the plane was rocked ...violently to the right" (Dallas Morning News, 4/20/96), and the right wingtip banked down toward the runway. The aircraft was so low in altitude, there was concern that the wingtip might actually impact the runway. He used full throttle to keep the plane airborne and advised the relevant air traffic controller to halt departures.

Figure 2. Data mosaiced from three of the four Airport Surveillance Radars (the "DFW-w" ASR-9 is not routinely included in the mosaic) is shown at half hour intervals leading up to the wind shear event. The range rings are drawn at 10 nm (18 km) intervals. The approximate location of the wind shear event is shown in the final panel, at the tip of the black arrow. The wind shear encounter took place in the stratiform region trailing the squall line.

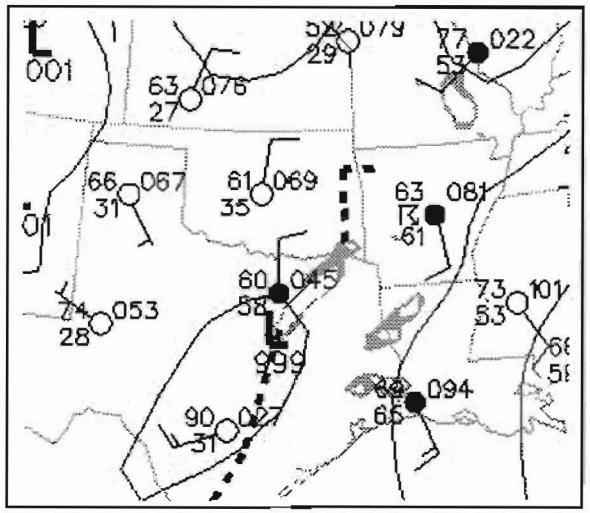
The surface synoptic chart around DFW at 0Z on 13 April is shown in Figure 4. A low pressure center of 999.9 mb is just south of Ft. Worth, where the pressure reads 1004.5 mb. The temperature at Ft. Worth is 60° F and the dew point is 58° F, after the passage of the line of thunderstorms. The heavy dashed vertical line depicts the location of the dry line, a line of density contrast with much drier air to the west. The cold front is not shown, but is associated with the northerly winds shown at Ft. Worth, Oklahoma City, and Dodge City, KS. It's orientation is approximately E–W through the low pressure center. The strong line of thunderstorms was triggered by the dry line, and the development was supported by the presence of the cold front and the broad lifting associated with the low pressure center.

Figure 4. Surface synoptic chart for 0Z on 13 April 1996.

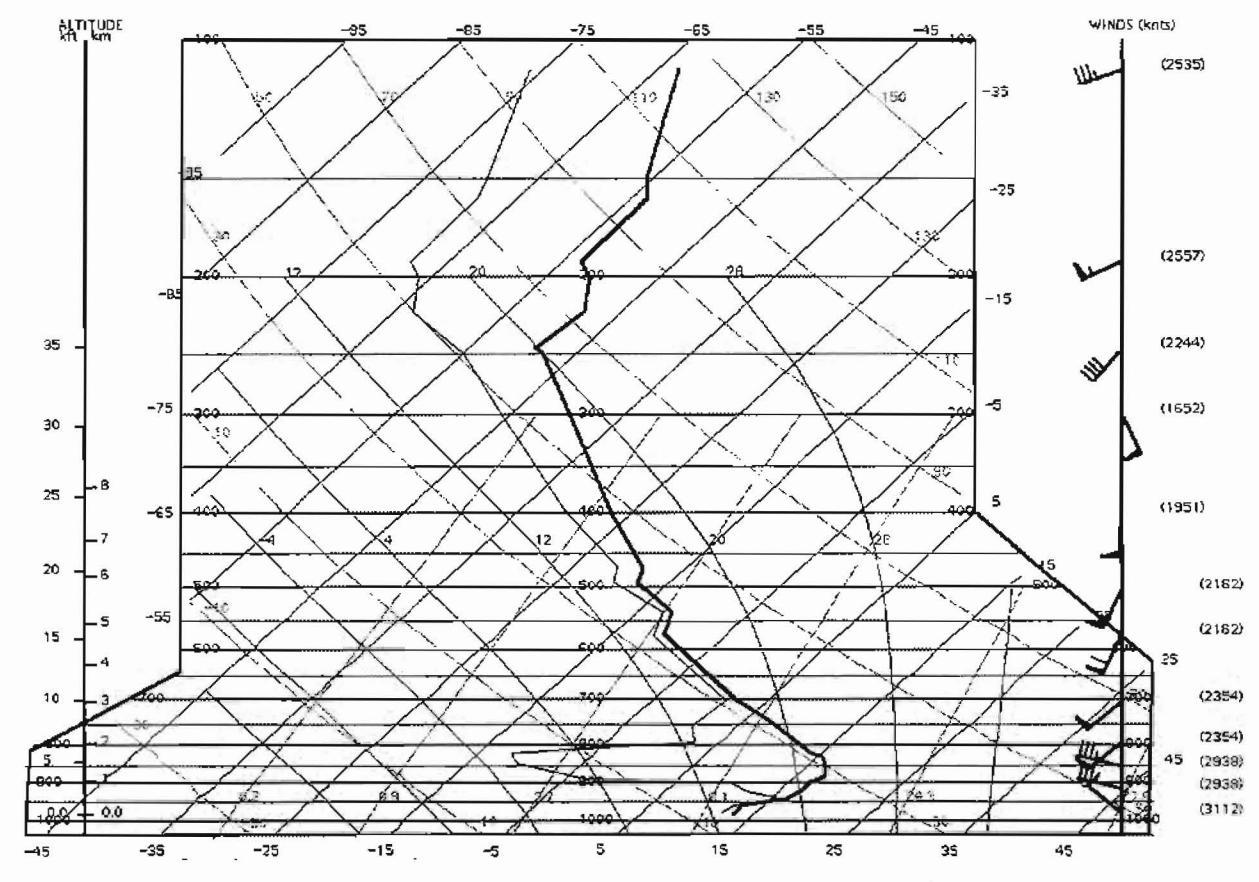
The NWS sounding taken at 0Z on 13 April (30 min after the incident) shows the characteristics of the environment behind the line of thunderstorms, in which the wind shear incident took place (Fig. 5). The most prominent feature is a strong surface inversion that is 1.0 km (3300 ft) deep. The air at the surface is cold and saturated due to the thunderstorm outflow, but the air at the top of the inversion is extremely dry, characteristic of surface air behind the dry line, with a dew point depression greater than 25°C. This extremely stable boundary layer provides an excellent "duct" for supporting buoyancy oscillations, or gravity waves. As we shall see, these play a prominent role in creating the low altitude wind shear conditions at DFW.

The sounding wind profile at this time also shows large vertical shear of the horizontal wind. The winds in the stable boundary layer are northwesterly, but shift to southwesterly at speeds >50 kts above the inversion. The large vertical wind shear throughout the atmosphere is due in part to the low pressure center situated just south of DFW.

Figure 5. The Ft. Worth NWS sounding taken at 0Z on April 13, 1996 (30 min after the incident) is shown plotted in a Skew-T format. The heavy curve is the temperature, and the thin curve is the dew point temperature. The winds aloft are plotted at the right. One barb equals 10 kts, and a flag equals 50 kts. The numerical direction and speed are written in parentheses to the right of the wind graphic [(1652) = 160° at 52 kts]. The vertical scale is in pressure (mb), but the conversion to altitude (in Kft and km) is given by the vertical scale at the left. The primary horizontal scale is temperature (skewed from lower left to upper right) labelled in °C across the bottom of the plot. Notice the sharp surface inversion 1.0 km (3300 ft) deep.

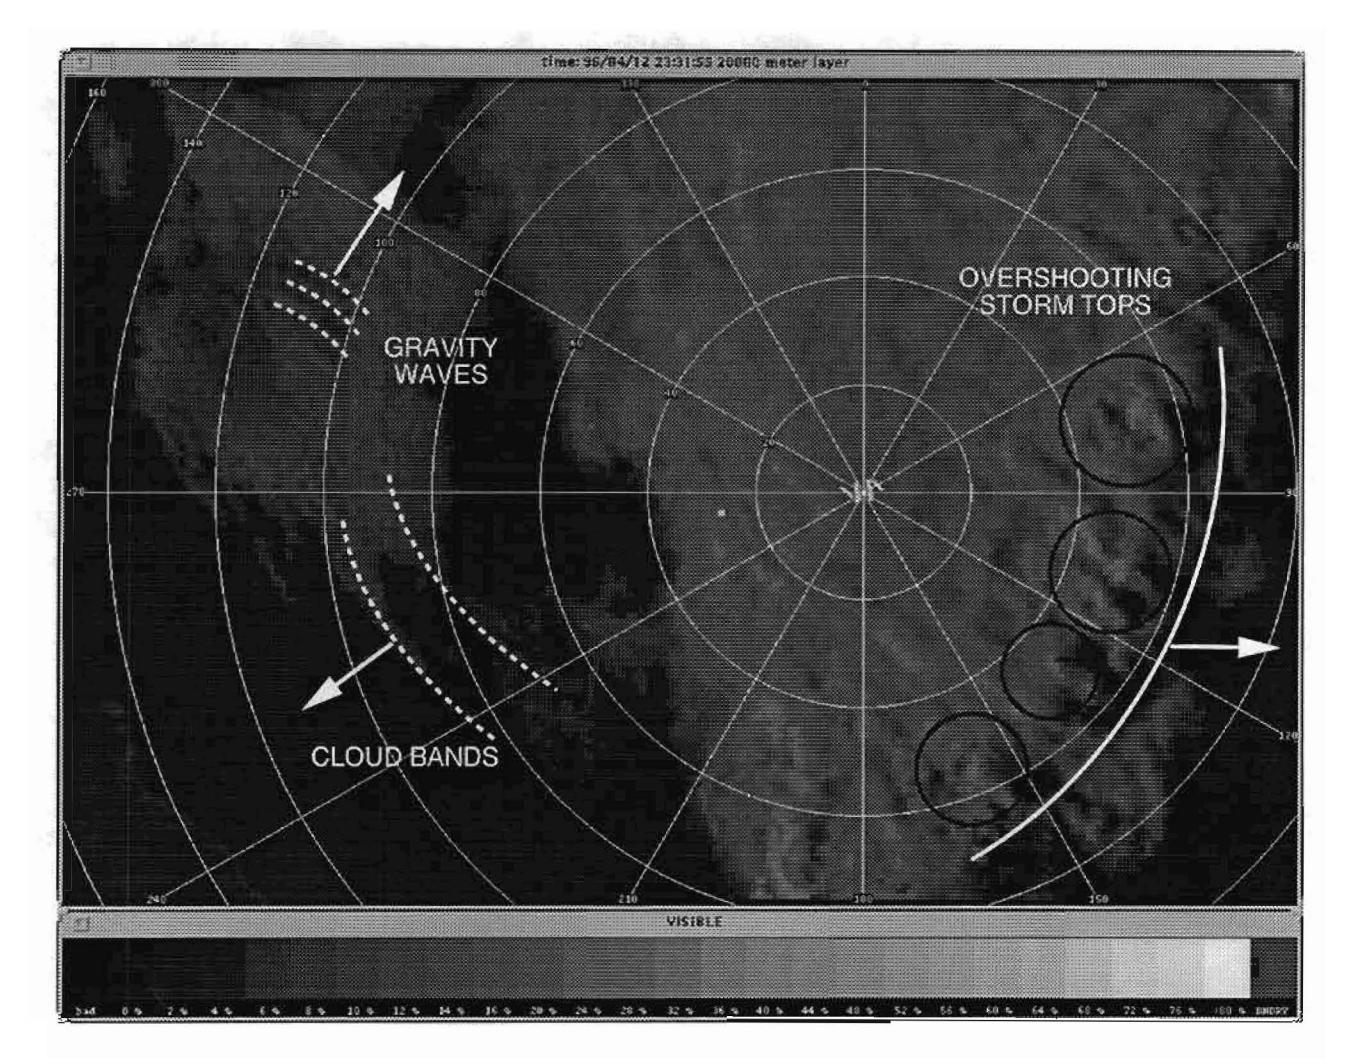
At 2223, wave fronts (low rolls made visible by cloud bands) emerged behind the line of thunderstorms. They are located 75–100 km southwest of the airport moving to the southwest in Fig. 6, at 2332. The fronts intersected a cloudy region to their north and triggered another patch of wave clouds moving in a different direction, still clearly visible at 2332 in Fig. 6. This sat-

Figure 6. GOES-8 visible satellite image taken at 2332 GMT on 4/12/96. The DFW runway pattern is shown at the center of the range rings, which are spaced at 20 km intervals. The high tops of the strong convection in the squall line are shown east of the airport between 40 and 60 km range rings. The atmosphere behind the front supports gravity wave activity, as evidenced by the visible waves oriented NW to SE in the patch of cloud west of the airport between 100 and 120 km range, and by the cloud bands to the southwest.

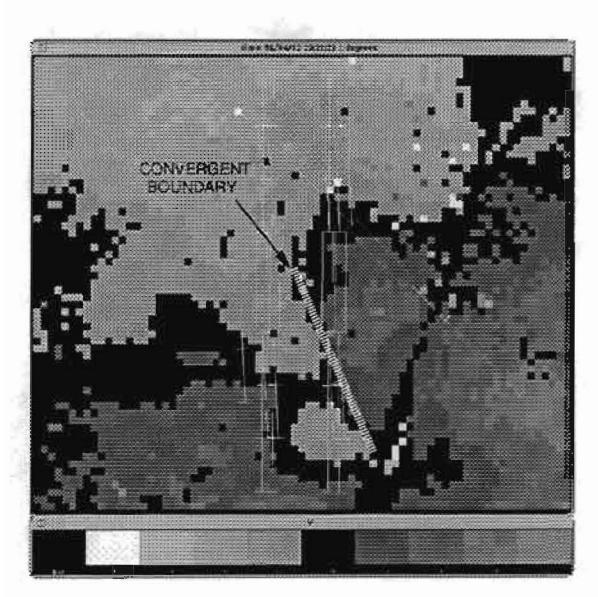
At 2320 GMT, a northwest-southeast orientated convergent boundary is apparent off the southern end of the four parallel north-south runways in the 0.3° (not shown) and 1.0° tilts (Fig. 7). This boundary was one in a series of gravity waves which were observed in a 0.3° surface tilt five minutes earlier southwest of DFW. The maximum observed velocity differential across this feature is 13 m/s (25 kts) at an altitude of 140 m (460 ft) AGL. The wind direction behind this feature is southwesterly which is consistent with the LLWAS and ASOS data discussed later. The reflectiv-

Figure 7. DAL TDWR Doppler velocity data from the 1.0° tilt at 2321. A zone of convergence can be seen approaching the east side of the DFW airport.

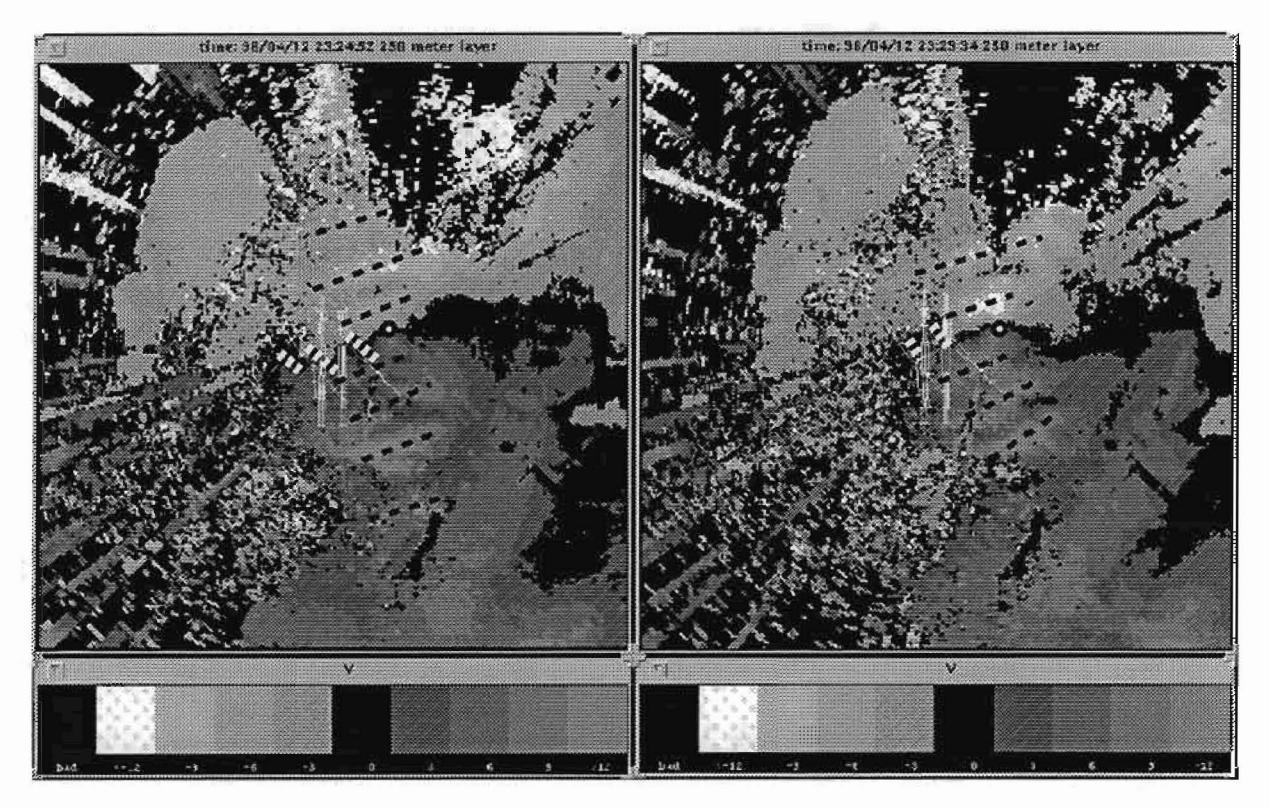
Surface winds remain northerly around 20 kts at 2329 GMT, 4 minutes prior to the incident. The radial velocity plot in Figure 8 shows a banding structure of weak winds bordered by strong winds blowing from north to south, which is indicative of more gravity waves. These bands are oriented west-southwest to east-northeast, and the northerly wind gusts are extremely shallow (100 m [330 ft] deep). The observed western

Careful analysis of the two time periods shown in Fig. 8 reveals that the average gravity wave wavelength is approximately 5.4 km (3.4 mi). The waves were moving relative to the ground at 14 m/s (27 kts) toward 75° azimuth (ENE). At this speed it would take approximately 4.5 minutes for the successive wave crests to cross a point on the ground. The LLWAS anemometer data from the CF sensor (discussed later) appears to also show evidence of this wind pattern.

Figure 8. Surface layer (125 m [400 ft] AGL) of Doppler radar data from DAL TDWR at 2324 GMT (left) and 2329 GMT (right). The dashed black lines highlight the bands of high velocity associated with a short train of gravity waves moving east-northeastward (relative to the ground). The thicker, hatched white lines highlight the bands of convergence propagating in from the southwest. The west end of the middle (third) wave is approaching the south end of the incident runway (35L) at 2329. The white dot northeast of DFW shows the location of the DAL TDWR.

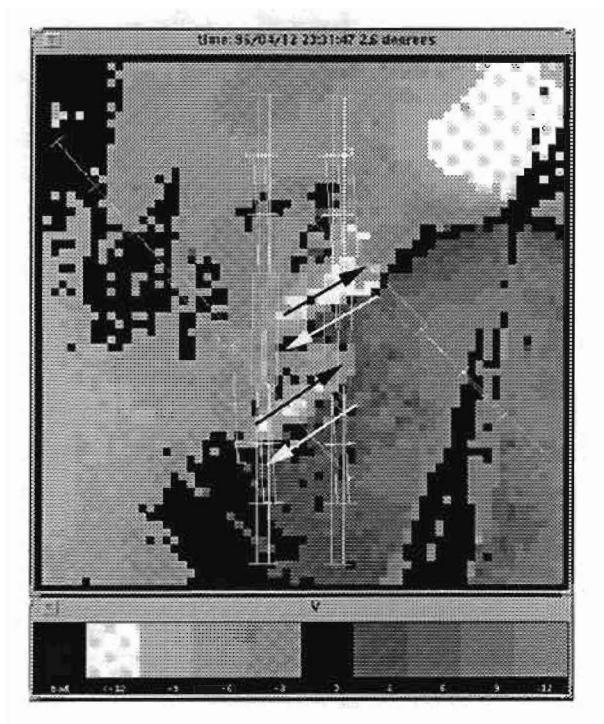
Strong banded azimuthal shear features, both cyclonic and anticyclonic, are evident in the 2.6° tilt at 2331 GMT (Fig. 9). The strongest winds toward the radar are located almost directly above the strongest northerly winds at the surface, and probably are part of the

Figure 9. DAL TDWR Doppler velocity field from 2.6° tilt at 2332 GMT. Azimuthal shear in a banded pattern can be seen. One particularly significant shear zone is located over the east runways. This feature is approximately 250 m (820 ft) AGL.

return flow of the gravity wave rolls. The azimuthal shear was particularly strong over the north end of the east runways, with a 32 m/s (62 kts) velocity differential (+10/-22) over an azimuthal distance of about 4 km (2.5 mi). Some shear at this altitude (250 m [820 ft]) was likely present over the west runways as well, and may account for the pireps of "wind shear at 1000 ft" reported on the west runways (Fig. 3).

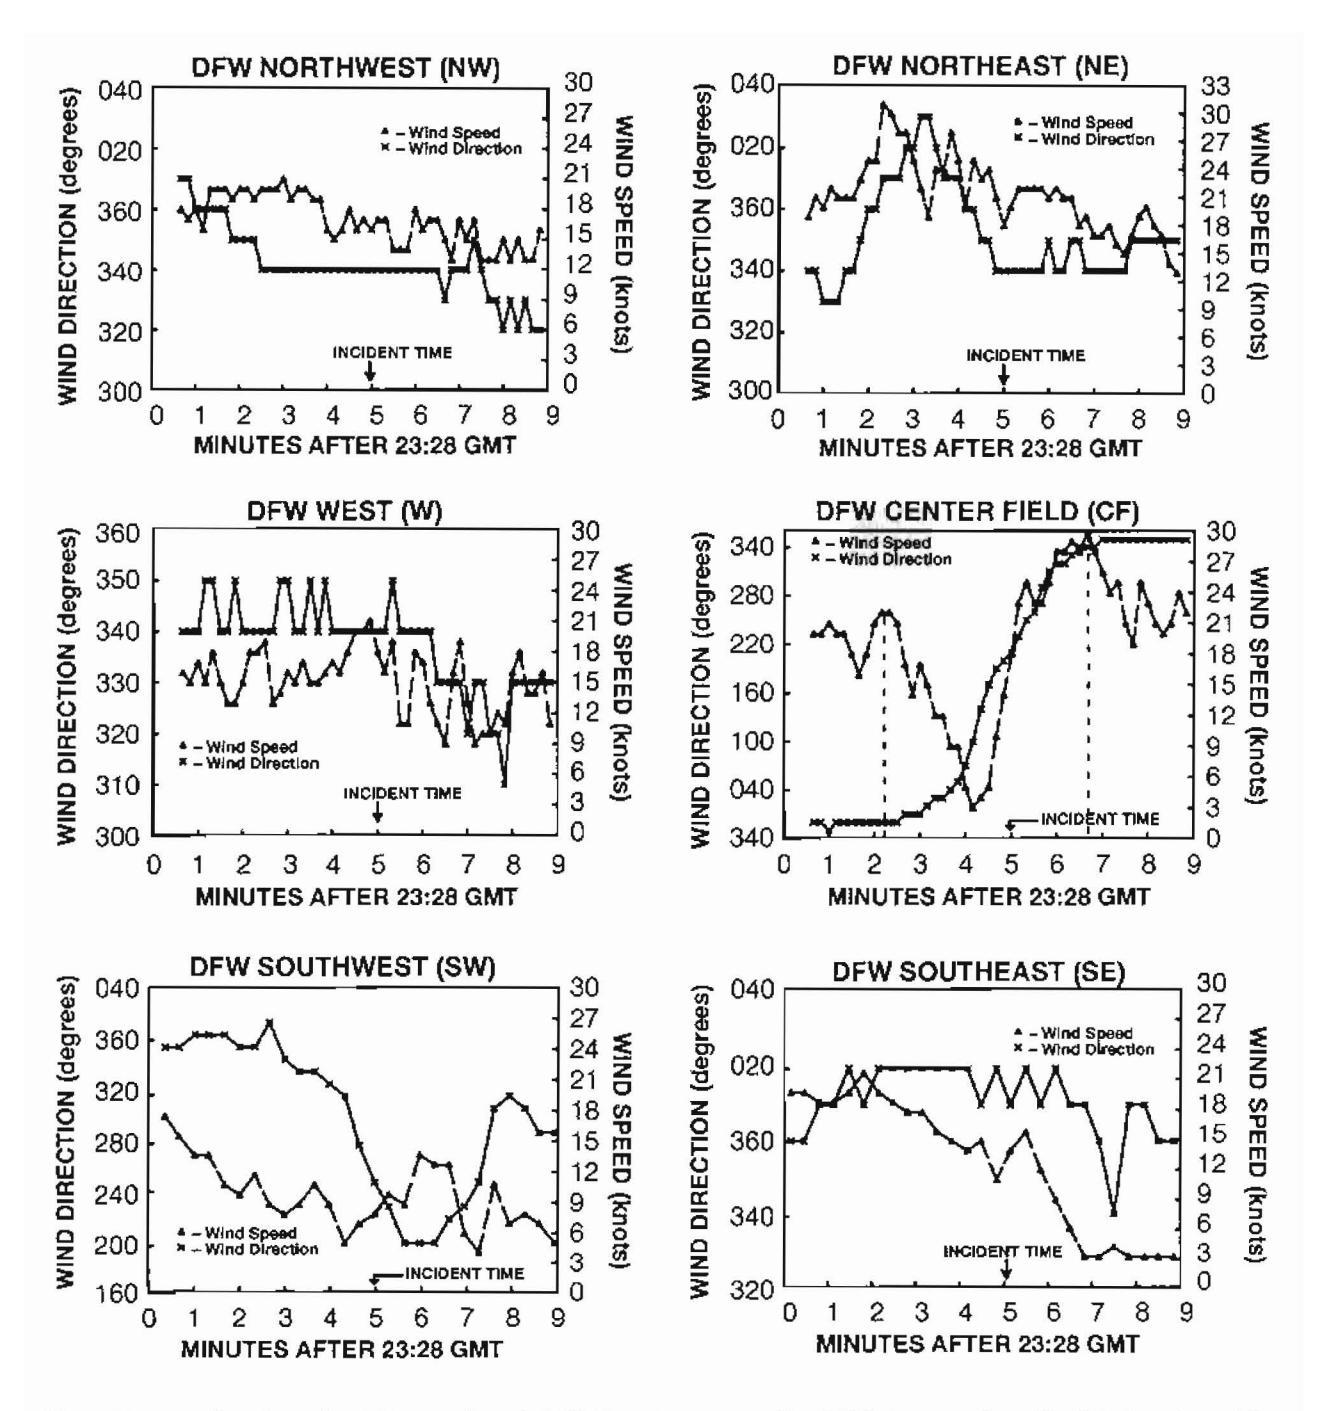
The CF sensor shows a wind pattern which is consistent with a gravity wave crossing the airport at the time of the incident. The winds begin as northerly and somewhat gusty around 20 kts. Just before the incident, they shift in direction through easterly, where the wind speed drops to less than 10 kts, then to southerly through westerly at the time of the incident, where the winds pick up again (20 kts), back around to northerly where the wind gusts to 30 kts and then settles back to the former approximately 20 kt speed. (Notice that the wind direction scale on the CF plot wraps around at 340°). The CF wind speed first peaks from the north at 2330:10 (360° at 22 kts) and again at 2334:40 (340° at 30 kts). These points are illustrated by dashed vertical lines on the CF plot in Figure 10. The time difference is 4.5 min, matching the time estimate for successive gravity wave crests to cross a point on the surface, based on TDWR gravity wave wavelength and motion estimates. The northerly wind direction at the time of the peak wind speeds also matches the pattern found in the TDWR velocity data.

The SW station also shows a significant wind shift prior to the time of the incident. The wind direction backs from 20° to 200° in advance of the incident, gusts from 5 to 14 kts, and then veers to 290° . It is interesting to note that this station shows a backing wind pattern with a wind gust from the southwest, while the CF sensor shows a veering wind pattern with gusts from the north. This could be evidence of the two different gravity wave trains we found in the TDWR data.

Figure 10. Plots of wind speed and direction from six LLWAS stations surrounding DFW airport. Refer to Fig. 1 for locations of the LLWAS stations relative to runways. Note that the scales on each plot are different in order to capture the wind profiles.

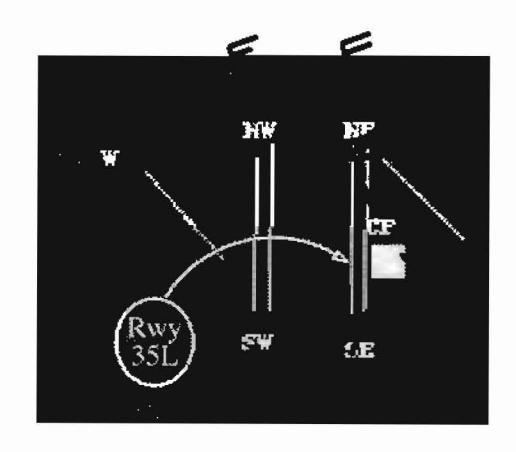
A small plot of the LLWAS and ASOS winds one minute after the incident, at 2334, is shown in Figure 11. The north end of the airport is clearly under the influence of northerly surface winds, with the strongest gust reported at CF. However, the ASOS station (and SW) show more southerly wind gusts. Figure 11 provides definite evidence of small-scale vorticity in the surface wind field on the south and especially east sides of the airfield near the time of the incident.

Figure 11. Plot of winds at 2334 GMT, one minute after the incident. The white square is the ASOS station, the others are LLWAS stations. One long wind barb equals 10 kts; a short barb equals 5 kts.
