Construction of the HUSIR Antenna

Nikolas T. Waggener

To add W-band capability to the Haystack X-band radar system, its 120-foot-diameter antenna was replaced with a new Cassegrain antenna with a surface tolerance of less than 100 μm . The installation of this antenna and its support systems was an incredibly challenging engineering construction project.

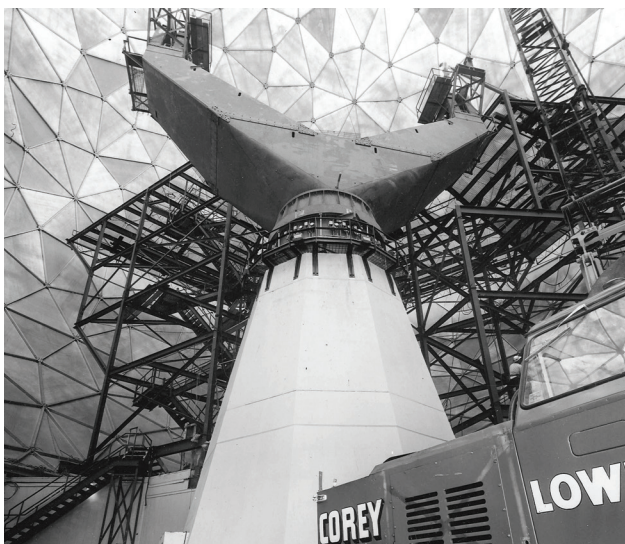
FIGURE 2. Mobile cranes and extensive scaffolding were used to build the original Haystack antenna within the confines of the radome.

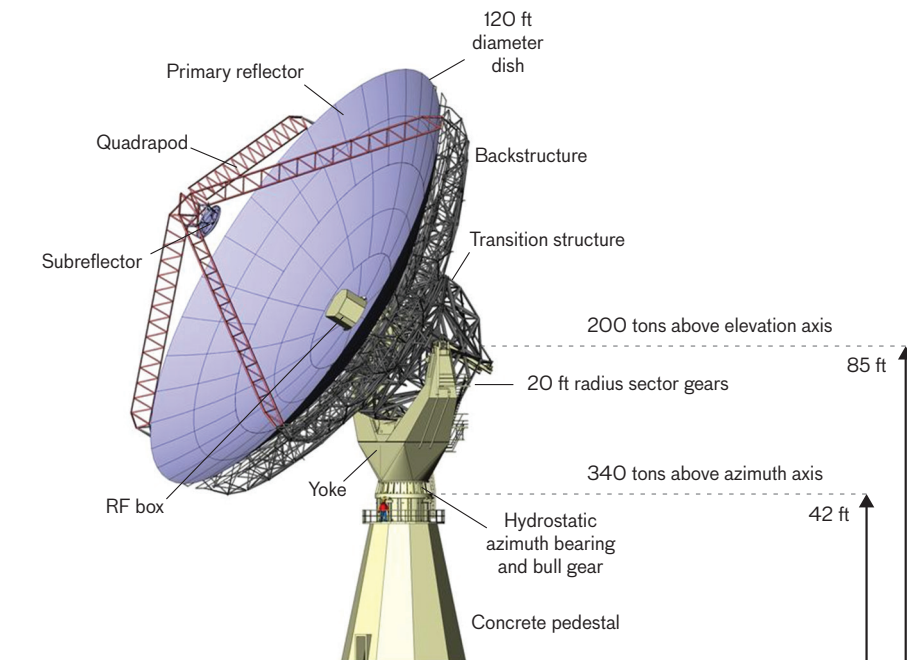
FIGURE 3. A computer-aided design rendering of the HUSIR antenna shows its key features.

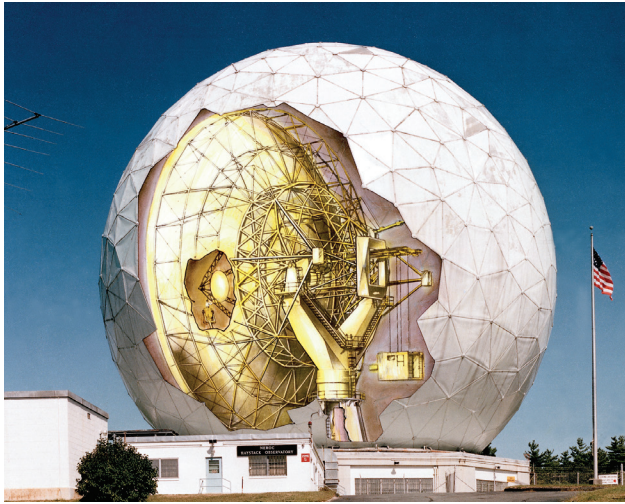
FIGURE 4. This rendering is a cutaway view of the old Haystack antenna that shows the RF box being lowered.

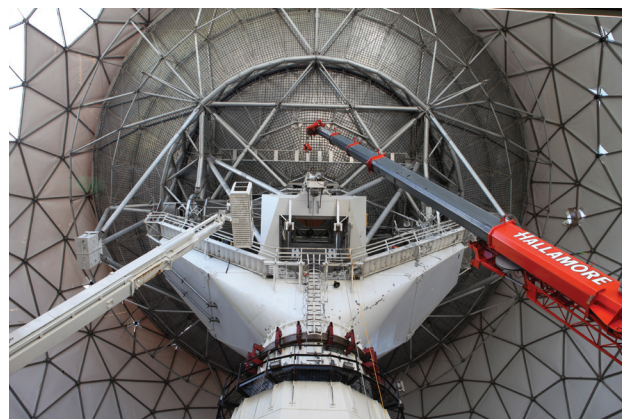
FIGURE 6. A crane connected to the 30-ton counterweight compensates for the missing RF box as the antenna is rotated to zenith for the last time.

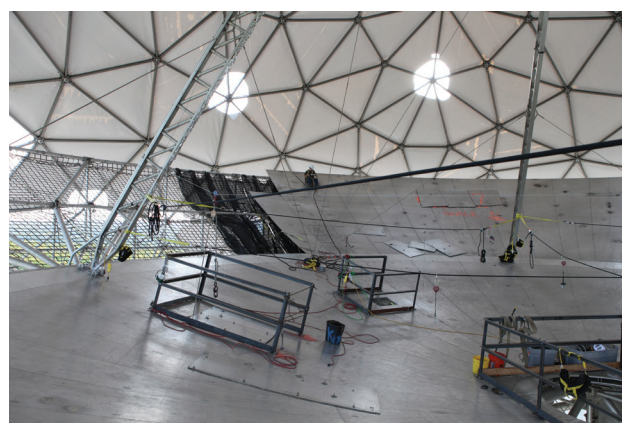
FIGURE 7. (a) Workers remove the first sections of the old antenna surface. (b) Meanwhile, radome membranes are dismantled around the separation line at which the radome will be “uncapped.”

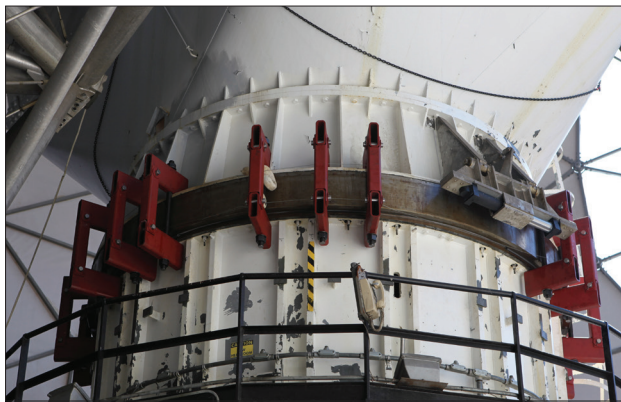
FIGURE 8. The 200 lb clamps around the azimuth bearing ensure that the antenna does not tip over when exposed to high winds.

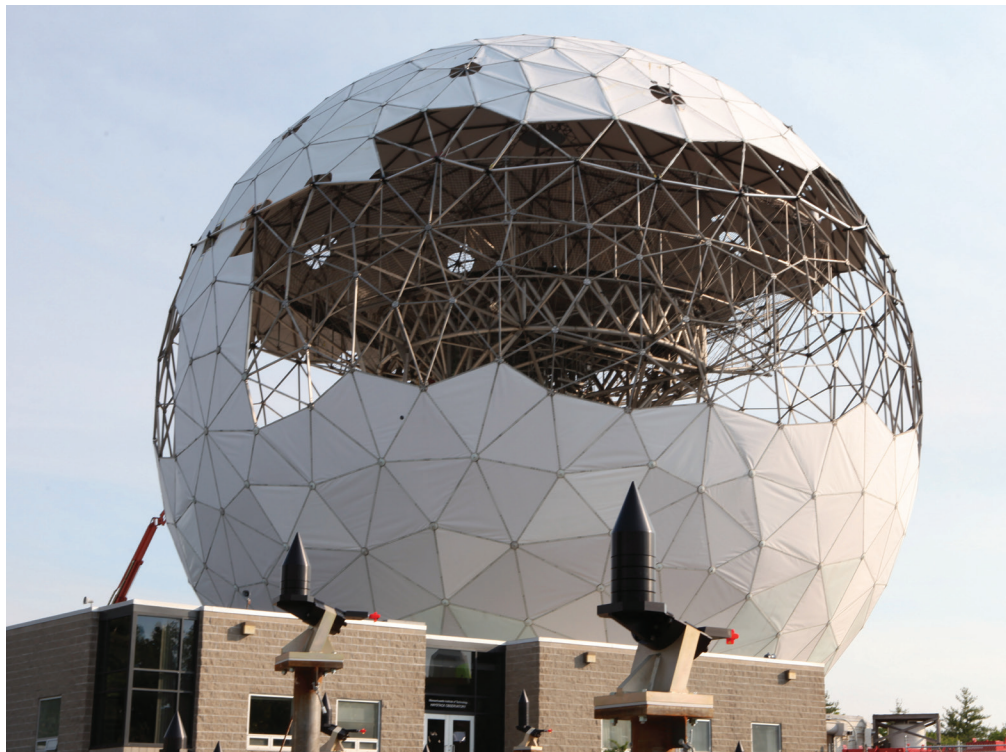
FIGURE 9. The ground support nodes in the foreground await the radome cap. In the background, the radome equator region is almost completely de-skinned, exposing the old Haystack antenna for the first time in its history.

the wind-loaded area to an acceptable level. Figure 9 shows the radome during membrane removal. Like the radome nodes they replaced, the split-line nodes connect the radome beams where they intersect, but were specially designed to split to permit the radome cap to be lifted away. The split-line nodes were also built with provisions for installing a stiffening ring, which would help the truncated radome maintain its shape once the cap was removed.

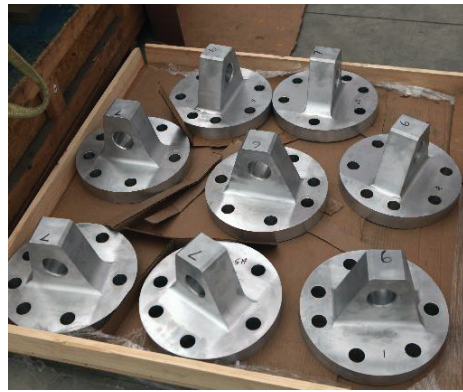
FIGURE 10. (a) Each split-line node has alignment cones and stiffening tubes that replicate the support of the beams that would be lifted with the cap. This cone was painted red to help index the position of the cap for reinstallation. (b) The lifting nodes in this box are ready for installation.

that would assist in matching the 35 node halves with their mates (Figure 10). The cone heights were staggered so that five of the alignment features would come into contact sequentially, progressively aligning all 35 nodes as the cap was lowered.

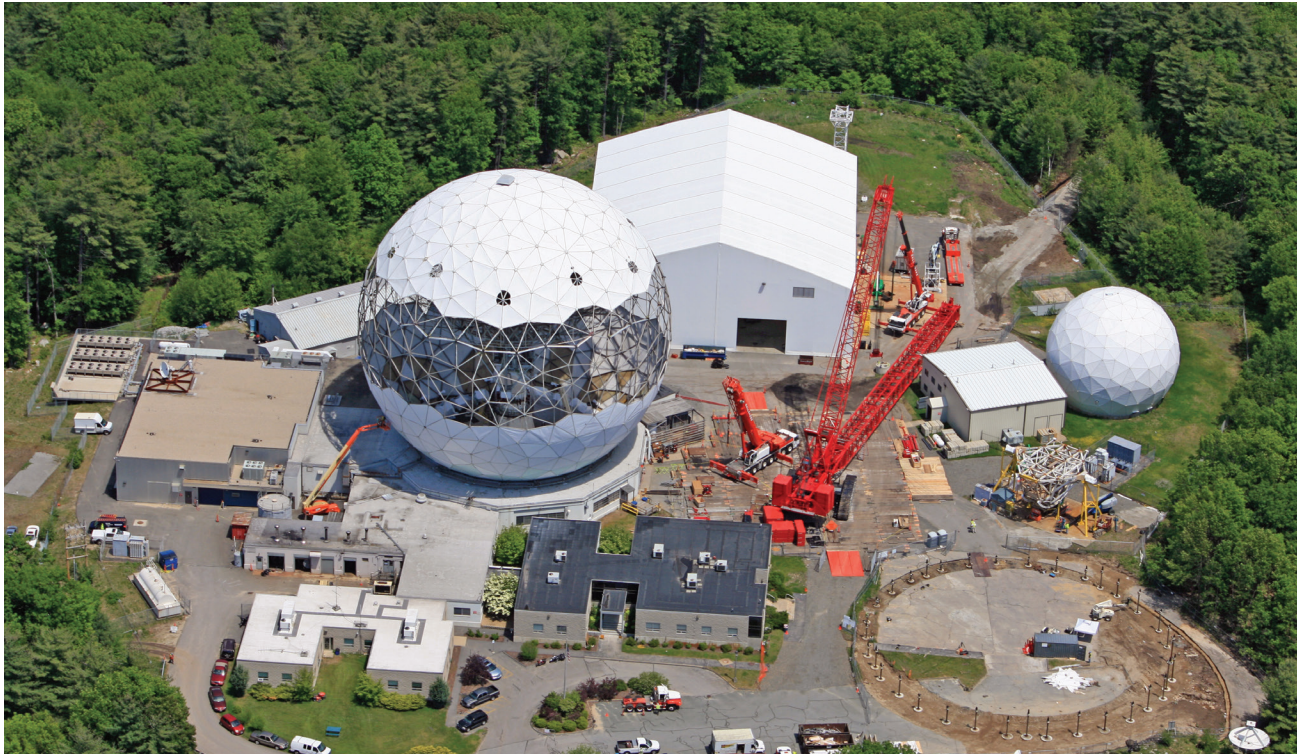
FIGURE 11. The assembly of the heavy-lift crane takes place along a 400 ft roadbed built into the treeline while the radome membranes around the equator are removed in preparation for the separation of the radome cap. The temporary landing zone for the cap is the ring of steel piers in the lower right corner.

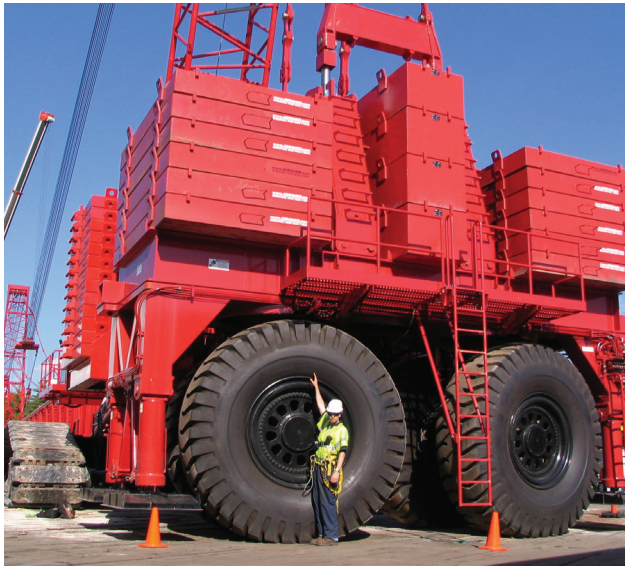
FIGURE 12. The author stands behind the auxiliary counterweight cart while a smaller crane assists with assembling the crane.

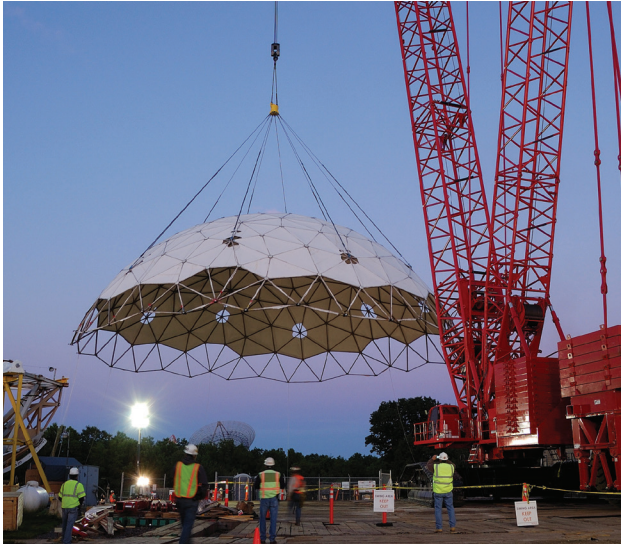
FIGURE 14. The cap was lifted off the Haystack radome and carefully swung to its temporary landing site.

the Haystack office building to the adjacent parking lot (Figure 14). Waiting in the parking lot were 35 steel columns anchored to the bedrock and laid out in the same configuration as the nodes along the split-line. Each column was topped with a duplicate split-node lower half and alignment cone, creating a replica of the split-line. The radome cap was lowered into place, and the cone-and-ring alignment features brought the two split-node halves together for a successful landing.

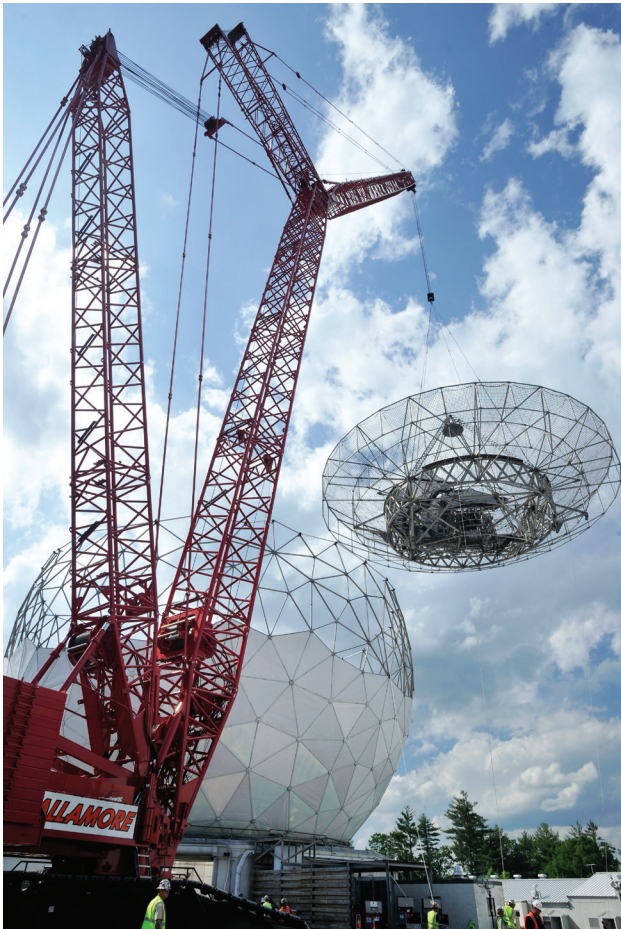
FIGURE 15. The 43-ton old backstructure was lifted over the edge of the radome and set down behind the temporary building to await demolition.

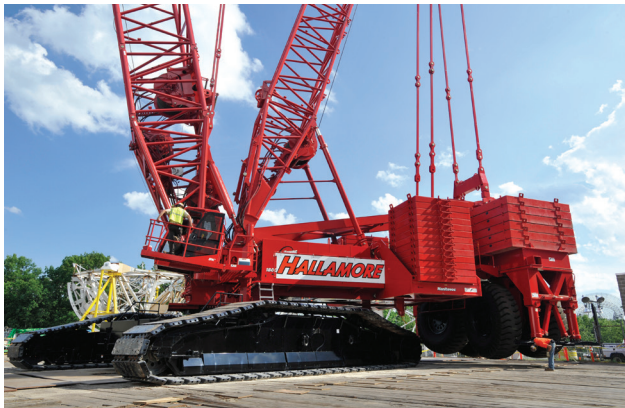
FIGURE 16. Under heavy loads, the crane's 230-ton auxiliary counterweight lifts completely off the ground.

The team authorized the crane operator to increase the load to the maximum allowable load of the weakest component: 43 tons. If the weight exceeded that limit, the lift would have to be postponed until the rigging plan could be modified. When the structure finally did lift free of the yoke, the weight of the backstructure was 35% more than originally anticipated and nearly 100% of the rated load of the weakest rigging component (Figures 15 and 16). The mystery of the antenna weight was com-

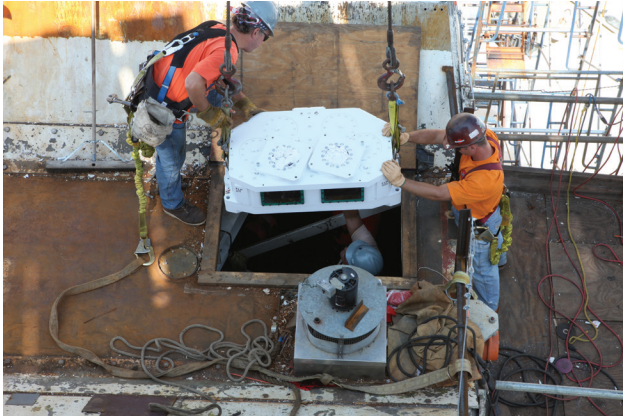
FIGURE 17. The first of the 1-ton gearboxes is lowered into the yoke. The gearbox was then transferred to a series of overhead chainfalls and a rail system in order to position it in place.

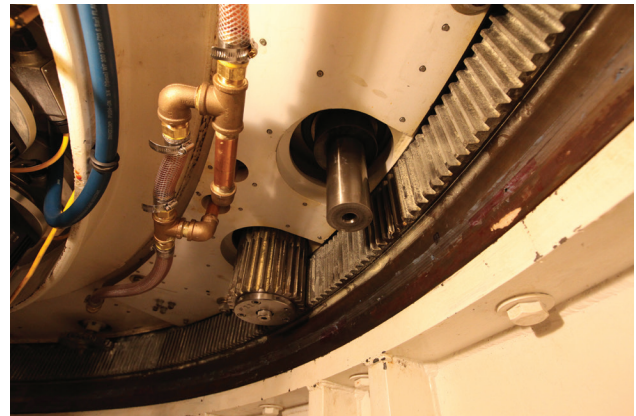
FIGURE 18. One of four pairs of pinions that drive against the stationary 12-foot-diameter bull gear. The shaft on the right is awaiting installation of the pinion gear.

Internal yoke modifications, primarily to the azimuth drive support area, had been ongoing since the start of the integration phase. The azimuth motors drive pinion gears against a 12-foot-diameter internally toothed stationary bull gear located between the steel yoke and the concrete pedestal. Because the bull gear is part of the azimuth bearing, and therefore inaccessible without removal of the yoke, this 50-year-old component would not be upgraded as part of the HUSIR project. To minimize the risk of fatigue failure caused by higher inertia and higher acceleration rates, the number of drive pinions in the upgraded antenna was doubled from four to eight, thereby reducing the individual tooth loads to an acceptable level. The additional drives would permit the antenna to reach its design speed of $5^\circ/\text{s}$ and acceleration rate of $2^\circ/\text{s}^2$.

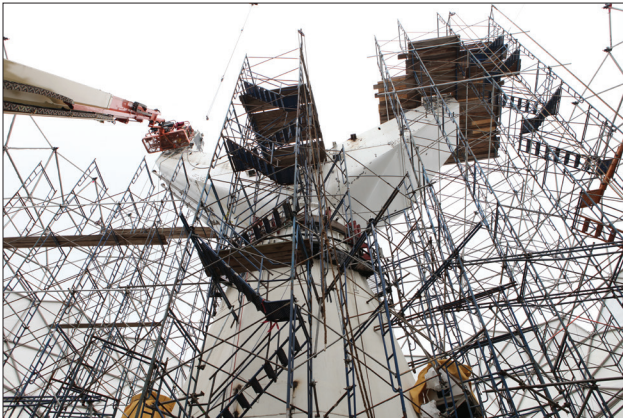
FIGURE 19. Towers of scaffolding ascend from the floor of the radome as the yoke structure is stripped of old components and modified to accept the new transition structure.

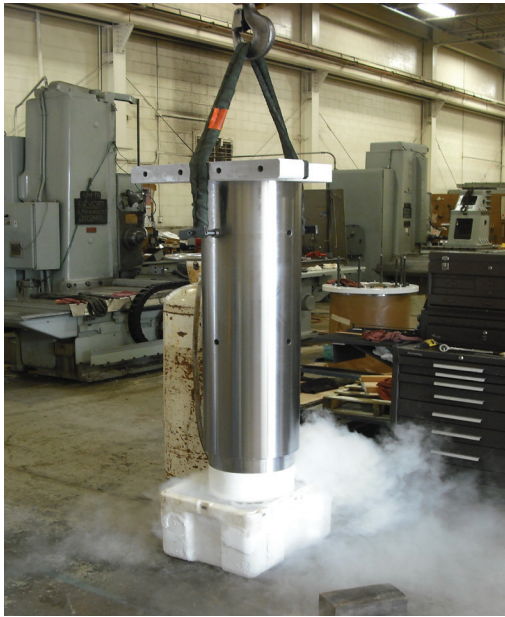
FIGURE 22. Liquid nitrogen boils as the 6-foot-long stub shaft is lowered in. Once cooled, the stub shaft is pressed into the inner race for a permanent “thermal fit.”

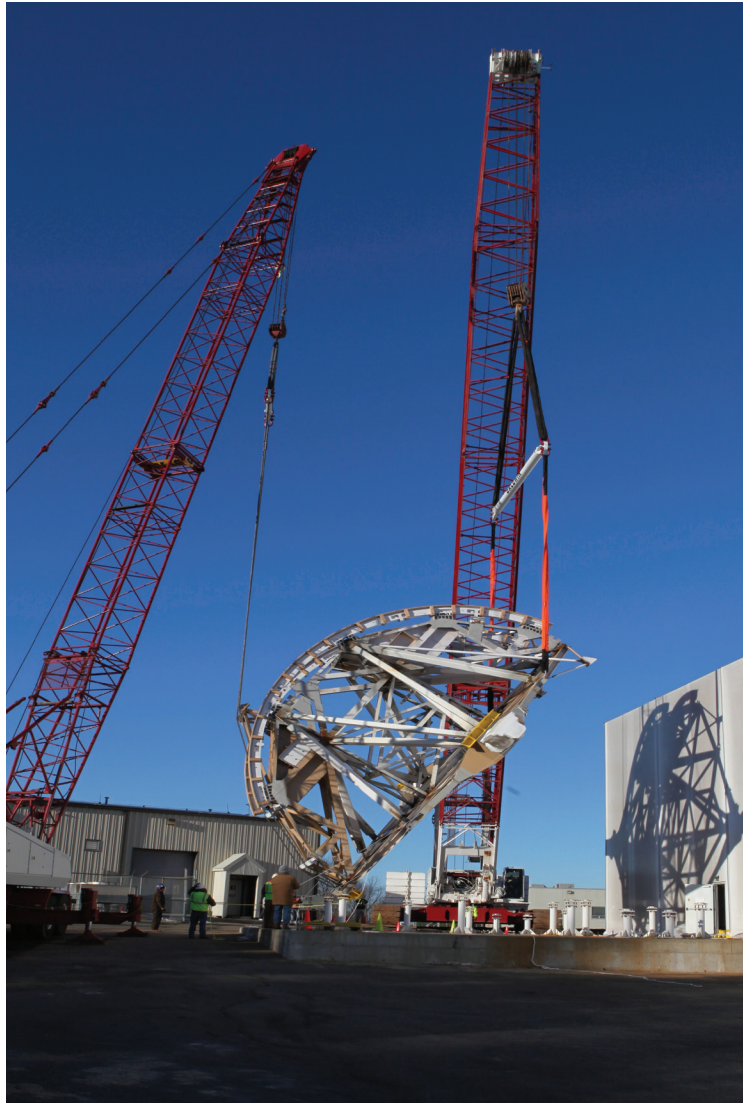
FIGURE 23. During a tandem lift operation, the transition structure is inverted and moved from its face-down assembly area to a pair of supporting tripods where final integration continues face up.

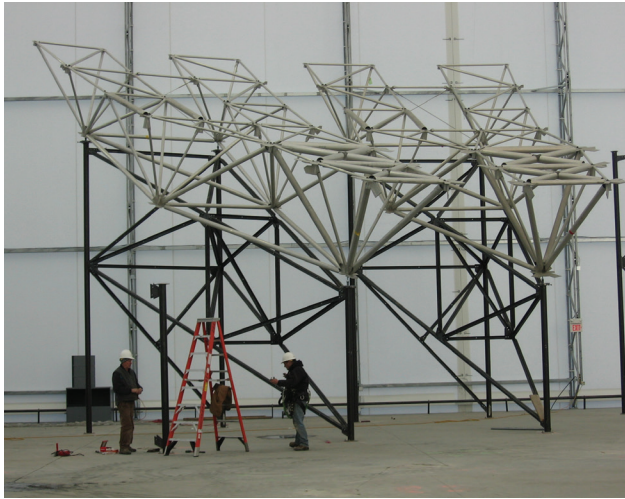
FIGURE 26. The first two radial rib sections are installed on their assembly stands inside the temporary building. Note the workers and the 8-foot stepladder for scale.

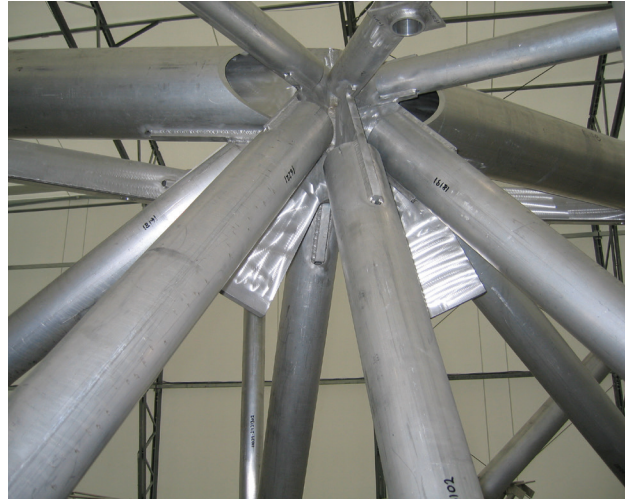
FIGURE 27. This node point has 13 connecting elements.

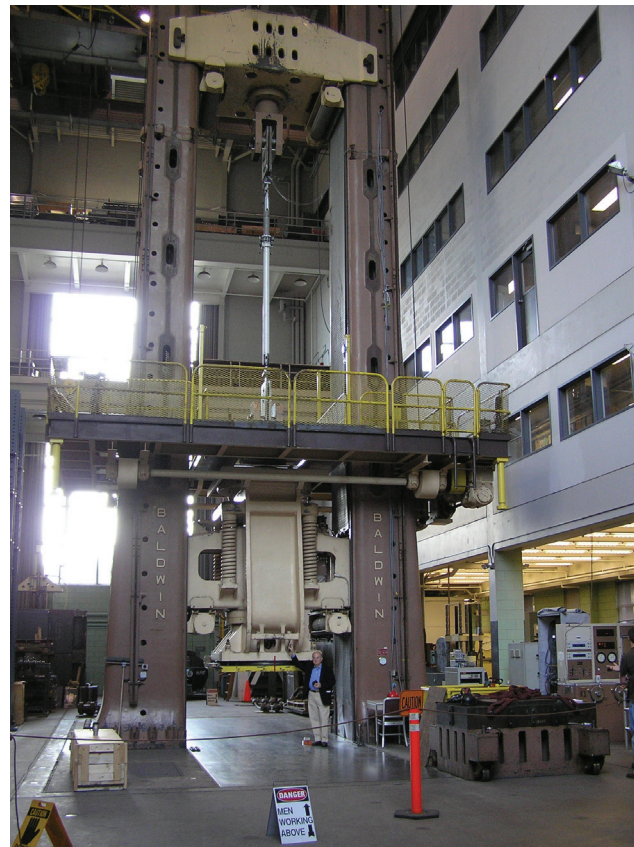
FIGURE 30. The 12-foot-long reflector support struts were tested to more than 200% of the design load in both tension and compression in Lehigh University's testing machine (note the person on floor for scale).

a stainless steel spacer for galvanic corrosion resistance. To verify the strength of the RSS legs, one was tested on a large compression testing machine; it survived a 116,000-pound load, well above the maximum design load of 45,000 pounds (Figure 30).

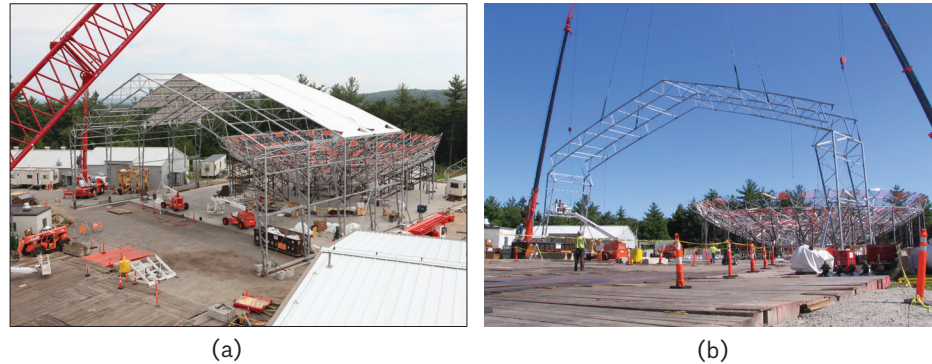
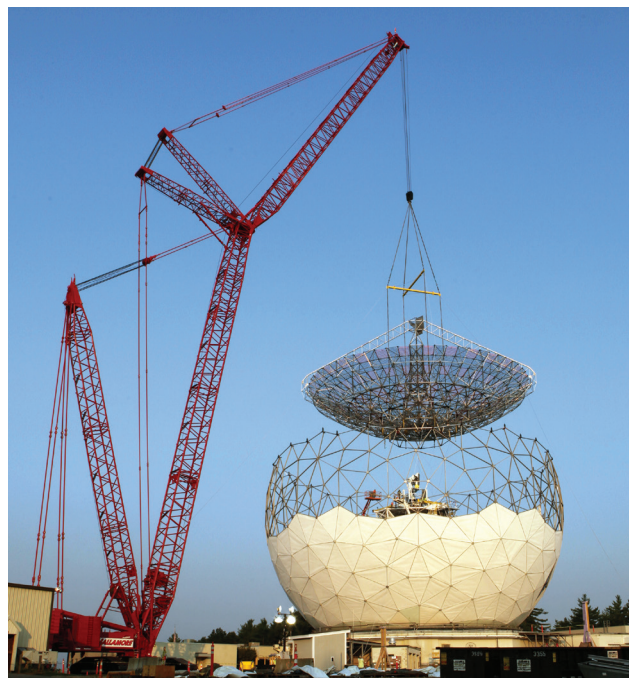
FIGURE 32. The new backstructure is carefully lowered into position on top of the waiting transition structure.

The ratchet straps, operated by ironworkers at the front face of the transition structure, provided lateral and circumferential restraint as the backstructure was slowly lowered, preventing the backstructure from swinging or spinning about its axis and making contact with any of the projecting structures. This careful coordination between the crane operator and the teams of ironworkers was the focus of the test lift, and proved that the crossed ratchet straps could adequately control the position of the 120-foot-diameter, 30-ton backstructure. The actual lift, completed on the morning of 2 September 2010, was successful largely because of the careful planning and additional time taken for the test lift (Figure 32).

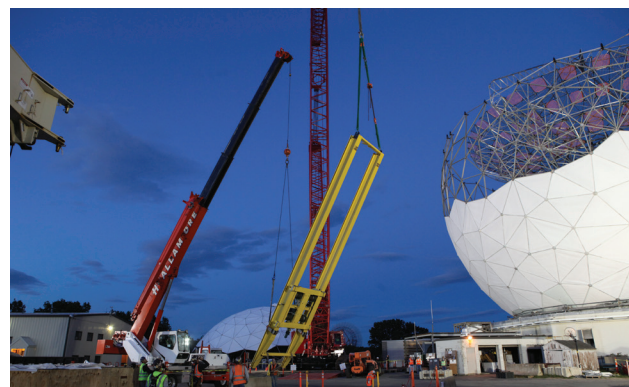
FIGURE 33. The rails and dolly for the RF box insertion system are raised up in preparation to be threaded down into the transition structure.

of roof-mounted air-conditioner units on subway cars. The design, similar in function to that of the legacy hoist system, comprises a dolly, with two electric winches, that rides on a pair of 37-foot-long steel rails. The rails, in turn, can be driven along rollers to cantilever out the rear of the transition structure and provide a clear path for the RF box to be lowered to the ground. The rollers had been pre-installed in the transition structure while still on the temporary stands, and the two rails with the associated dolly were lifted and carefully guided into the roller cradles and secured in place (Figure 33).

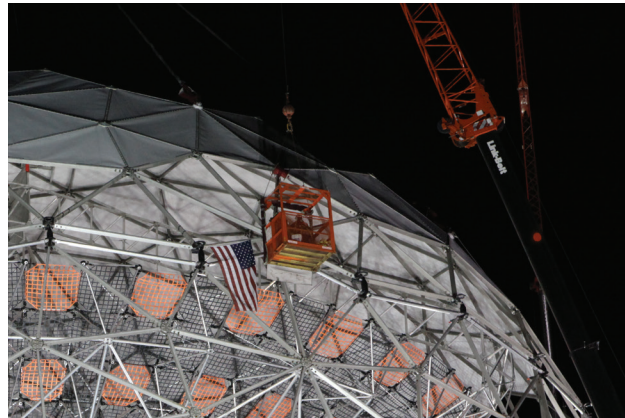
FIGURE 36. Workers in aerial lifts and crane baskets guide the radome cap onto the truncated radome.

Just prior to the pre-dawn liftoff, the ironworkers affixed an American flag to one of the radome beams in a tradition known in the industry as “topping off.” As the cap passed over the top of the new antenna and began to be lowered, half a dozen ironworkers in aerial lifts and crane-suspended man-baskets ascended to the edge of the radome to monitor the engagement of the alignment features on the split-nodes (Figure 36). The alignment

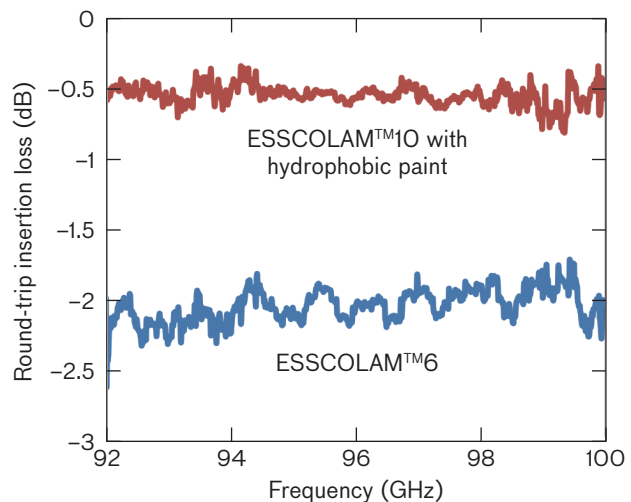
FIGURE 37. Measurements of the new three-ply ESSCOLAM™10 showed significantly better membrane performance at W band than the performance of the legacy two-ply ESSCOLAM™6.

While the metal space frame of the Haystack radome was unchanged during the upgrade process, the radome membranes (“skins”) did require replacement in order to minimize loss at the new 96 GHz operating frequency. The new membrane material is three-ply ESSCOLAM™10 (a proprietary polymer material) with a hydrophobic coating on the outer layer to repel water that would otherwise attenuate the W-band signals (Figure 37). The skins were fabricated and cut to the 15 unique shapes that compose

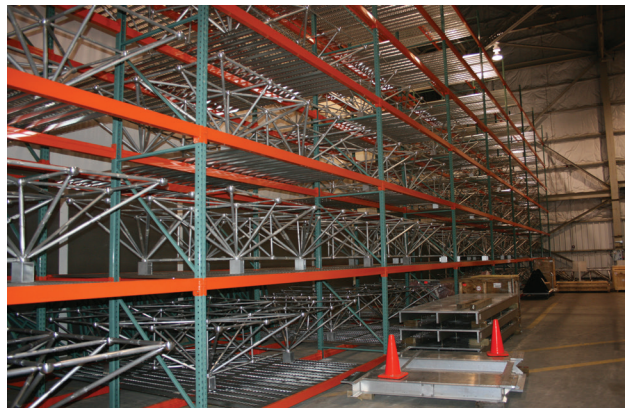
FIGURE 40. Completed subframe trusses await panel installation. All 104 subframe assemblies were stored on racks in an airplane hangar until they were transported to the site.

The primary reflector panels are thin (0.062 inch) aluminum sheets formed on vacuum molds with stiffening ribs epoxied to the backside to hold the deformed shape. Installation of the panels onto the subframes was performed in a custom-built, thermally stable room to minimize distortion of the surface panels. A laser radar was used to measure the four (or five, in the case of the larger subframes) surface panels as they were mounted via 10 adjustable rods. The measured positions were compared to the ideal computer-aided design (CAD) model and adjustment commands were generated for the workers. This process enabled placement of the panels within 16 μm of their ideal positions [2]. The completed subframe assemblies, whose weights range from 350 to 600 pounds, were stored on 35-foot-tall racks inside an airplane hangar until the new antenna was installed and the radome fully enclosed (Figure 40).

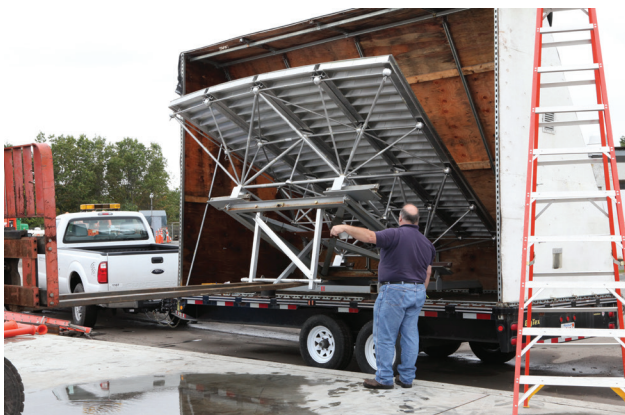
FIGURE 41. A subframe is secured to the steel frame on the transport trailer and then pivoted to fit inside the 8-foot-wide trailer body.

The completed subframe assemblies were transported 45 minutes to the construction site on a pair of custom-built enclosed trailers that prevented damage from weather or road debris. Each trailer could carry a single subframe assembly on a mounting fixture that angled the 12-foot-wide subframes such that they fit within a standard trailer width (Figure 41). To support the installation goal of six subframes per day, a temporary storage shelter for the subframes was built in close proximity to the Haystack radome to act as a buffer in case of disruption to the supply chain. A clear-span tent capable of storing up to 20 subframe assemblies was erected on the concrete pad where the backstructure had been assembled. From this tent, the subframes were moved by forklift into the radome and up onto the roof of the control room inside the base of the radome. Here they were loaded onto large dollies, rolled to the center of the roof, and prepped to be lifted into position on the surface of the backstructure.

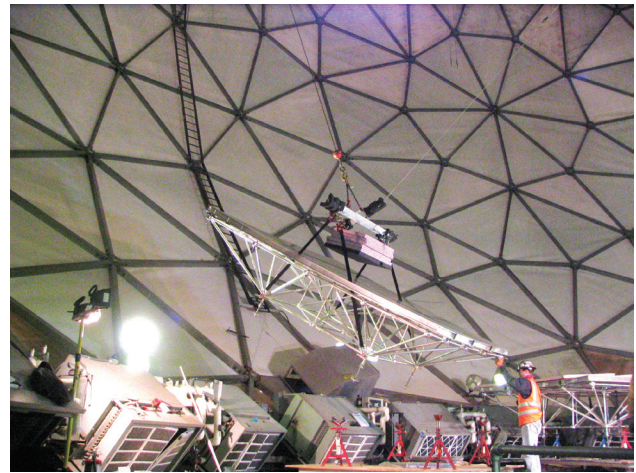
FIGURE 43. A subframe is lifted off the control room roof.

radome is too small for a subframe to fit through, so a small section of one of the backstructure ribs had been left off during assembly to provide an opening large enough to pass a subframe through. This notch was at the 6-o'clock (bottom) position of the dish, which coincided with the centerline of the control room roof. The knuckle-boom crane, which had been folded up no larger than the RF box, now unfolded and telescoped until the tip of the jib was directly over the backstructure notch. The lifting line was lowered and simultaneously pulled in toward the center of the radome with the help of a tagline wound around a capstan winch located at the base of the yoke. This tandem line technique allowed the hook to be lowered at an angle of approximately 20° from vertical, placing the hook directly over the subframe assembly waiting on the control room roof (Figures 42 and 43).

The top surfaces of the panels do not have any lifting features, so custom lifting straps had been fabricated from seatbelt webbing, a single ply of which was just thin enough to fit through the 3 mm gaps between adjacent panels. The straps, carefully threaded between panels, were used to lift the subframe from the same four nodes that would be attached to the backstructure. Because the panel gaps were too small to pass the double-thickness loop ends through, the straps had to be cut from below once the panel was installed. Each panel was guided into position by a team of ironworkers working in nets that

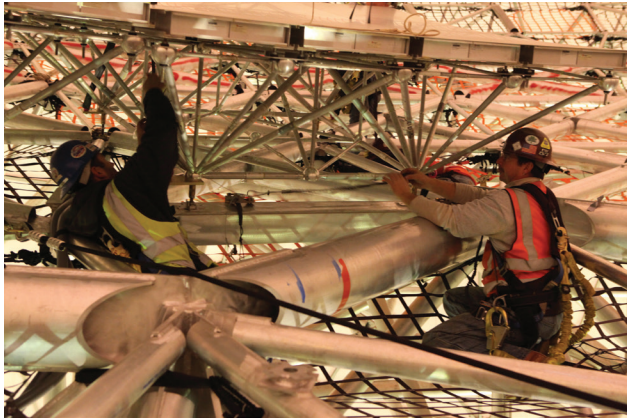
FIGURE 44. Workers in the nets must be careful around the fragile aluminum tubes above and below them.

had been installed while the backstructure was still in the temporary building. Workers in the nets had to be cautious when moving around the backstructure as some of the aluminum tubes have such thin walls that even leaning against them could result in damage. As the surface began to take shape, the space available for the workers was restricted to small triangular “tunnels” formed between two adjacent subframes (Figure 44).

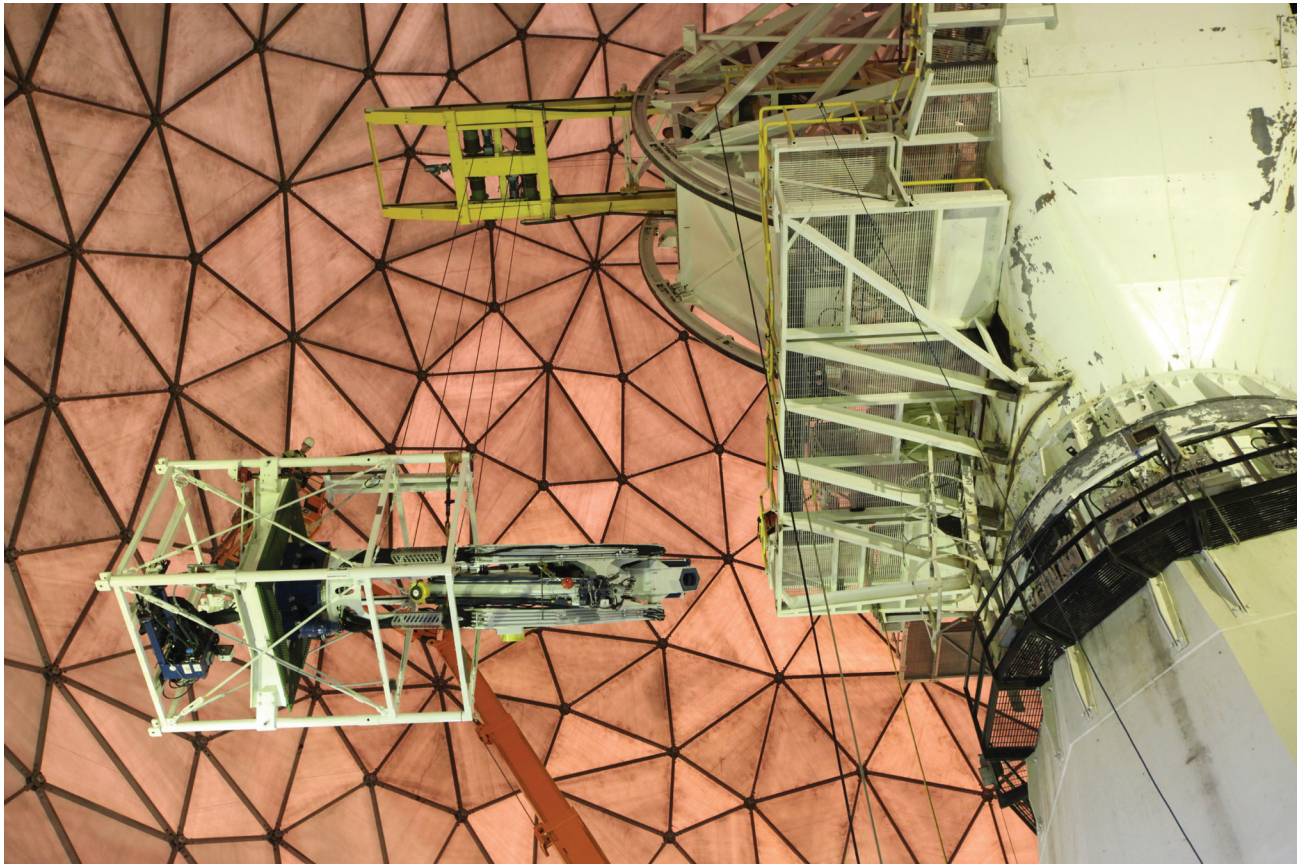
FIGURE 46. The RF box insertion system (RFBIS) hoist lowers the folded-up knuckle-boom crane down to the floor after completion of the subframe installation.

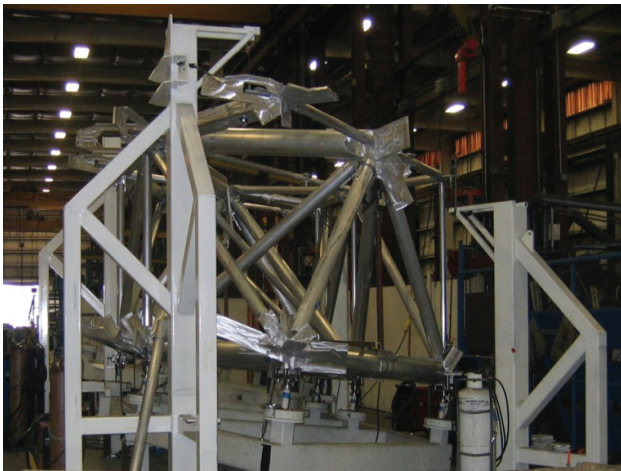
FIGURE A3. Torque ring assembly fixture.

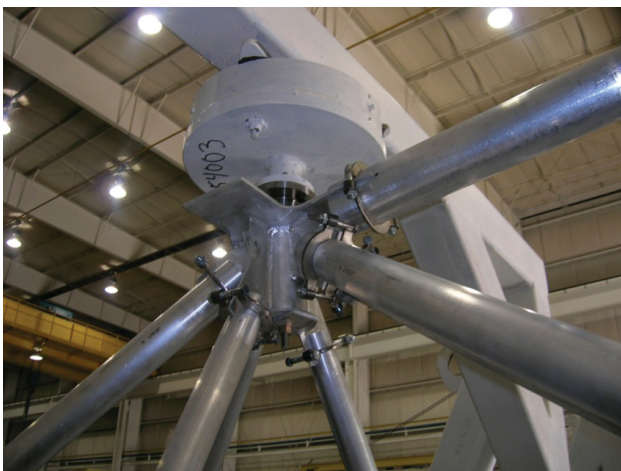
FIGURE A4. Fixturing of backstructure rib tubing to nodes prior to welding operations.

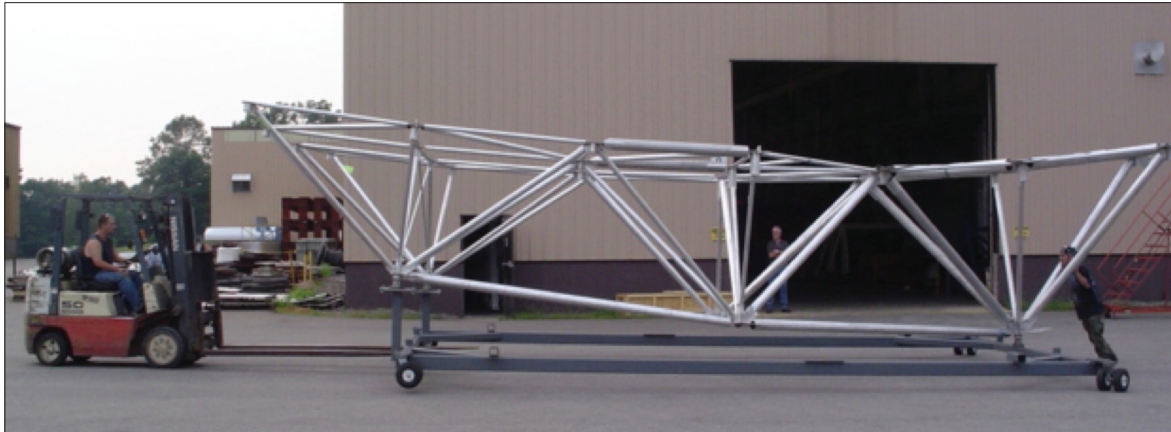
FIGURE A5. Completed radial rib assembly.

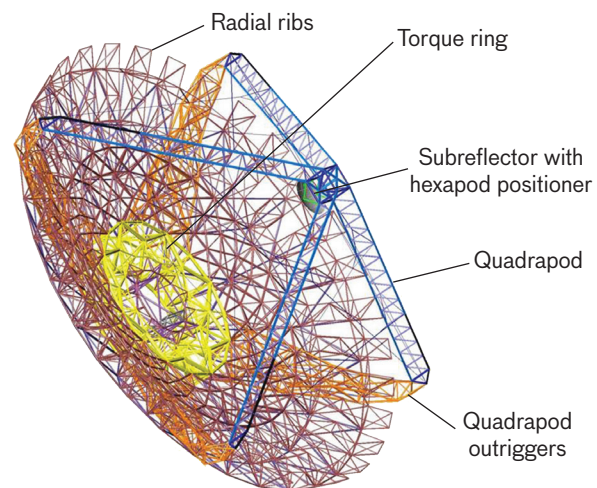
FIGURE A6. Aluminum backstructure with subreflector, quadrapod, and outriggers.

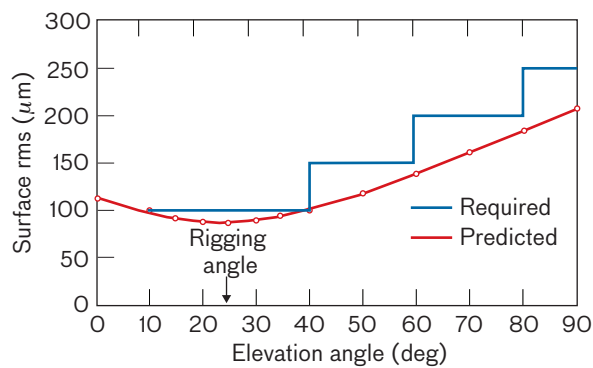
FIGURE A13. Predicted surface rms error when bias-rigged at 25° elevation.
