ANALYSIS OF THE 12 APRIL 1996 WIND SHEAR INCIDENT AT DFW AIRPORT**

Cynthia Meuse, Linda Galusha, Mark Isaminger, Michael Moore, Dale Rhoda, Frank Robasky, Marilyn Wolfson

MIT/Lincoln Laboratory Lexington, Massachusetts

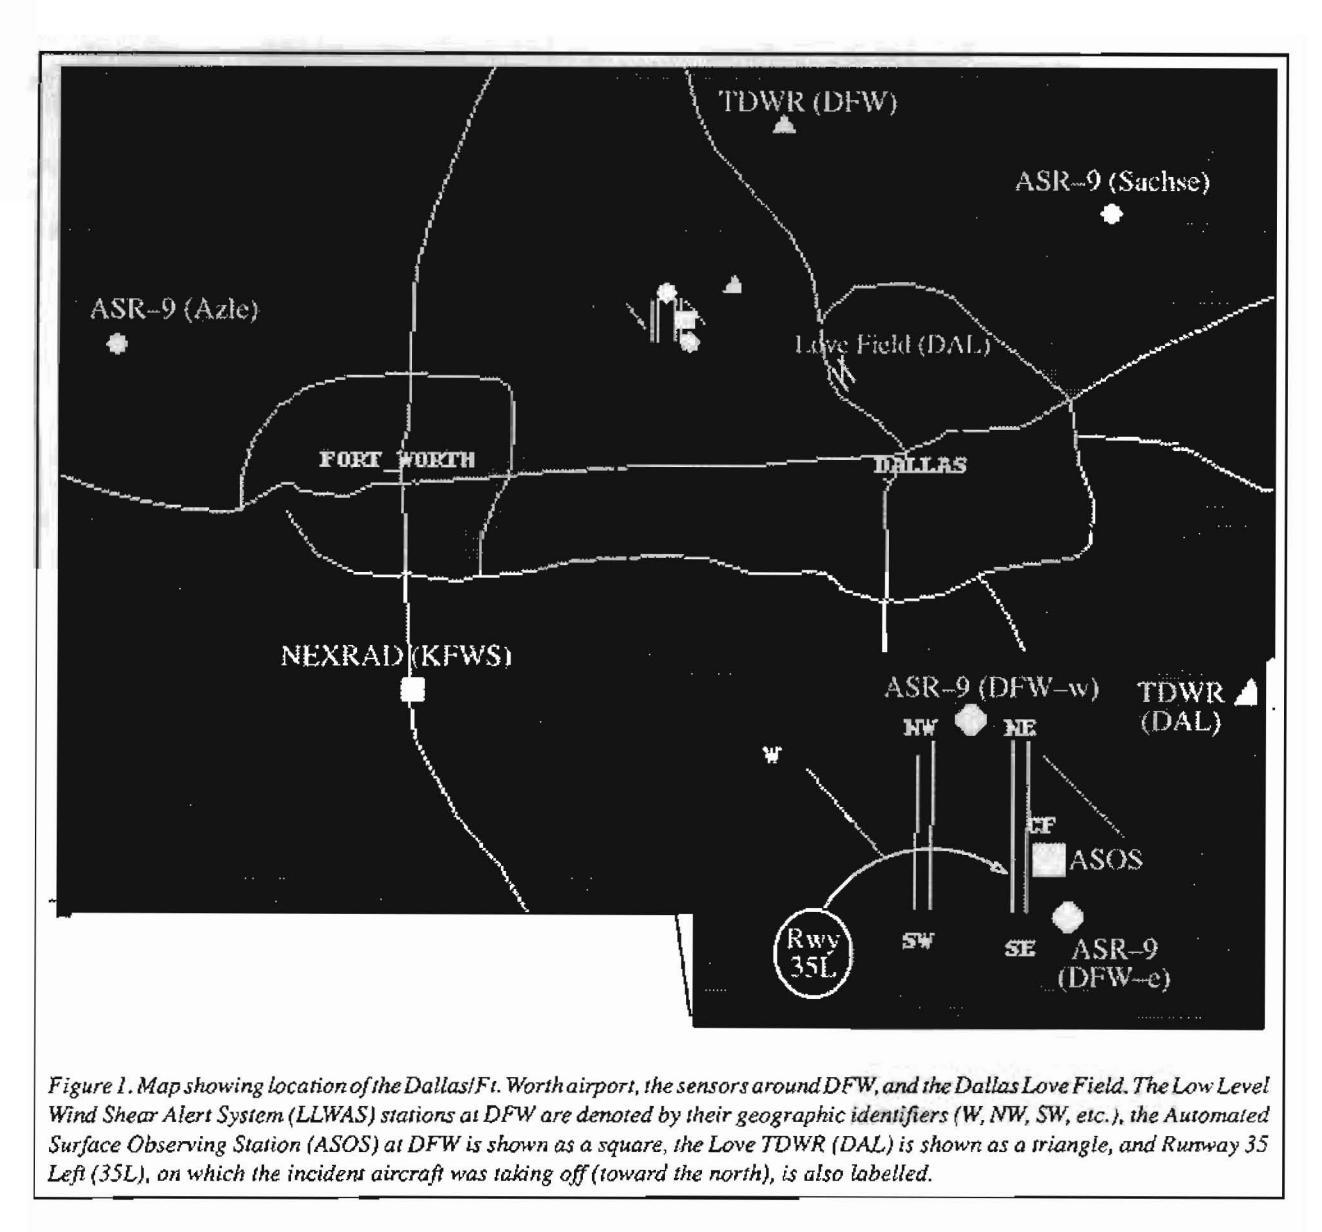
The airport was operating in a "south flow" (planes taking off and landing towards the south) before the storms reached the airport. The line of storms approached from the west and prevented arrivals starting at 2205 GMT (Fig. 2). Departures continued until 2227 GMT. The thunderstorms caused a wind shift at the airport which necessitated a change in runway configuration with nearly 100 aircraft on the ground waiting to depart. The first post-storm departure occurred at

By the time the departures resumed in earnest, precipitation at the airport had diminished to level 1 and the line of thunderstorms was approximately ten miles east of the airport moving eastward at 30 knots (Fig. 2). Approximately 15 aircraft took off to the north without incident before two aircraft on the west side of the airport reported wind shear encounters at approximately 2330 GMT. (Figure 3 shows a transcript of the weather-related transmissions on the west and east side tower frequencies for the period of reported wind shear.) Three minutes later the pilot of AA 1352 taking off on Runway 35L on the east side of the airport reported an encounter with severe wind shear. Reportedly, the winds gusted to 40 kts from the southwest (a tailwind), "the plane was rocked ...violently to the right" (Dallas Morning News, 4/20/96), and the right wingtip banked down toward the runway. The aircraft was so low in altitude, there was concern that the wingtip might actually impact the runway. He used full throttle to keep the plane airborne and advised the relevant air traffic controller to halt departures.

Figure 2. Data mosaiced from three of the four Airport Surveillance Radars (the "DFW-w" ASR-9 is not routinely included in the mosaic) is shown at half hour intervals leading up to the wind shear event. The range rings are drawn at 10 nm (18 km) intervals. The approximate location of the wind shear event is shown in the final panel, at the tip of the black arrow. The wind shear encounter took place in the stratiform region trailing the squall line.
