# Advanced Land Imager: Mechanical Design, Integration, and Testing

Steven E. Forman

■ The Advanced Land Imager (ALI), currently in operation on the Earth Observing 1 (EO-1) satellite, was developed at Lincoln Laboratory during the period from mid 1996 through early 1999. Within significant constraints of size, mass, power consumption, and cost, the ALI was designed to improve on the current Landsat land-sensing satellite technology, providing spectral and radiometric data with high resolution and stability. This article describes the mechanical design, integration, and testing of the ALI at Lincoln Laboratory prior to the launch of the EO-1 satellite in November 2000.

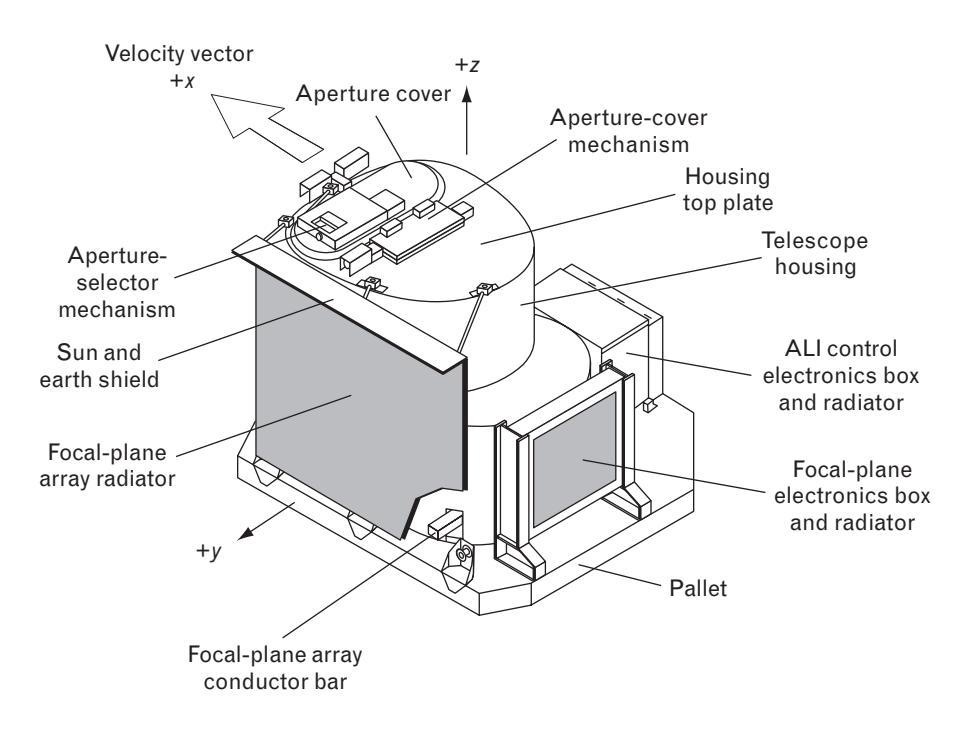
**FIGURE 2.** View of the ALI with the multilayer insulation removed. The positioning of the ancillary components complied with the goals of compactness and mass distribution.

Figure 2 illustrates all the exterior elements of the ALI instrument with the multilayer insulation removed for clarity. This exterior view shows the following elements: mounting pallet; focal-plane electronics (FPE) box, radiator, and supports; ALI control electronics (ALICE) box; telescope housing; housing top plate with the aperture-cover assembly and its open-close mechanism and the aperture-selector mechanism; and the focal-plane array radiator, sun shield and conductor bar. Figure 3 shows a cross-sectional view through the housing. Illustrated here are the telescope and optics, the calibration plate mechanism, and the fo-

Figure 2 shows a drawing of the ALI exterior without its multilayer insulation. Outwardly the STM and the flight unit appear the same. The primary differences are the lack of polished optics and a photon-sensitive focal plane in the STM, considerably reduced cleanliness, and simplified versions of ALICE and the focal-plane electronics.

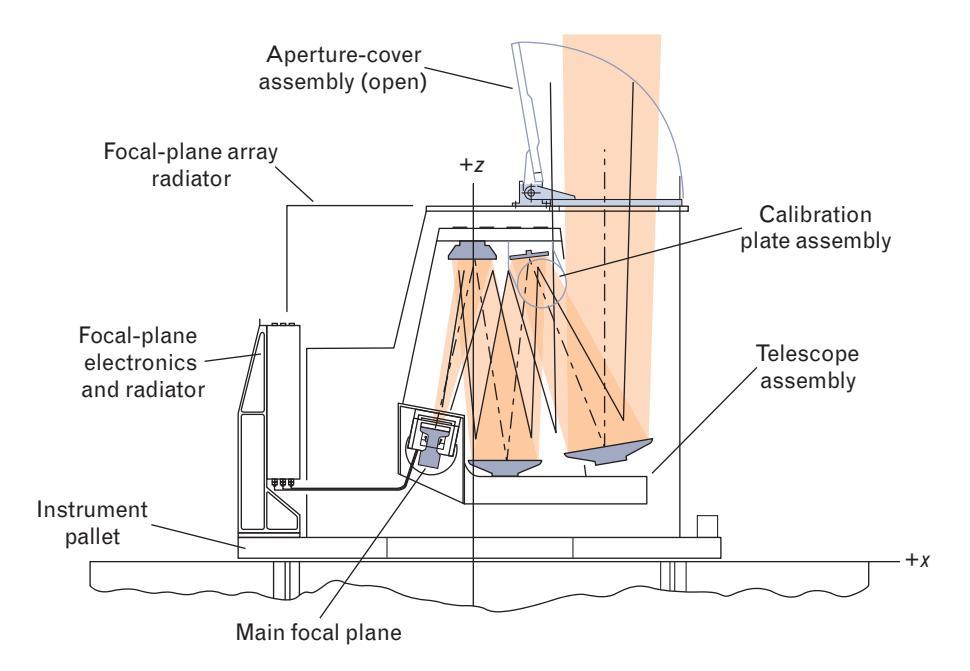
**FIGURE 3.** Cross-sectional view showing the interior elements and optical path of the ALI as viewed from the ALI control-electronics side of the instrument.

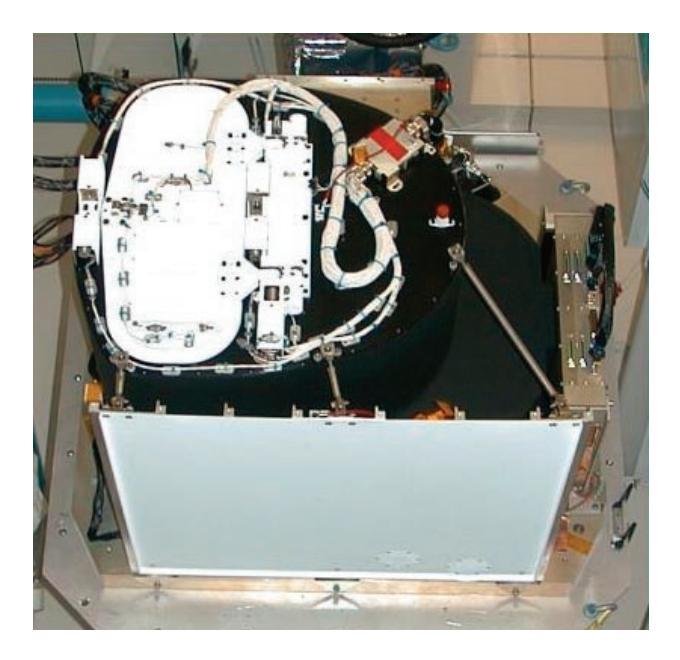
**FIGURE 4.** The exterior of the ALI. The predominantly white area is the aperture-cover assembly. The large gray panel in the right image is the focal-plane array radiator.

cal plane. Descriptions of these features are provided later in the text. Figure 4 shows two photographs of

the ALI exterior with the multilayer insulation again removed for clarity.

mentioned earlier, the focal plane is thermally controlled by an aluminum conductor bar joined to the large white radiator illustrated in Figure 4.

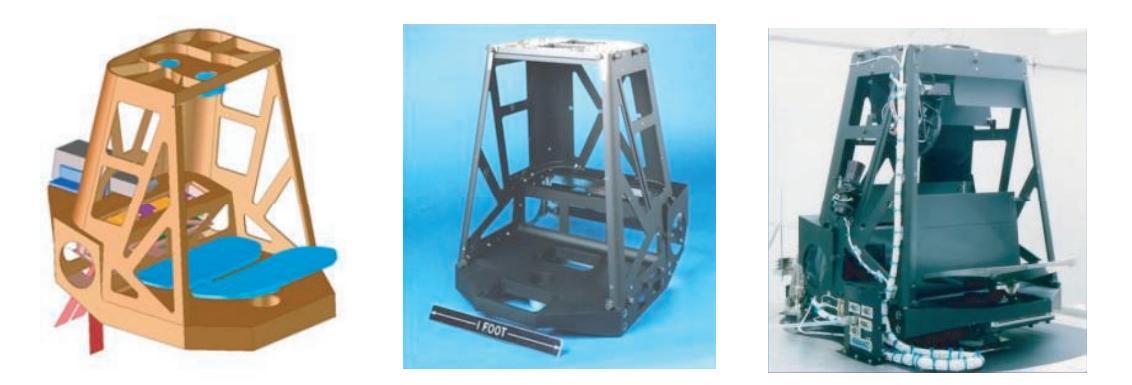
**FIGURE 5.** The three stages of development of the ALI metering truss with silicon-carbide optics. The original computer-aided-design (CAD) model is on the left, the middle image is the completed Invar truss, and the right image shows the completed telescope with the silicon-carbide mirrors in place.

Figure 5 illustrates the progression from the computer-aided-design (CAD) model of the telescope to the machined and bolted Invar truss to the fully assembled telescope. We designed and fabricated the truss at Lincoln Laboratory. SSG provided the polished mirrors and aligned them on the truss. The truss interior and exterior surfaces were painted with black Chemglaze Z-306.

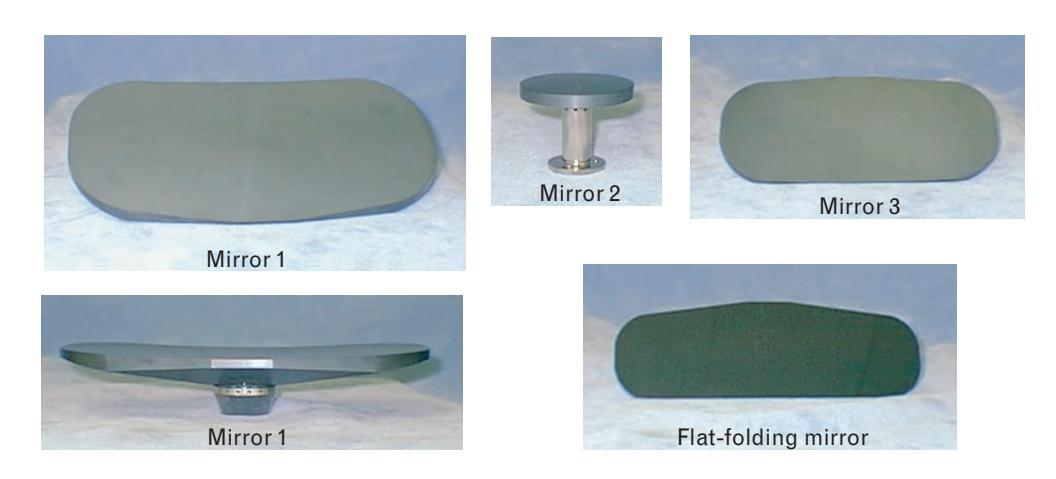
**FIGURE 6.** ALI silicon-carbide optics. The mirrors are shown in approximate comparative sizes. The image of mirror 2 and the second mirror 1 image show the silicon-carbide stub and Invar mounting hub. Note that mirror 2 is covered with the Spectralon diffuser during calibration.

Figure 6 shows the four silicon-carbide mirrors. Each mirror has an Invar mounting hub glued to a silicon-carbide stub, integrally machined on the back side of each mirror, for attachment and alignment in the metering truss. Once completed, the metering truss is attached to a lightweight aluminum pallet with three kinematic titanium supports. We chose titanium for its thermal-isolation characteristics, and the kinematic aspect allowed for differential thermal expansion between the Invar truss and the aluminum pallet. The thermal conductivity of titanium is 7.5 W/m-K, compared to 167 W/m-K for aluminum.

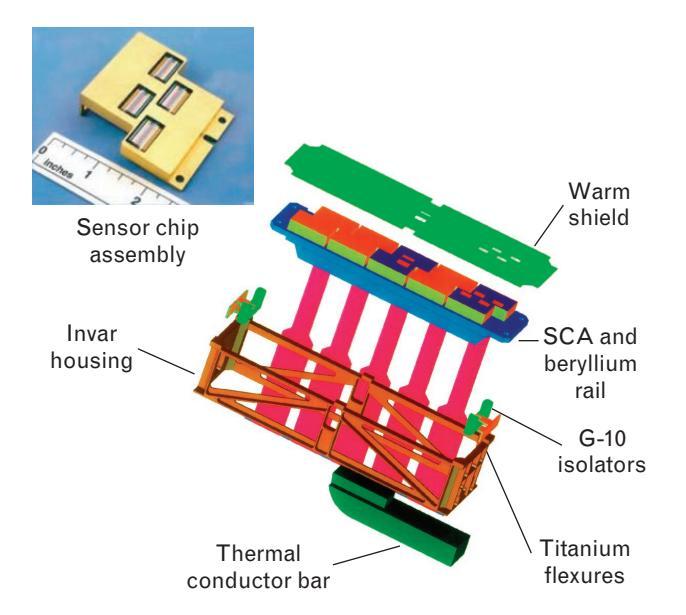
**FIGURE 7.** Focal-plane assembly. The warm shield, G-10 isolators, and the thermal conductor bar control the temperature of the sensor chip assembly (SCA), while the titanium flexures vibrationally isolate the sensor chip assembly.

nium flexures to allow the focal plane to be mounted in the metering truss and aligned to the optics. The focal-plane optical bench is made of beryllium. Any differential thermal expansion between it and the Invar metering truss is compensated for by the titanium flexures. Figure 7 illustrates the design of the focalplane assembly, along with one of the SBRS sensor chip assemblies. The flight instrument contains one active and four simulated sensor chip assemblies. As

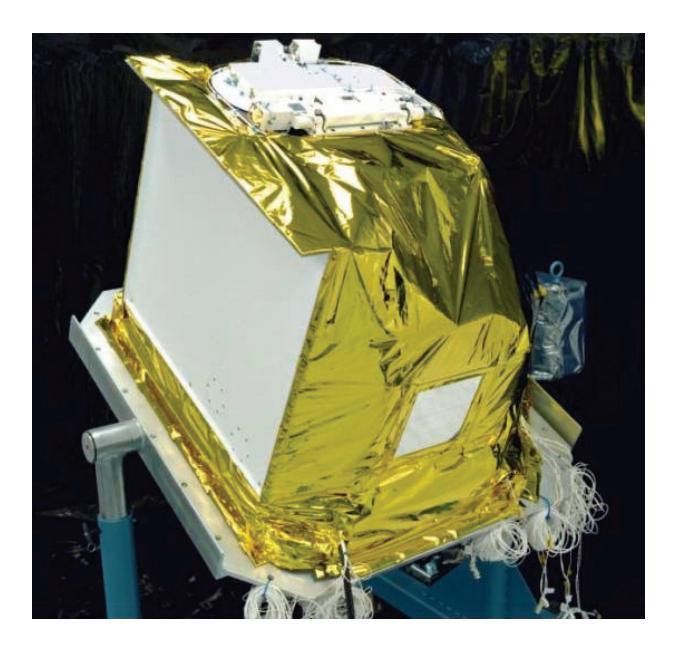
**FIGURE 8.** ALI with multilayer insulation. The regions without insulation are the aperture-cover assembly on top, the focal-plane array radiator on the left, and the focal-plane electronics box radiator on the lower right.

*Mass Properties.* In its fully configured form, shown in Figure 8, the ALI mass was 89.7 kg, very near its allowable value of 90 kg. Using the center of the spacecraft nadir deck as a reference, we placed the ALI center of mass at -1.3 cm, 14.5 cm, 26.7 cm, all within the allowable limits defined in the EO-1-to-ALI Interface Control Document. Table 2 indicates the distribution of system mass among the ALI elements.

The thermal design of ALI involves direct coupling of some components, isolation of others, and both active and passive controls. Figure 8 illustrates the flight instrument wrapped in its multilayer insulation. Figure 9 indicates how the temperature of the focal

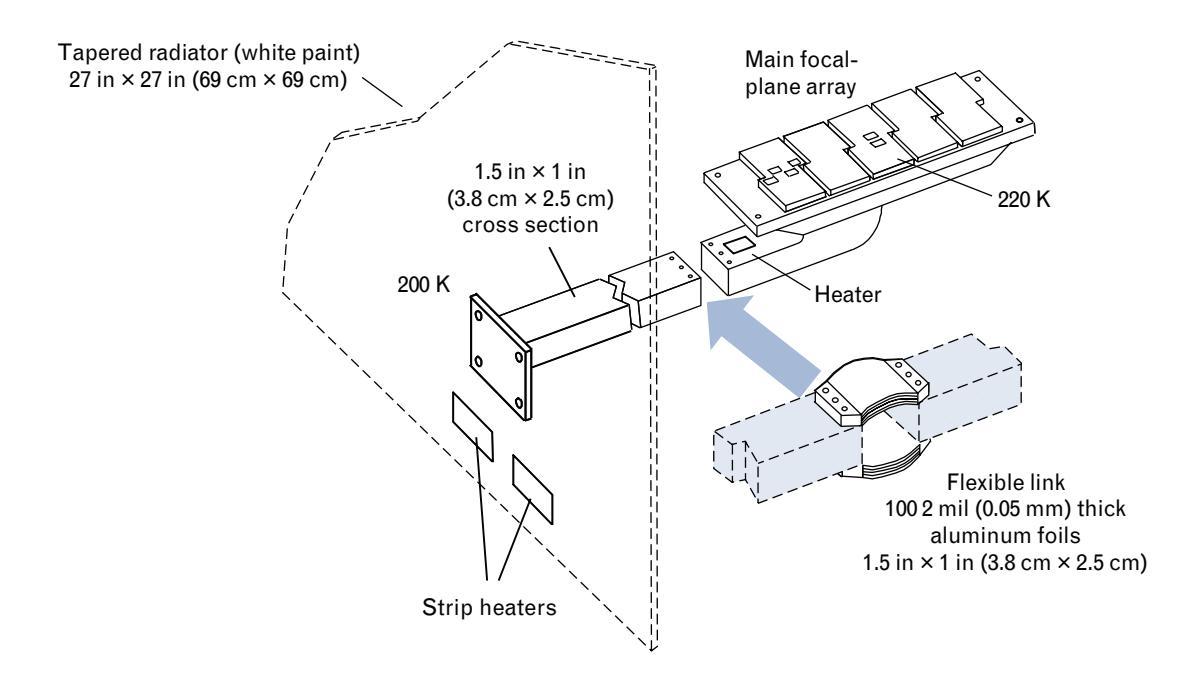
**FIGURE 9.** Attachment of focal plane to radiator. The focal-plane array is maintained at 220 K by a localized heater and the thermal connection to the radiator.

plane is controlled. The aluminum conductor bar at the bottom of the array is linked to the large white radiator through a flexible coupling. If we look closely at the lower right-hand corner of the radiator in Figure 8, we can see the hexagonal bolt patterns of two cover plates, one of which covers the four attachment screws for the solid link of the coupling. The radiator is nominally held at 200 K on-orbit to control the focal-plane temperature to 220 K. Strip heaters are located at selected sites on the radiator and conductor bar to control the focal-plane temperature; set points of 215, 220, 225, and 230 K can be selected through software commands to the ALICE. The radiator is painted with Illinois Institute of Technology Research Institute Z93P white paint.

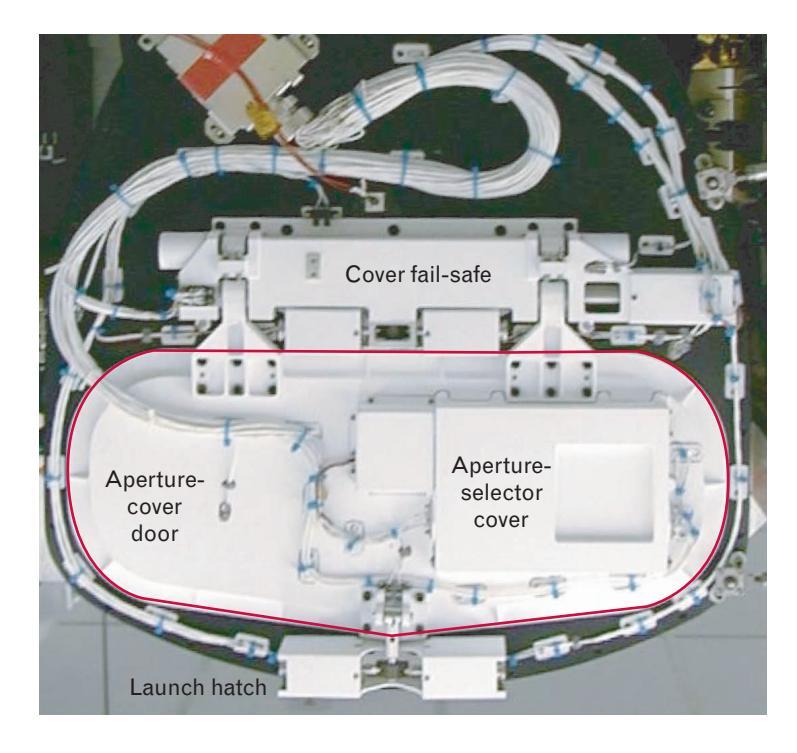
**FIGURE 10.** Aperture-cover assembly mechanisms. The square opening of the aperture-selector cover opens to reveal a series of slits for solar calibration.

The aperture-cover door can be opened or closed as needed during the mission. The door is machined from aluminum and painted white with Z93P on the outside, and anodized black on the inside. Figure 10 shows the aperture-cover assembly and the door. It is

Figure 10 also shows the aperture-selector cover, which is used as part of the calibration scheme. In the square opening, an aluminum plate can be opened or closed on command. When the plate is opened, a progressively increasing array of slits is exposed. The slit array is illustrated in Figure 12, along with front and back images of the selector mechanism. The cover plate is moved by using another Astro stepper motor, which drives a ball screw, advancing a ball nut coupled to the cover plate. A resolver counts shaft revolutions. The motor-resolver-ball screw component is Astro Instrument part CV5-A.

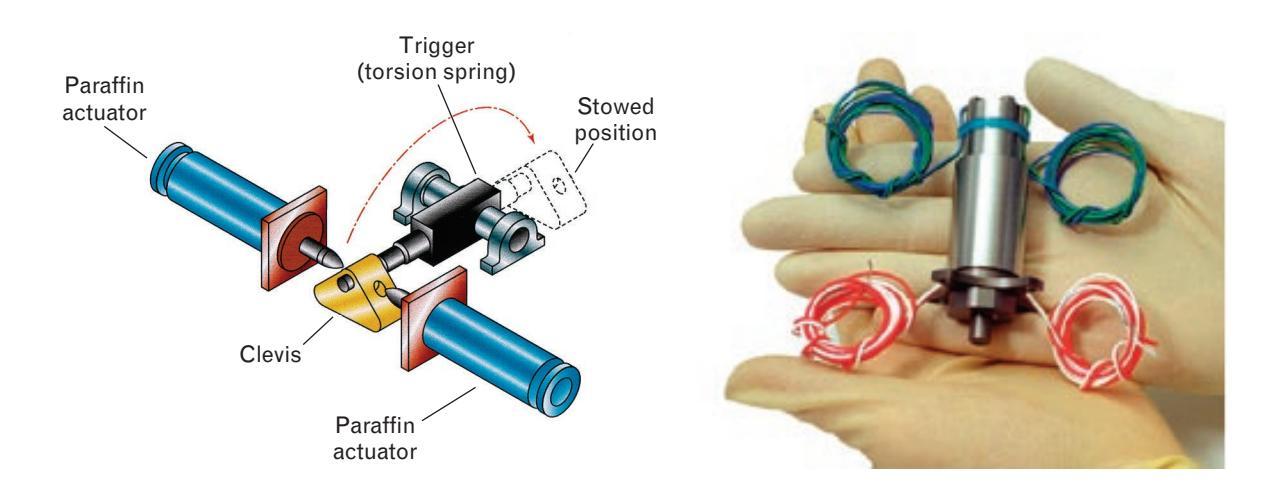
**FIGURE 11.** Launch latch mechanisms. An individual high-output paraffin actuator (HOPA) pin puller is shown in the right image to give an indication of its size.

opened and closed by an Astro stepper motor CV4-A. The door is held closed during launch by the launch latch shown in Figure 11. The latch consists of two Starsys high-output paraffin actuators (HOPA) EP-5025, which engage a triangular clevis on a torsion spring-loaded shaft. On command, one actuator re-

leases, the clevis rotates, and the shaft springs out of the way, allowing the cover to open. Should the actuator fail to operate, a second actuator can be commanded to operate, thus providing a redundant backup.

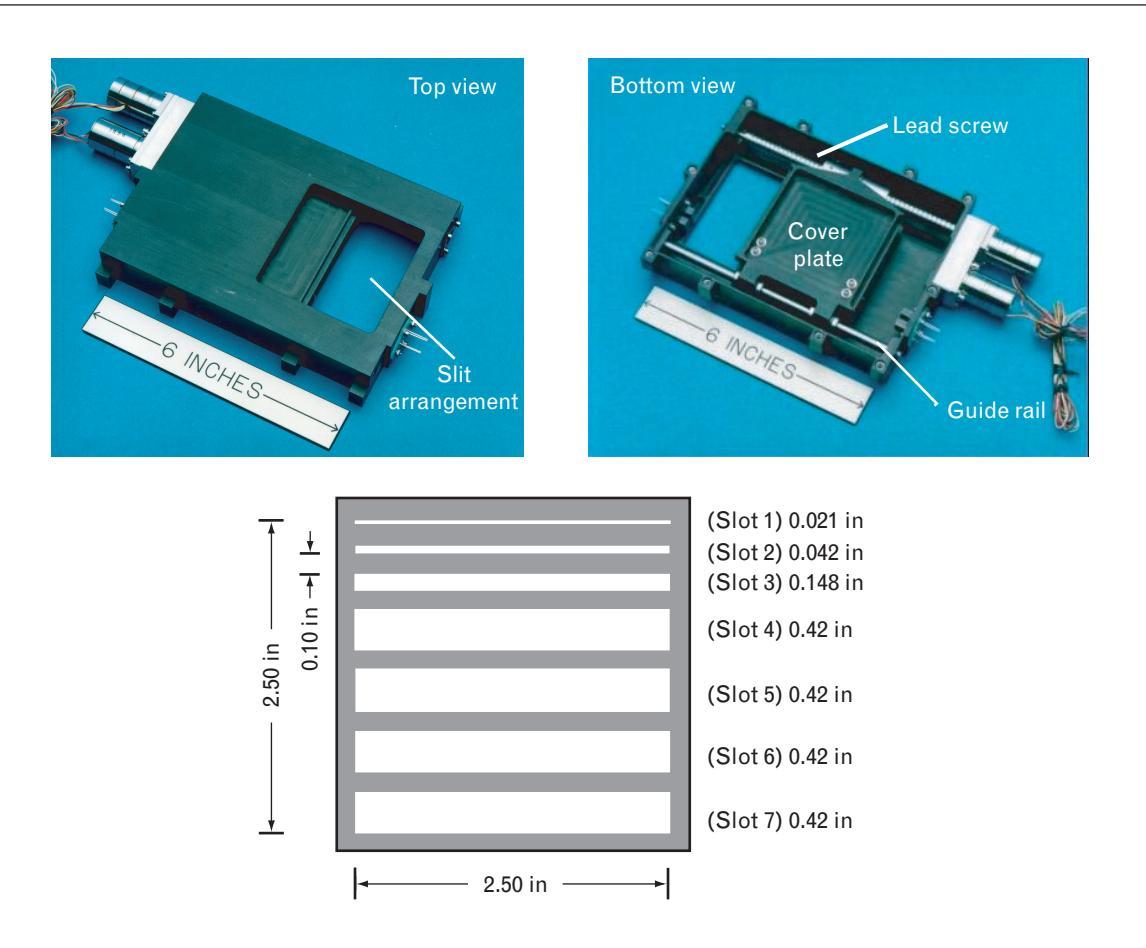
**FIGURE 12.** Aperture-selector mechanism; top view, bottom view, and the slit arrangement. The cover plate opens to reveal the slots in order, with a cumulative aperture of 1, 3, 10, 30, 50, 70, and 90 times 0.021 in.

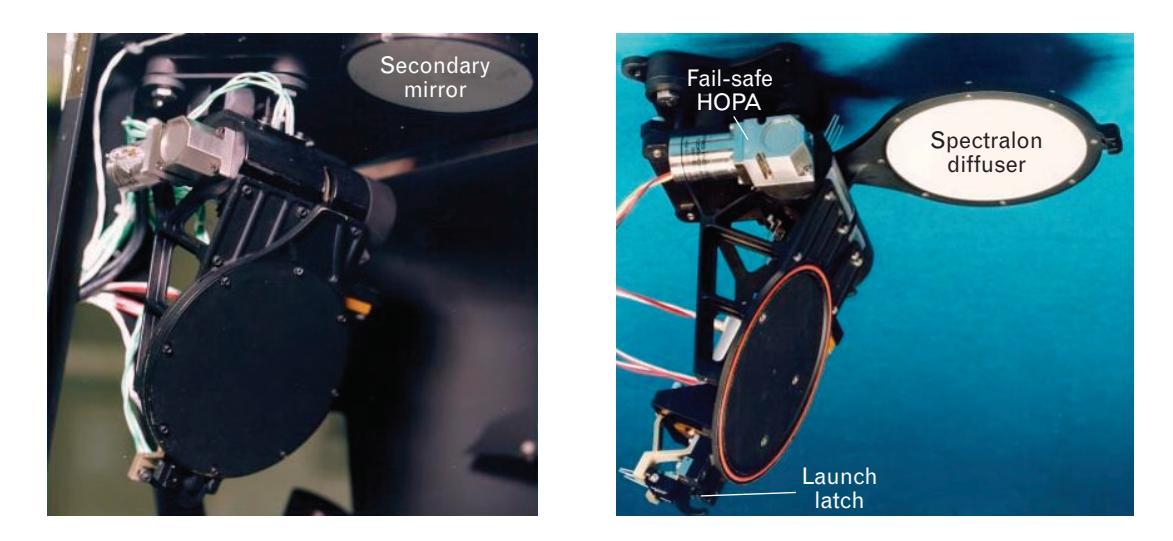
**FIGURE 13.** Secondary-mirror-calibration diffuser mechanism. The left image shows the diffuser in closed position, while the right image shows the diffuser in open position.

The third mechanism, illustrated in Figure 13, is the secondary-mirror diffuser, which is also used for calibration. Here a Spectralon disk can be rotated in front of the secondary mirror to prevent direct sunlight from falling onto the focal plane during solar calibration. Once again, a paraffin actuator from Starsys is used to control a launch latch, which is released once EO-1 reaches its orbit. The disk is rotated by the third Astro stepper motor part CV3-A. In the event the motor fails, a second paraffin actuator can be released, activating a torsion spring, which can backdrive the motor and return the disk to its initial position. This mechanism, along with the aperture-cover door and the aperture-selector cover, contain light-emitting diodes to provide indications of fully open or closed positions.

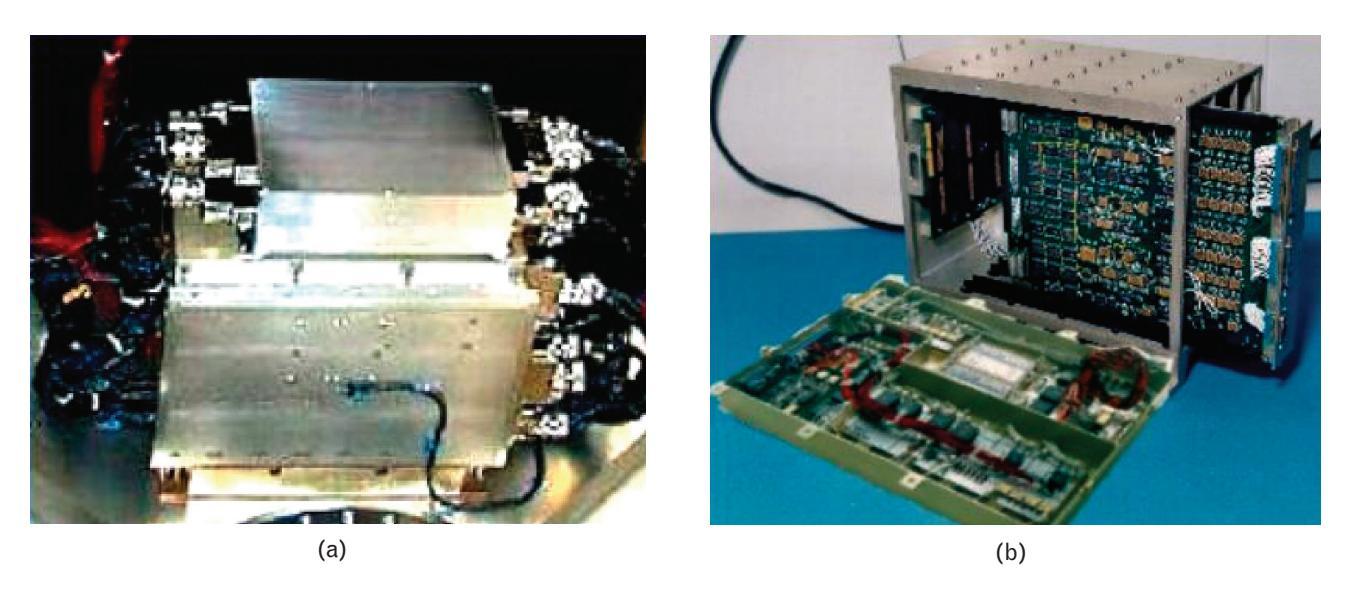
**FIGURE 14.** ALI Control Electronics (ALICE) packaging. (a) Three printed circuit boards are bonded to metal cores and thermally bonded to the pallet. (b) The panel containing the power converters, which generates the majority of the heat, is in front of the unit.

Figure 14(a) shows the external packaging of the ALICE unit. The wire on the front side of the box is used to monitor the box temperature. Immediately below the wire, at the bottom of the box, a solid alu-

minum bar is used to thermally connect the box to the pallet. Heat is generated by the power converters contained in the package shown lying on its side in Figure 14(b). Both chassis are machined aluminum. The AL-ICE contains three printed circuit boards that connect to a back plane and are secured in place by thermally conductive wedge clamps. Each board assembly consists of an aluminum heat sink with an active board on one side and a compensating board on the other for thermostructural symmetry.

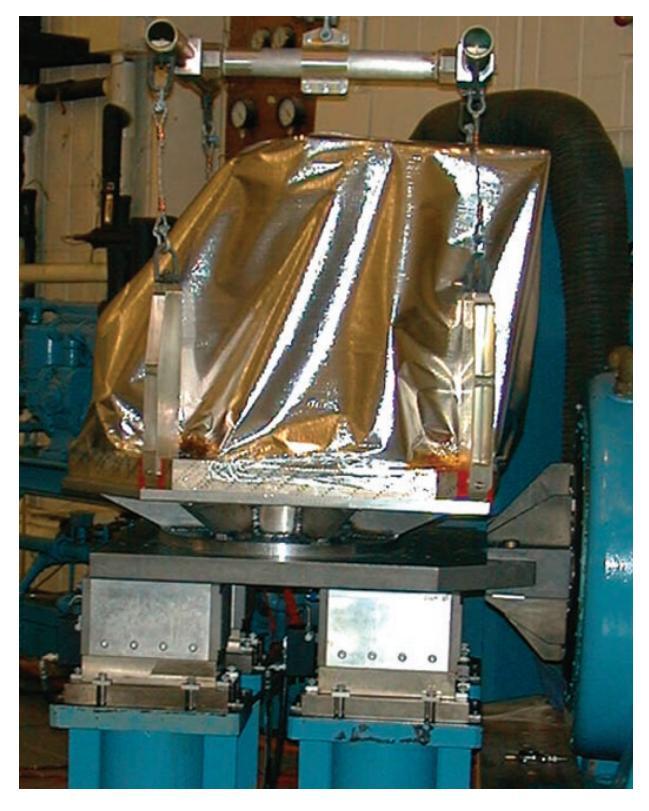
**FIGURE 17.** Flight instrument mounted on vibration table. A suite of triple-axis protoflight tests, including sine sweeps and random-level tests, were applied to the ALI.

The fully integrated telescope underwent vibration testing, as shown in Figure 17. We performed sine sweeps and random vibration tests along all three axes. The instrument was double bagged to prevent particulate contamination, because the vibration test equipment was not in a clean area. Notching random inputs ensured that no loads exceeded the quasi-static allowables. There were two exceptions to the test; we did not install multilayer insulation, and we used a mass mock-up for the ALICE, because it had not been fully completed at the time of the test.

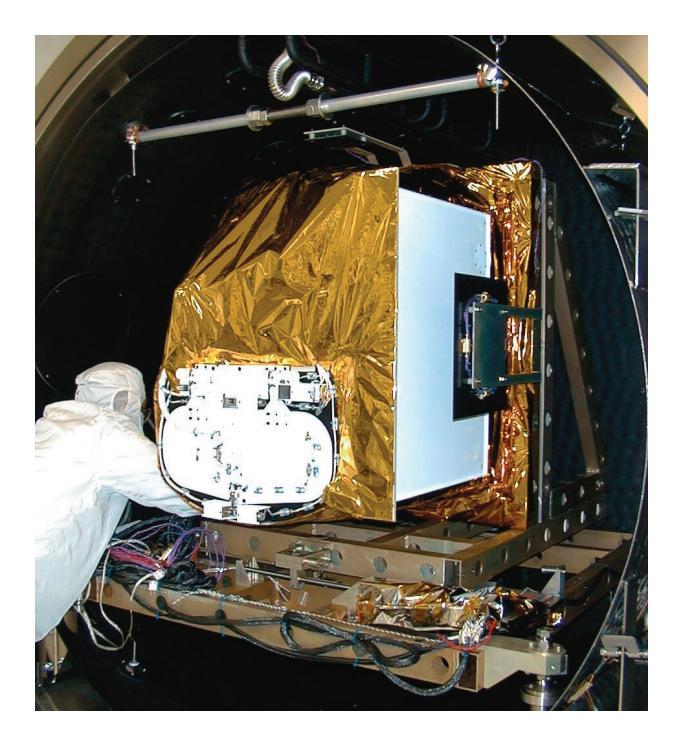
**FIGURE 18.** ALI in vacuum tank. Two heater plates are in position for the thermal testing.

clean-room vacuum tank for thermal-vacuum cycling and testing. Figure 18 shows a photograph of the vacuum tank installation. We controlled the temperature of the ALI through a spacecraft simulator, which provided an EO-1 nadir deck-temperature control and other heater plates facing radiating surfaces. Two of those heater plates are illustrated in Figure 18—one is facing the focal-plane radiator on the right side and the other is above the focal-plane electronics radiator at the top in the center of the tank.
