Further Studies of ATCRBS Based on ARTS-III Derived Data

A. G. Cameron

13 December 1974

1. Report No. FAA-RD-74-145	2. Government Accession No.	3. Recipient's Catalog No.	
4. Title and Subtitle Further Studies of ATCRBS Based on ARTS-III Derived Data		5. Report Date 13 December 1974

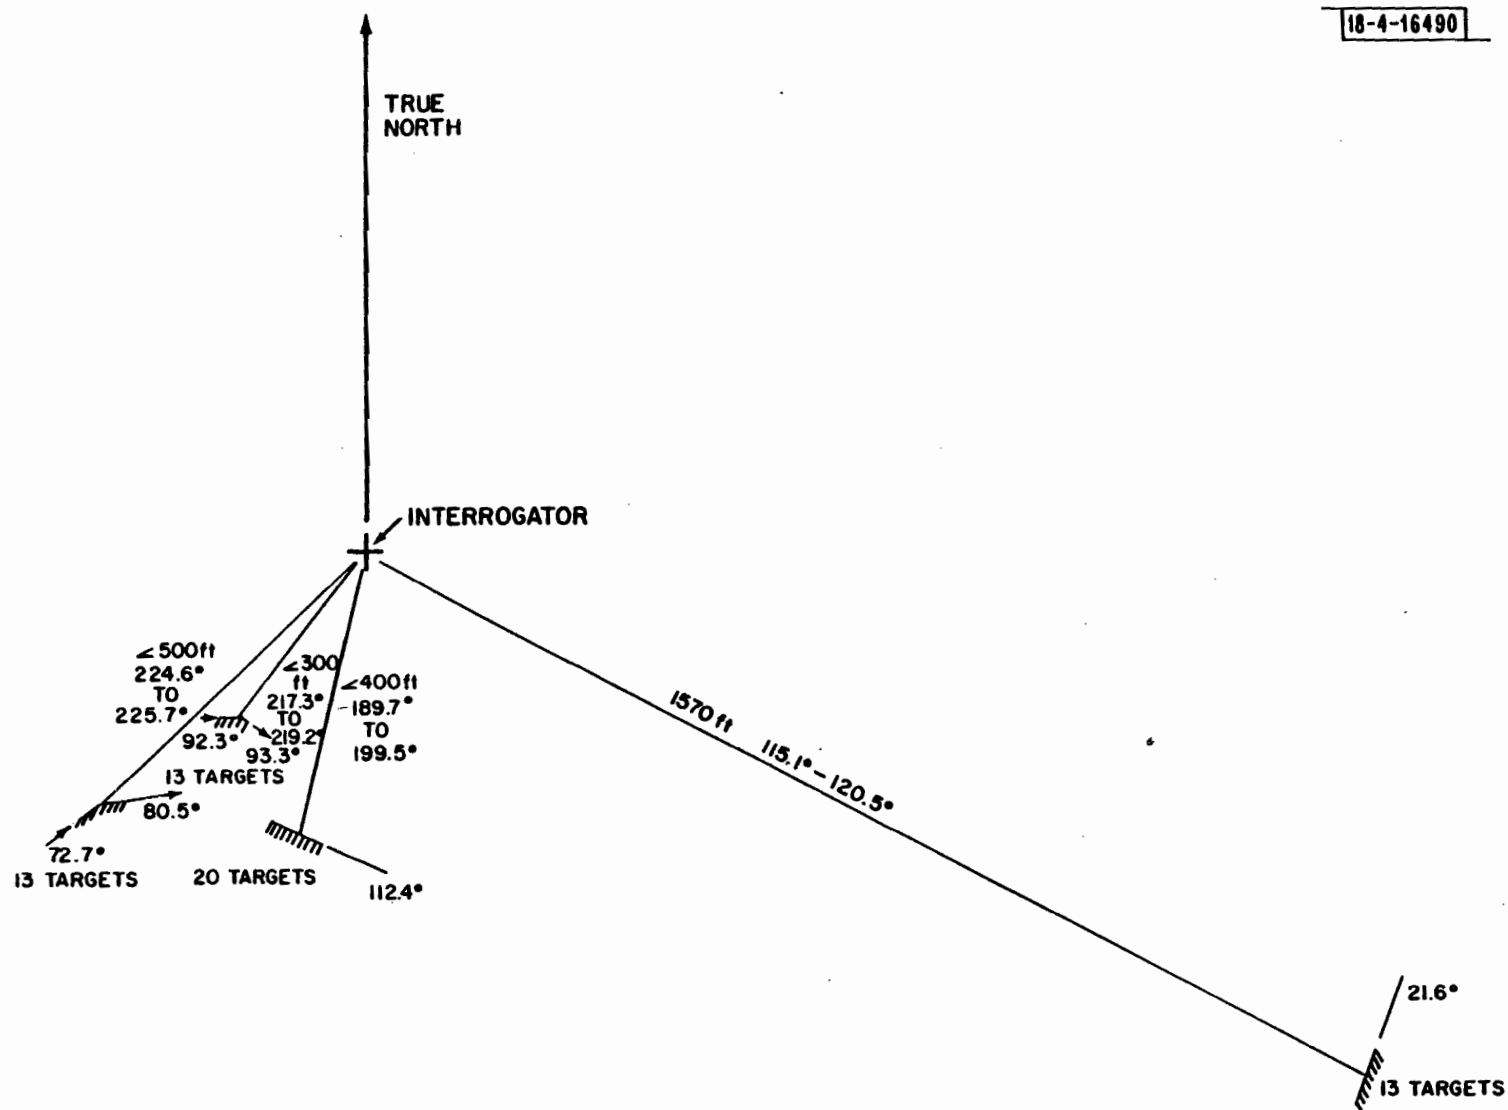
Fig. 4. Reflectors noted at Saitland

As noted, approximately 60 discrete-code aircraft were within the coverage area over the 32 scans examined. The target code listing was examined for instances in which any discrete code appeared at azimuths other than that of the actual aircraft. Of course, splits and dual occurrences of the same codes apparently assigned to two different aircraft were not counted. Fifty-nine instances attributable to reflections were noted in the 32 scans; all were consistent with reasonable reflection geometries.* That is, the false declarations were always at ranges between 0 and 2 miles greater than the instantaneous (interpolated) positions of the actual aircraft, and at azimuths removed by many degrees from those of the aircraft. The 59 false declarations were grouped in azimuth and found to fall entirely with 4 distinct narrow azimuthal sectors; all data pertaining to any one of these sectors agreed quite closely with regard to reflector orientation and range (well within a degree in orientation, and $1/8$ nmi in range difference). The locations and orientations of the reflecting surfaces responsible for the false targets are shown in Fig. 4. As can be seen from that figure, two surfaces appear "bent." In each case, the calculated orientation angle appeared different at one extreme of the reflector azimuth segment than at the other. Differences are larger than can be explained from measurement inaccuracies, and are due either to edge diffraction, to the presence of two separate reflecting surfaces close to one another, or to some combination of these effects. In the case of one of the reflectors, half of the data samples fell to one side of an azimuth near the center of the reflector, and resulted in orientation angle data tightly

bunched around one value; the other half, which fell to the other side, all yielded orientation angle data tightly bunched around another value, which differed by one degree from the first.

The lengths of the false target tracks resulting from these reflectors varied widely: several only occurred once. A few occurred on 4 or 5 scans in sequence. One false target track, due to the reflector at 190° , continued over 11 scans within the 32 scans which were examined. That particular track was followed past the 32nd scan, and found to persist for a total of 51 scans* (slightly more than 8 minutes!). During that occurrence, the actual aircraft range decreased from 57 nmi to 20 nmi, and azimuth varied by about 8° (the aircraft was apparently inbound to DCA). Of course, false target position varied in a similar fashion.

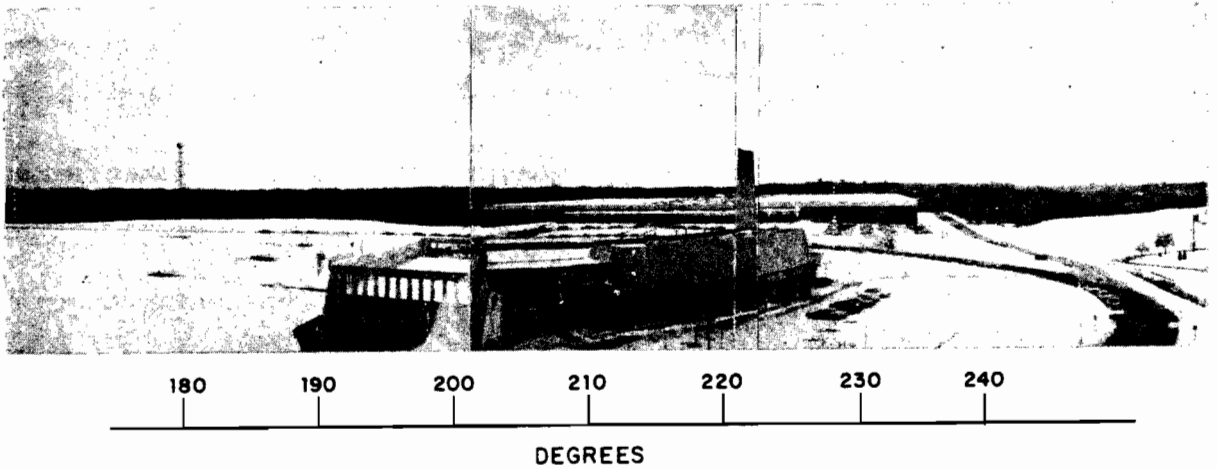
Fig. 5. Southerly sector of panoramic photograph taken from Suitland, MD. ARSR.

Upon completion of the false target analysis, discussions were held with Washington ARTCC and ECAC personnel about the surroundings of the radar. They noted, and a subsequent panoramic photo confirmed, that there is indeed a building at close range to the south, whose shape fits the pattern

The incinerator building looks to be about 150 ft long; it would certainly be possible to modify its surface to cure the reflection problem it causes. Modifications of this sort would undoubtedly alter the lines of the building substantially. The other building, on the other hand, appears quite long, and probably prohibitively expensive to modify.

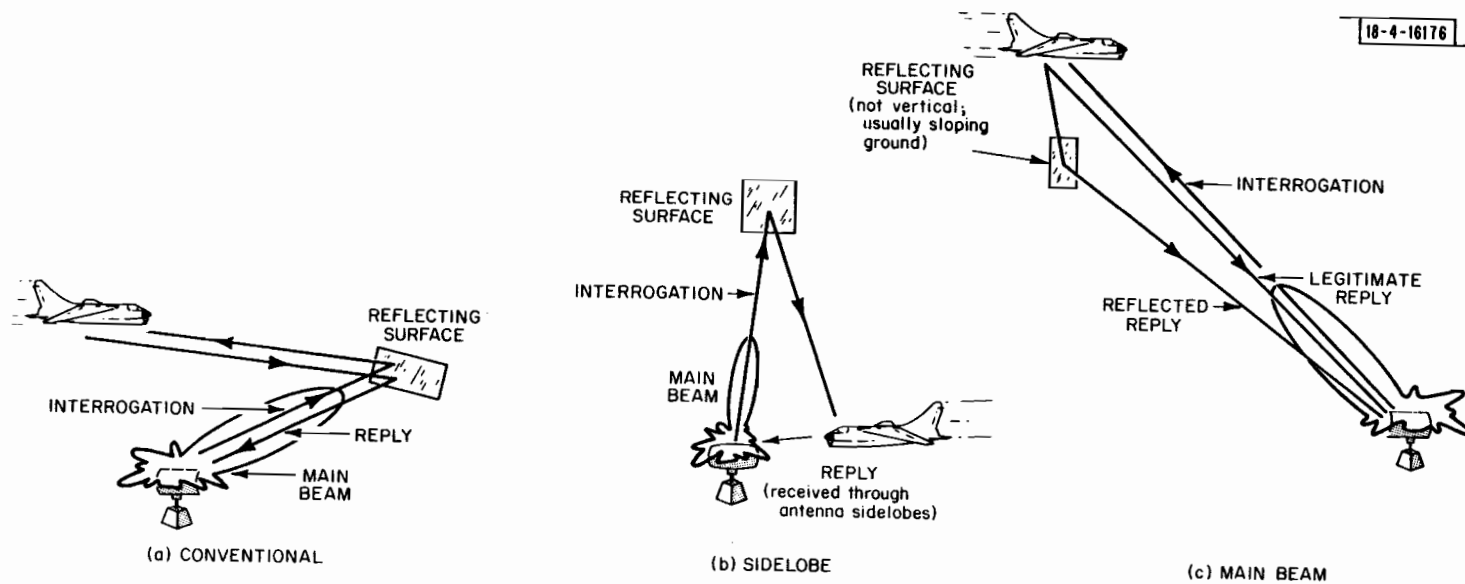
Fig. 7. Types of false targets

"Mainbeam" false targets, or range splits (Fig. 7(c)). These have been observed only rarely, and are problematic to our knowledge only at the Las Vegas, Nevada ASR. They result from reflection of legitimate replies (during the time the aircraft is in the mainbeam) off of properly-oriented patches of planar ground, also in the mainbeam.

It is noteworthy that more than half of all the "sidelobe" false reply sequences were actually declared as targets by ARTS-III, most of which were accompanied by one or two replies received via the conventional (reflecting) path. That these were often of sufficient width to cause declaration while the

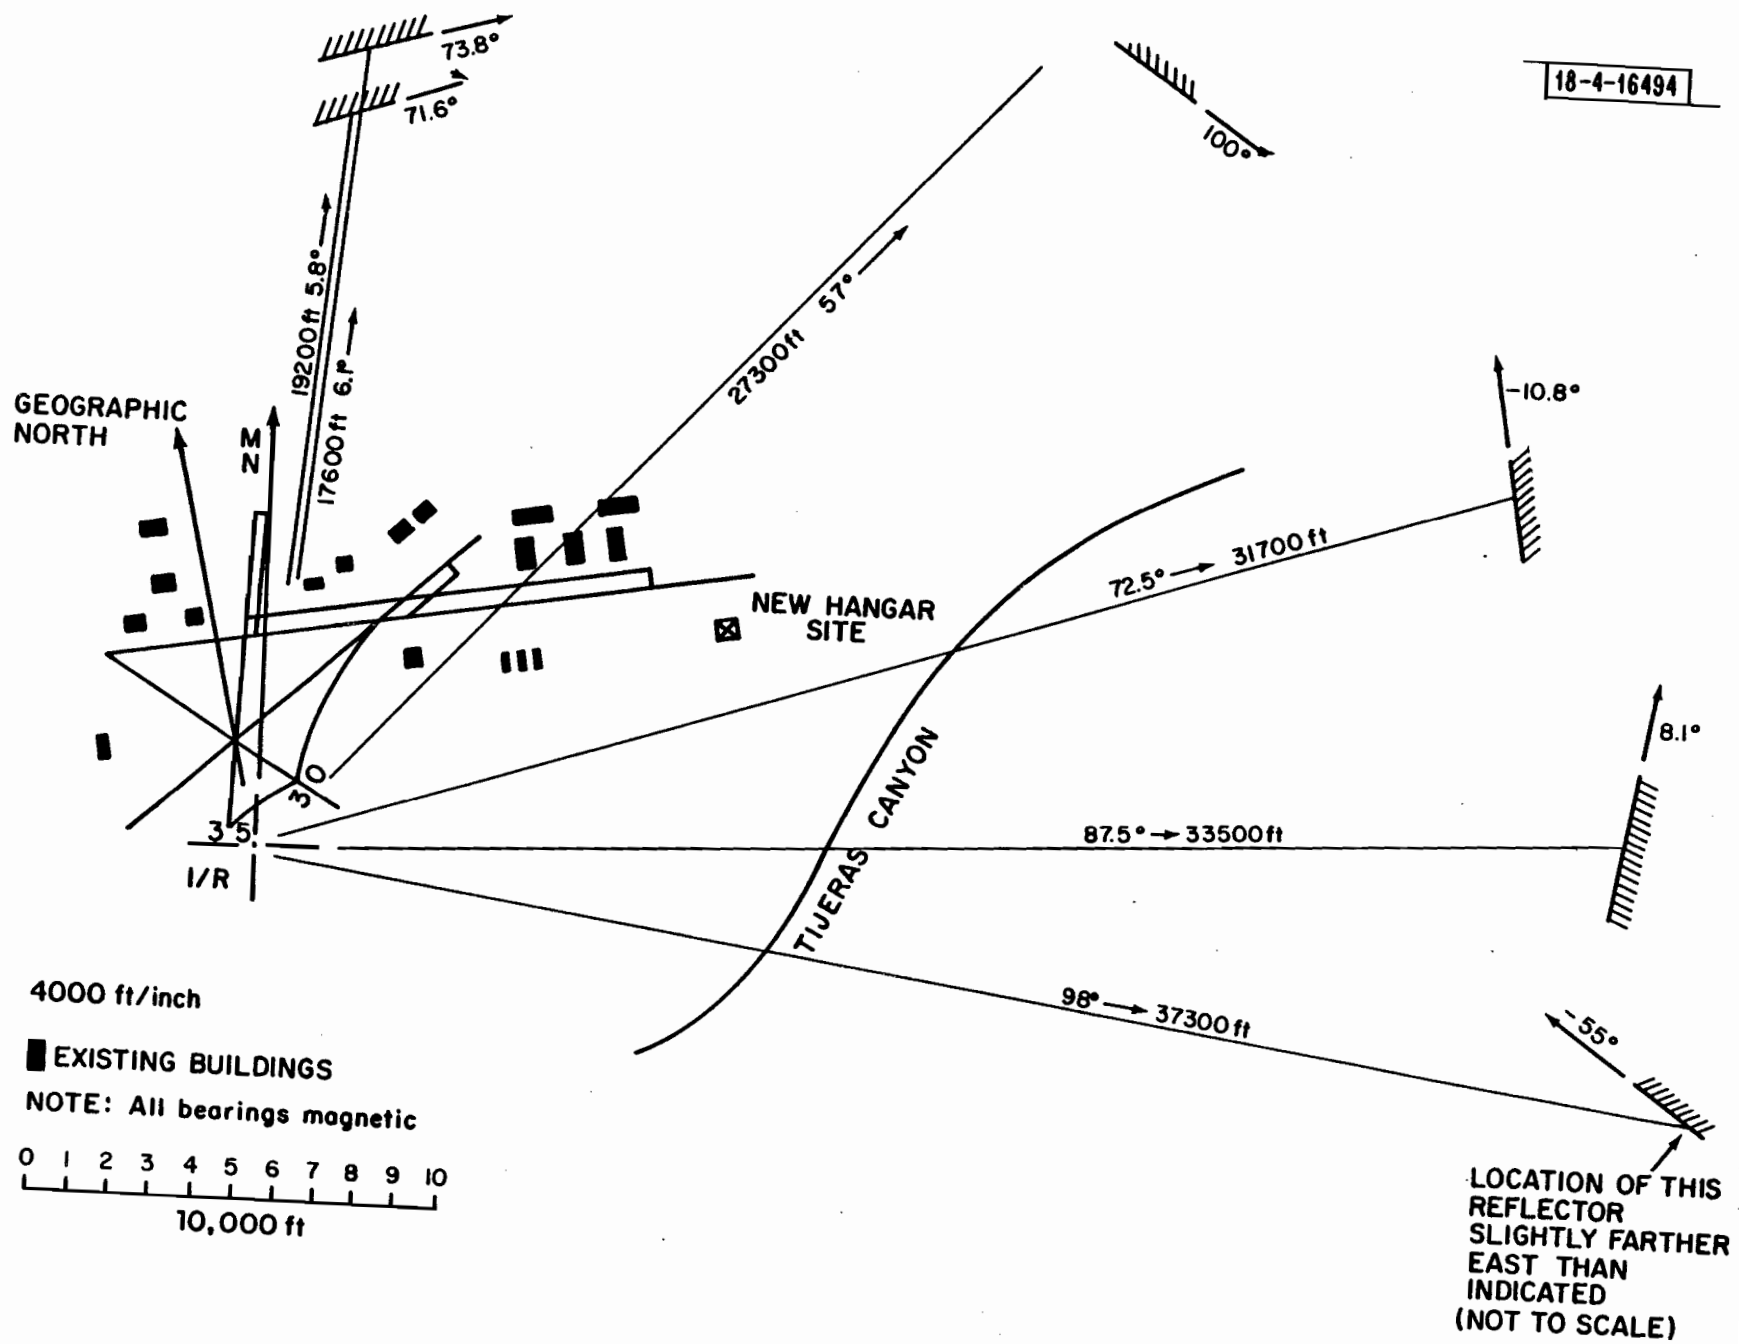
Fig. 8(a). Nearby reflectors - ABQ

The geometries of the 61 false reply sequences were analyzed, and found to be due to 11 different reflecting surfaces. The locations and orientations of these surfaces are as shown in Fig. 8 (a), (b), and (c). (Three separate figures were used for clarity; the reflectors were at quite disparate

ranges.) The quantities of false replies caused by these reflectors, compared with those caused by other reflectors at comparable ranges observed in past data from other sites (with appropriate corrections made for differences in system parameters), suggests that several of these reflectors are quite large, and long in extent, notably the two to the East at 72.5° and 87.5° . The reflectors and pertinent parameters are listed in Table 8.

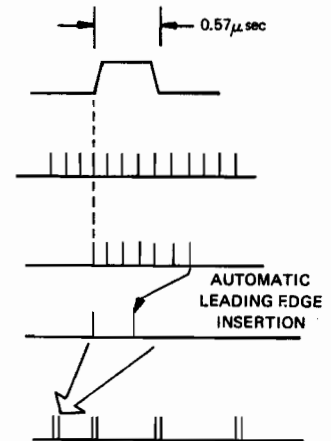
There are two mechanisms by which ATCRBS reply pulses could be widened excessively: short time delay multipath and ATCBI receiver/ARTS-III front-end misalignment. Instances of both have been seen in past data. Indeed, two instances of multipath were noted in the 16 November 1973 Albuquerque data (the two "mainbeam" reflectors shown in Fig. 8(c)). However, in both these cases, the replies were separated by two or more range cells (rather than one). This amount of separation is inconsistent with excess pulse-width, and can only result from a channel in which a single input pulse results in a distinct pair of output pulses, separated by a microsecond or more.

INPUT TO BRACKET DETECTOR (Different Time Scale)

WIDE PULSE

SINGLE REPLY SENSED

BRACKET DETECTIONS

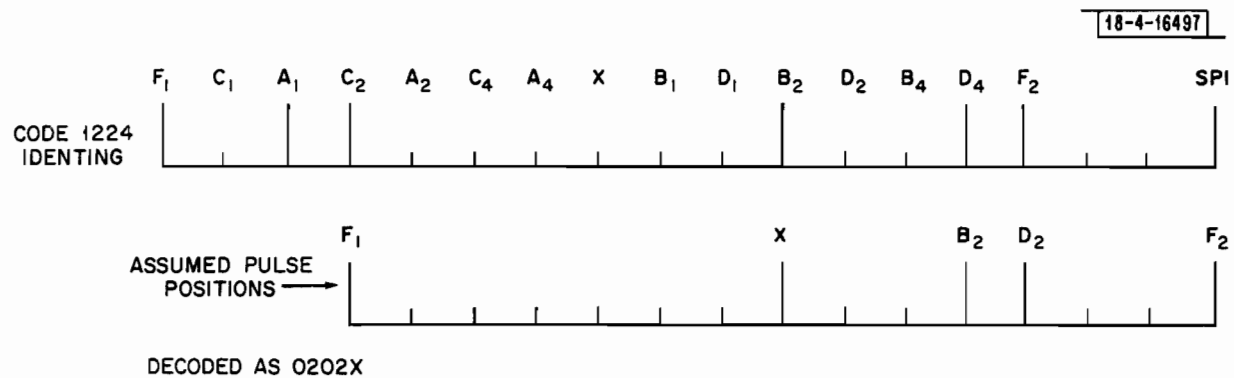
Fig. 10. Generation of a C_2 - SPI Phantom.

This phenomenon was noted on Mode A in connection with SPI operation, which occurred only rarely. It was far more prevalent on Mode C; early specifications for altitude encoding transponders (cf. Ref. 7) required that the SPI pulse be set in a Mode C reply whenever the D_4 pulse was set. Many airline transponders today encode altitude in this fashion; the D_4 pulse only becomes set above pressure altitude 30,800 ft. Three of the aircraft in the ABQ coverage area replied in this manner, and whenever they were at altitudes such that the C_2 pulse was set as well (this occurs about 60% of the time in Mode C replies), their reply sequences contained multiple C_2 -SPI phantoms.

Approximately one time in four, these were of sufficient quantity to result in low validity or defaulted altitude decoding.

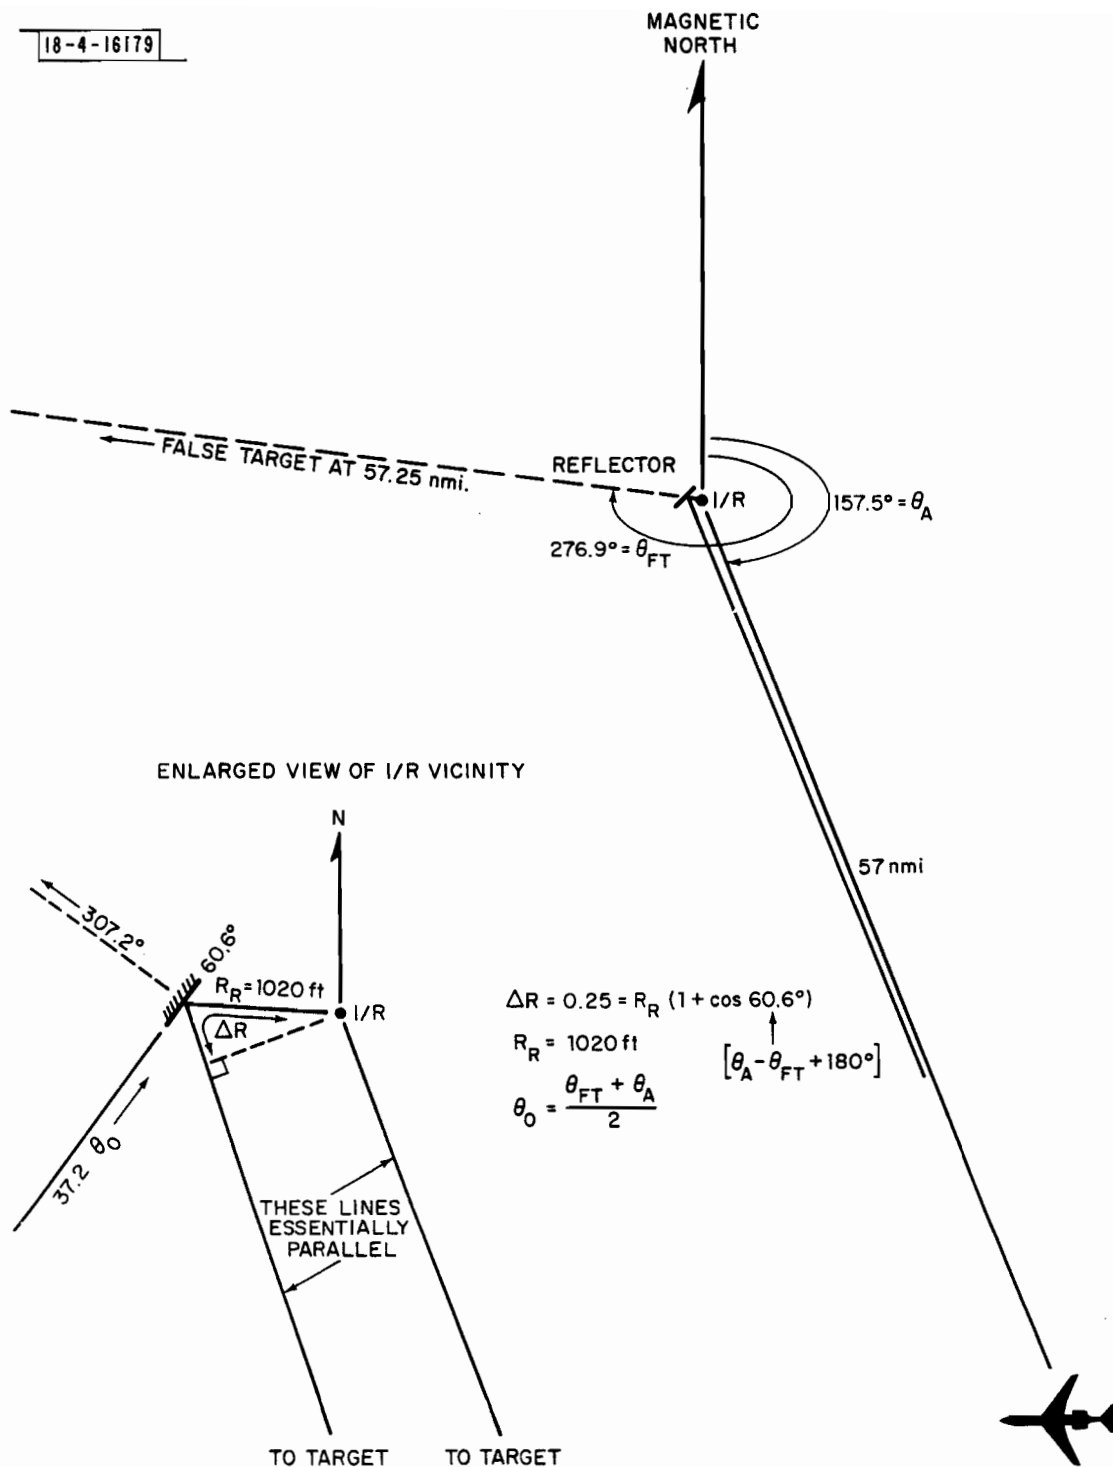
Fig. 11. Simplified geometry $R_A \gg R_R$.

These assumptions appear quite appropriate for the particular situation at Albuquerque. Should they prove undesirable in other applications, it is fairly straightforward to remove their effects from the algorithm. The basic false target elimination algorithm is first described in general terms, and then specifically tailored to the Albuquerque situation. The process involves recognition of aircraft in regions where they can cause false targets, calculation on where those targets would be, search of those areas to see if correlated targets are present, and identification of those targets as false.

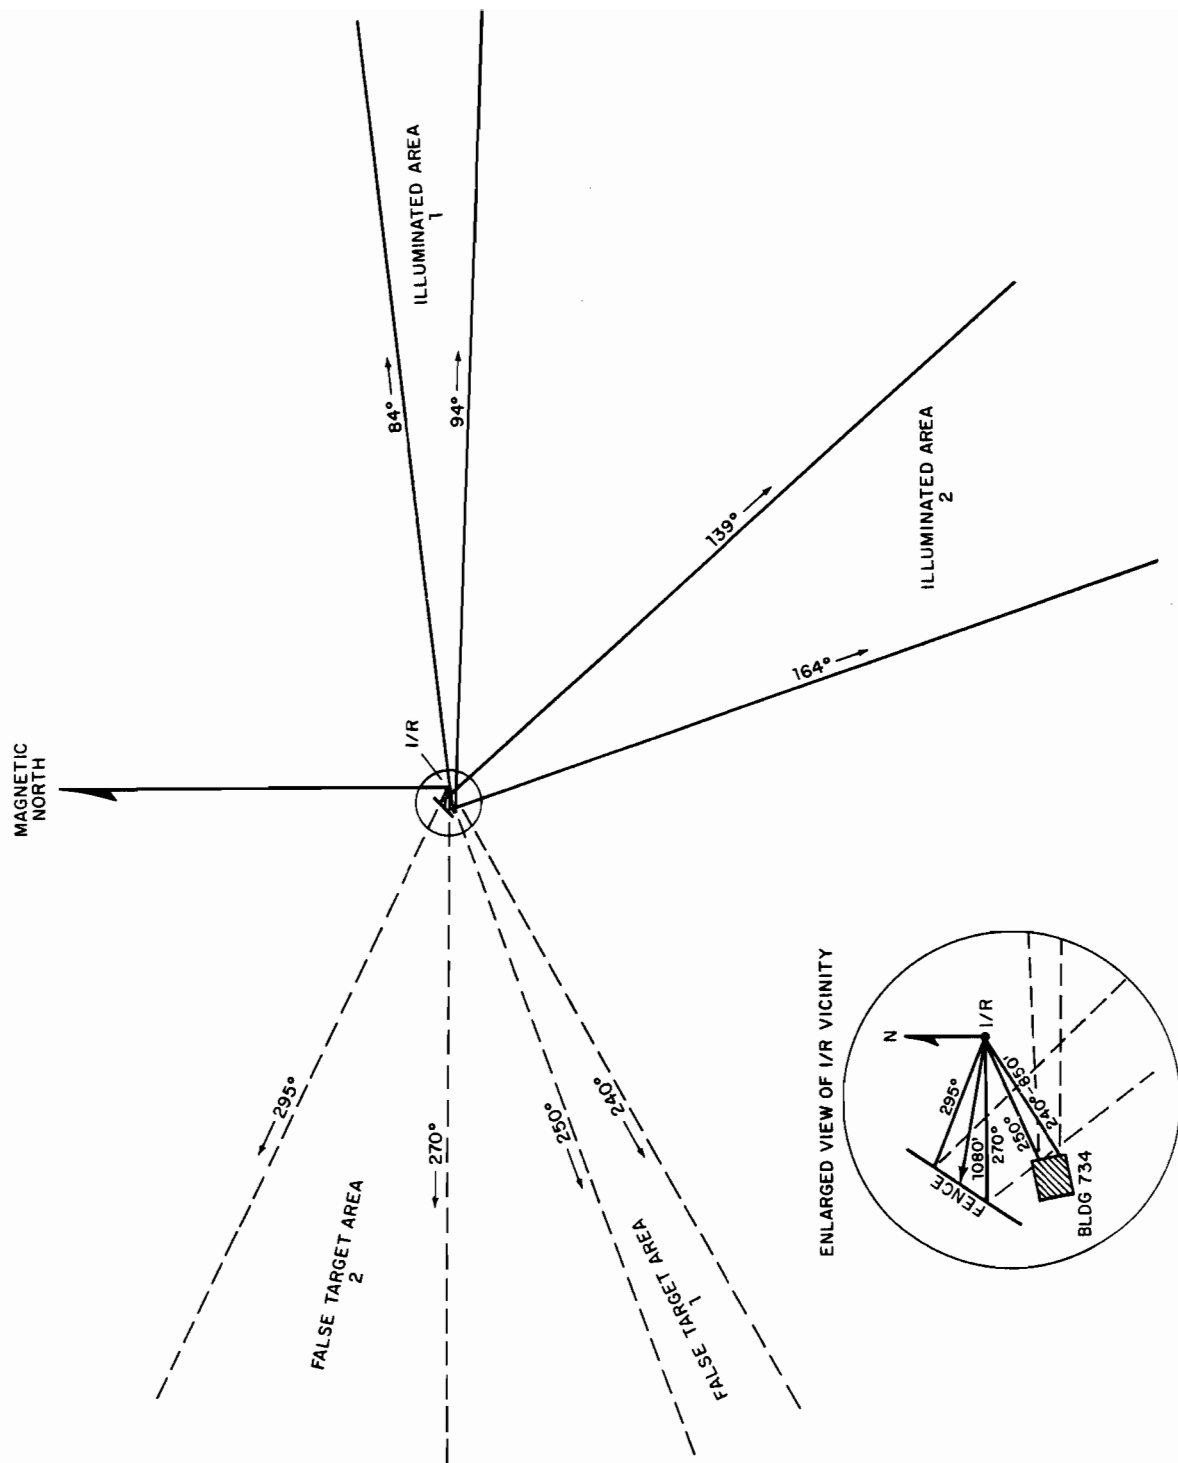
Fig. 12. Typical close-in reflection geometry.
(observed at Albuquerque)

$$\theta_{FT} = 2\theta_o - \theta_A$$

Here, A denotes the actual target and FT denotes the false one.

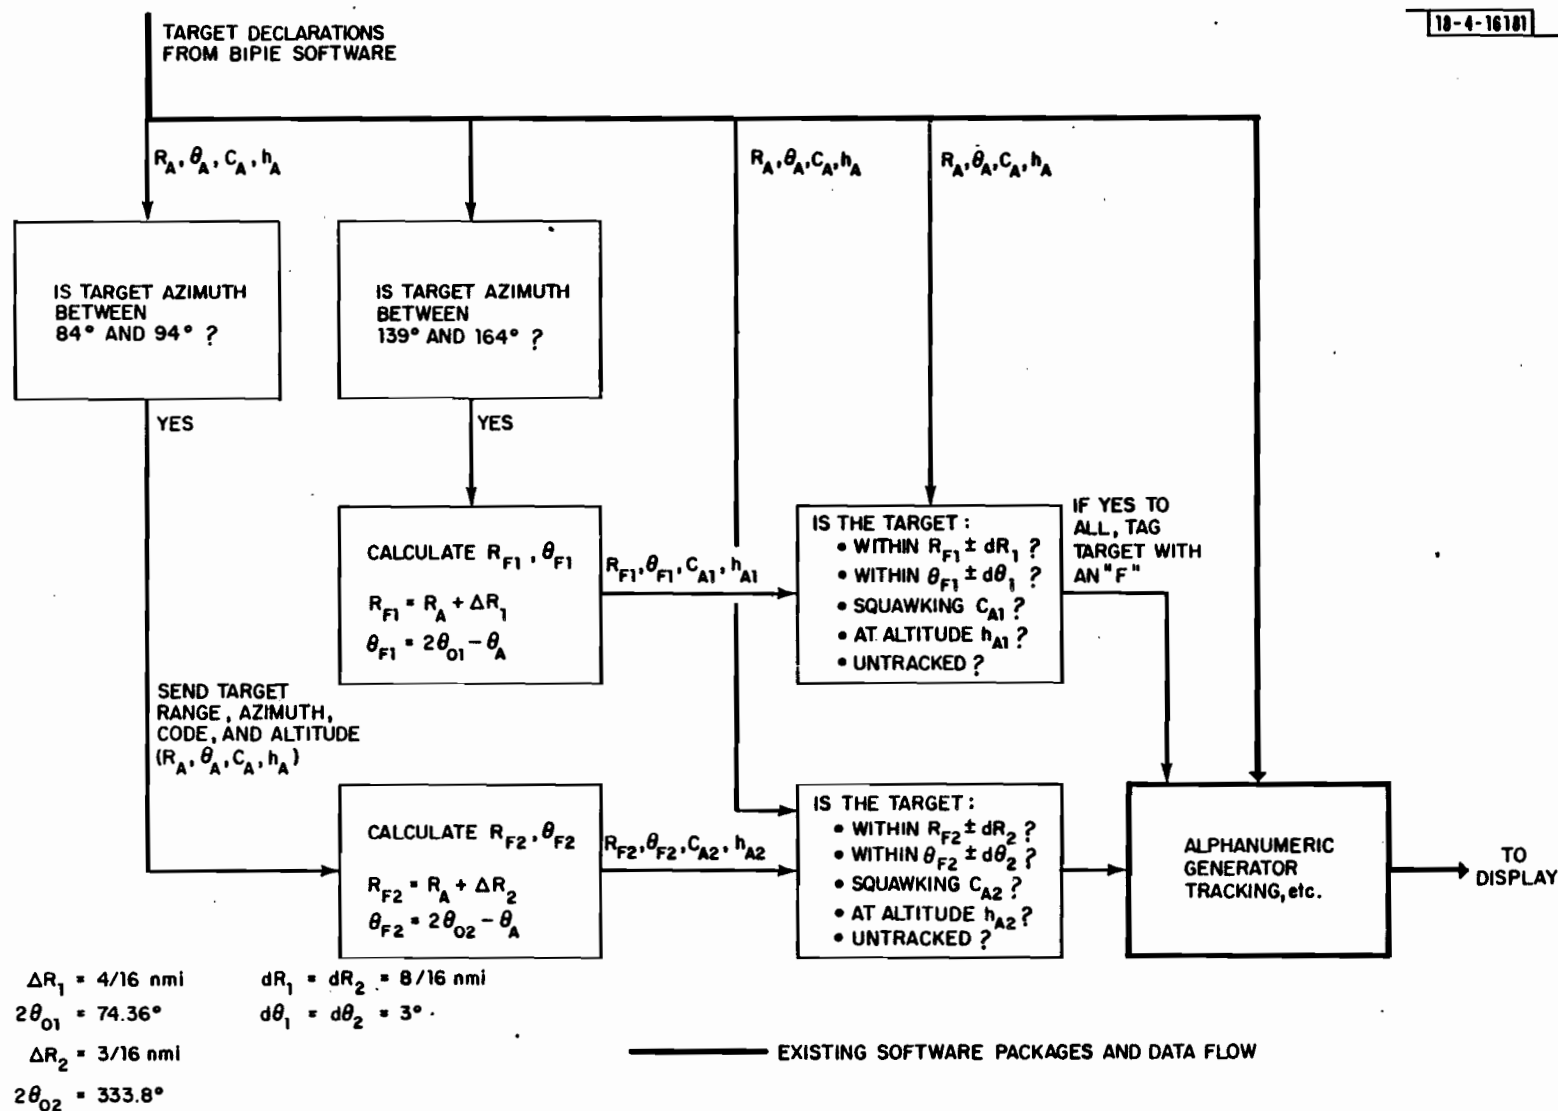
Fig. 13. Simple false target identification algorithm.
(tailored to parameters shown in Fig. 9)

The process next creates a window of size $2 d\theta$ by $2 dR$ around the expected false target location, and examines the subsequent target declarations occurring in the next scan to determine if they, a) fall within the window, b) agree in code and altitude with the actual target, and c) are not updated positions of tracked aircraft which were at one time outside the illuminated area. If all of these conditions are satisfied for a particular target declaration, it is concluded to be false, and tagged with a special symbol (e.g., an "F").

Window size is determined by the precision with which the false target position can be calculated, and by the distance over which the target can move between the times when it and the false target occur (typically, 1 to 3 sec apart). Manual solutions, in which aircraft position has been interpolated between the two target reports adjoining the false target to the instant at which the false target appears, regularly yield errors less than $\pm 1/16$ nmi (one range cell) and $\pm 0.5^\circ$. Additional error results from the fact that high-speed aircraft could change position by as much as $1/2$ nmi and 3° during the interval between their legitimate declaration and the time at which they next cause a false target. Thus, window size depends primarily on uncertainty in instantaneous position due to aircraft motion; basing window position solely on aircraft position as of the last declaration leads to a window of moderate size; basing it on instantaneous (interpolated or extrapolated) position allows the use of an extremely small window.

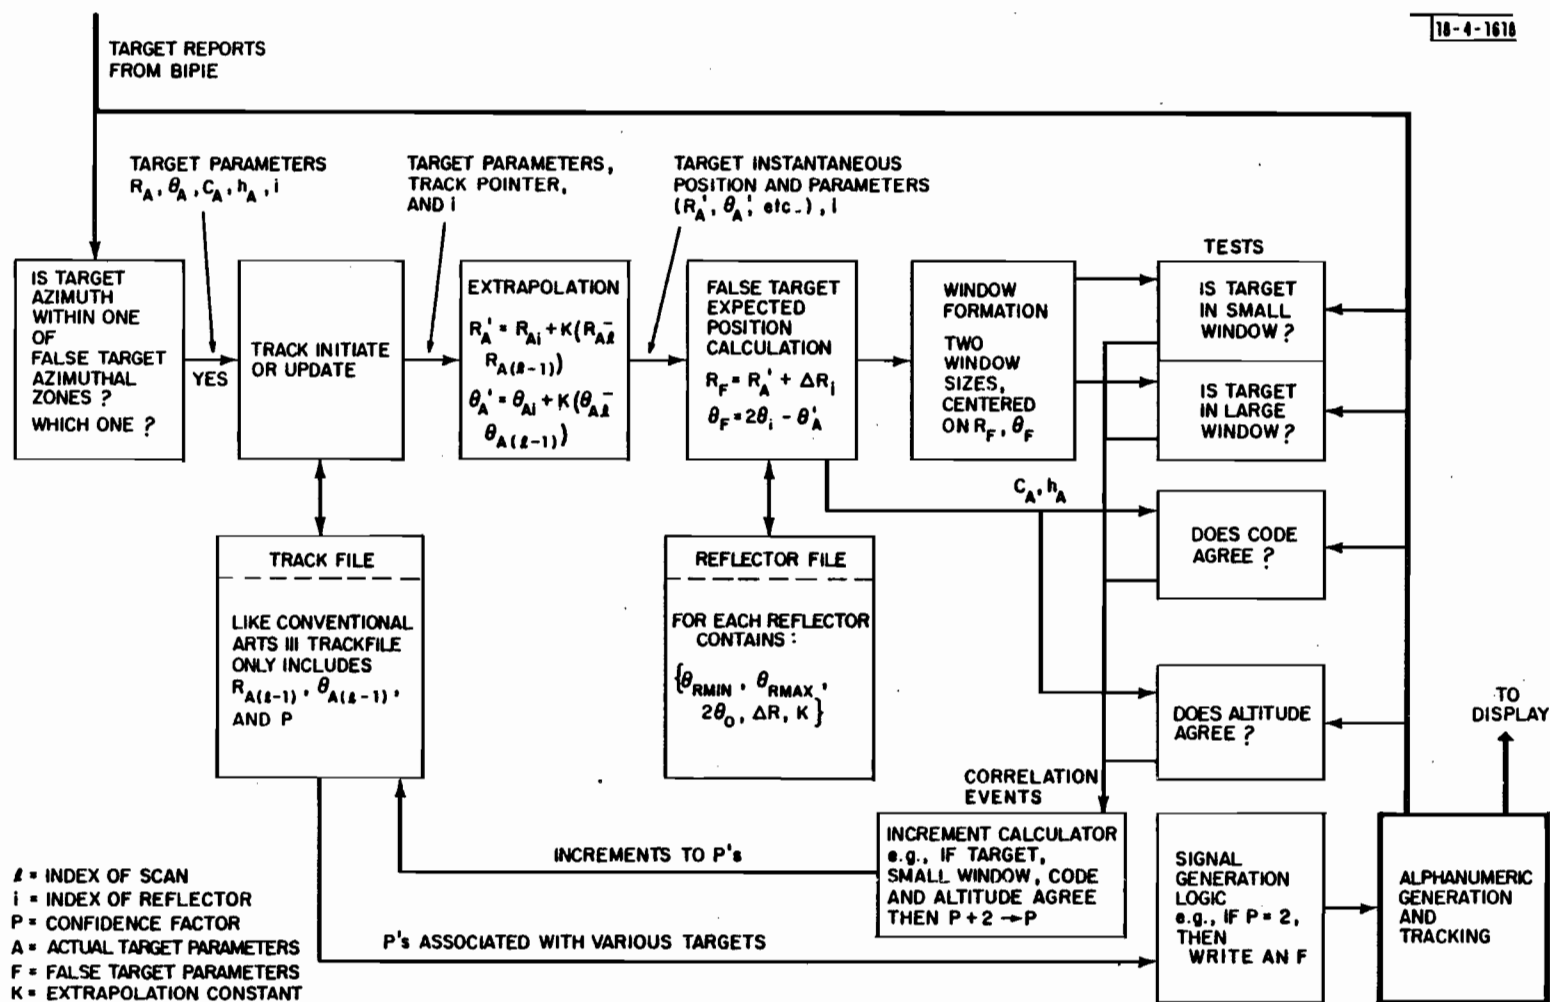
Fig. 14. False target elimination algorithm employing tracking.

It should be noted initially that experience with ARTS-III reply, target declaration, and tracking data has demonstrated clearly that declared target position data yields far higher precision than tracker output data. The only source of noise of the type which tracking can filter out in the range measurement process is quantization; whenever a target is declared, one can be certain that its range is within 1/16 nmi of the proper value. Tracked positions often deviate by more. Thus, only positions associated with target declarations are employed in what follows.

The target report correlation that results from tracking is used to advantage in two ways here: to allow interpolation, thus allowing reduction in the size of the "window," and to allow the use of a running record of the "confidence" that a target is false.

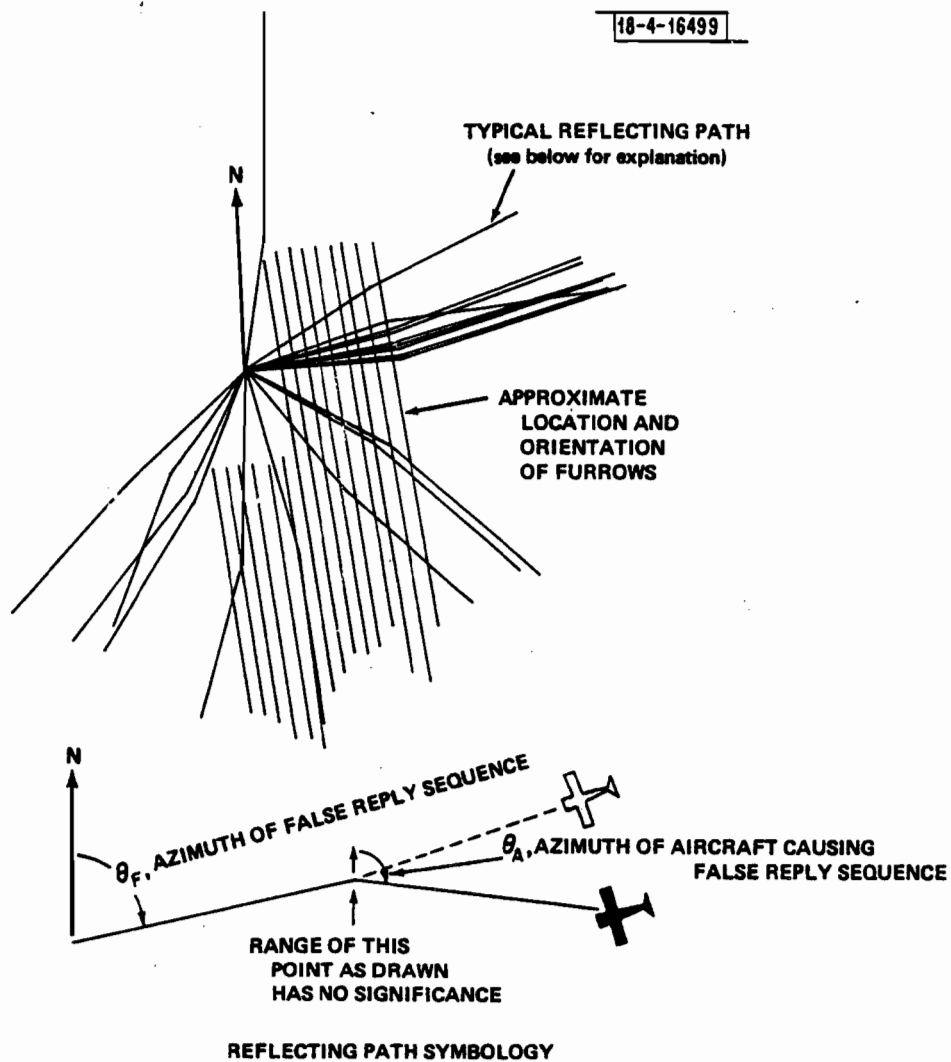
Fig. 16. Peculiar reflection geometry at Ontario.

In order to determine whether the Ontario situation was the result of similar terrain, a telephone conversation was held with the DSO at the site, who stated that the ground nearby is quite flat and level. When the nature of the terrain was discussed, he noted that the land around the interrogator is a vineyard, and is heavily planted with grapes. The planting is in long straight lines. Several Polaroid photographs taken from the radar tower revealed that significant portions of the nearby ground (out to perhaps a mile in some directions) were regularly furrowed; dimensions were difficult to determine from the photos. Spacing between furrows was about 3 ft; depth was perhaps 6 to 12 in. Small, self-supporting shrub-like grape bushes were planted along the crests of the furrows. A crude estimate of the orientation of the furrows to the east was made; they appeared to run roughly north-south, or perhaps from slightly west of north to slightly east of south (Fig. 16).

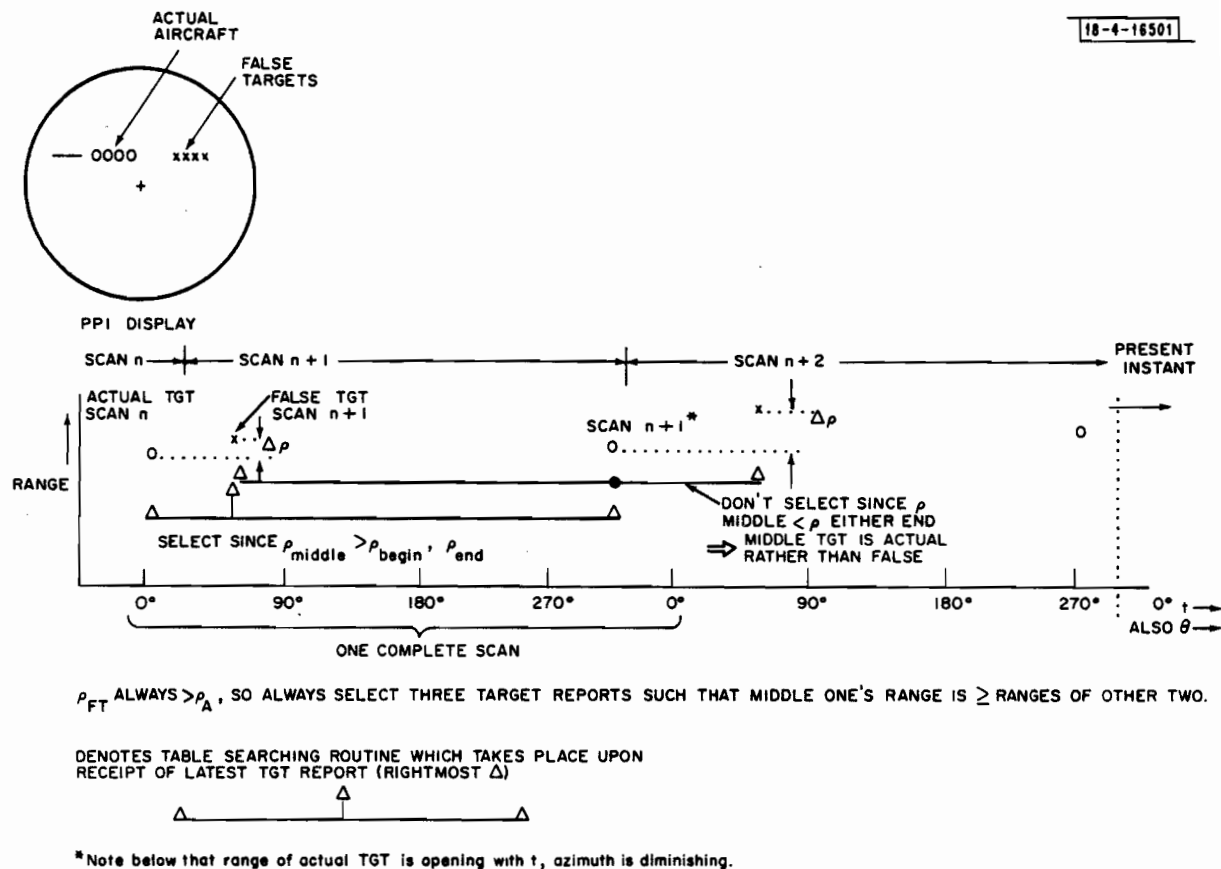
Fig. 18. A typical false target situation.

By scanning the record of target reports on a particular code, the processor determines that a false target is present (on the basis of whether that code is declared at different azimuths on the same scan), and, if so, it determines which target is false and which is real (on the basis of which has the greater range). The information needed to determine reflector geometrical parameters includes false target location (ρ_F , θ_F) and actual aircraft position at the instant the false target was received. This latter data is determined by interpolation of the measured aircraft positions prior to and subsequent to the false target declaration. The output from the false target determination process is, therefore, a set of three locations, that of the actual target prior to generation of the false target, that of the false target, and that of the aircraft subsequent to generation of the false target. The process is as follows:

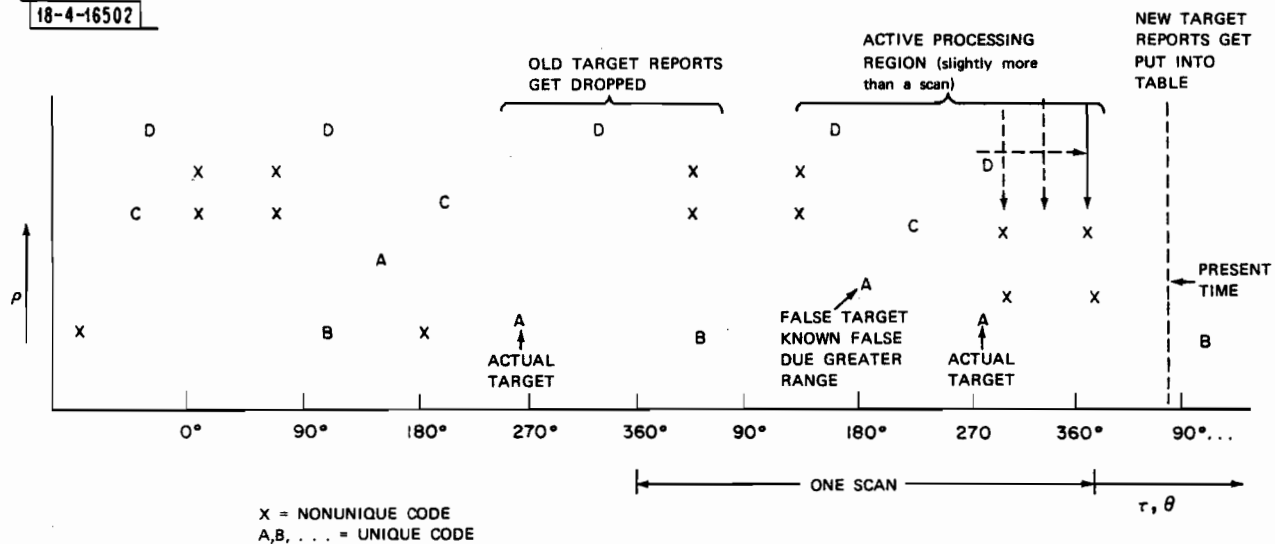
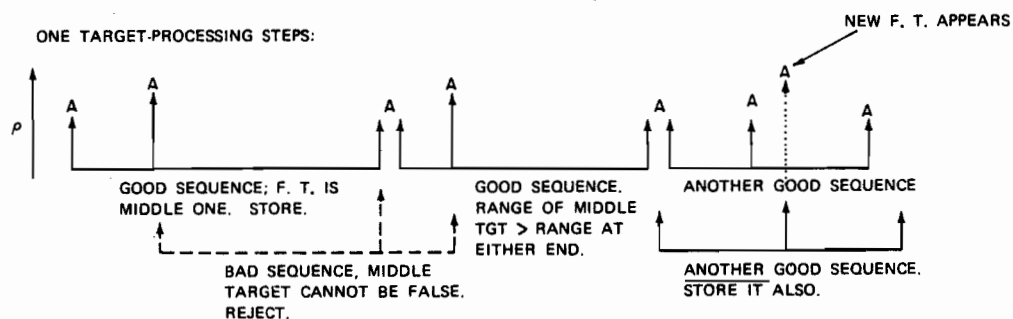
Fig. 19. Discrete-code false target processing.

- If the false target azimuth is within $\pm 5^\circ$ of that of the actual target, put in "mainbeam" category.

- If the actual target is within the sidelobe reply range of the interrogator (say, eight miles), and more than one false target is noted at one or more azimuths, then put in "sidelobe" category.
- If in either of the above, put in "conventional" category.

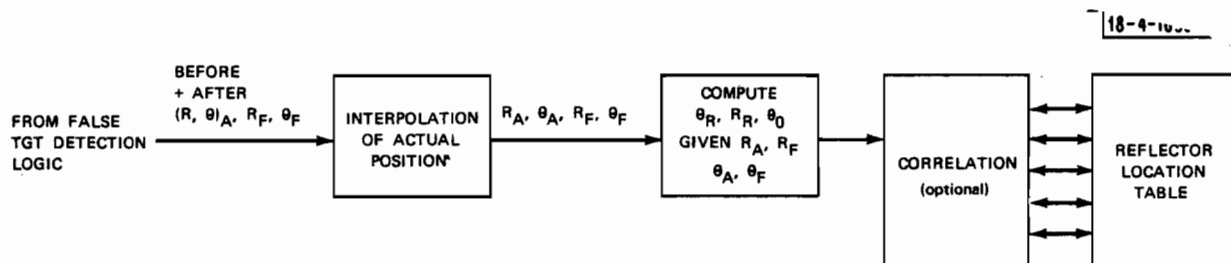
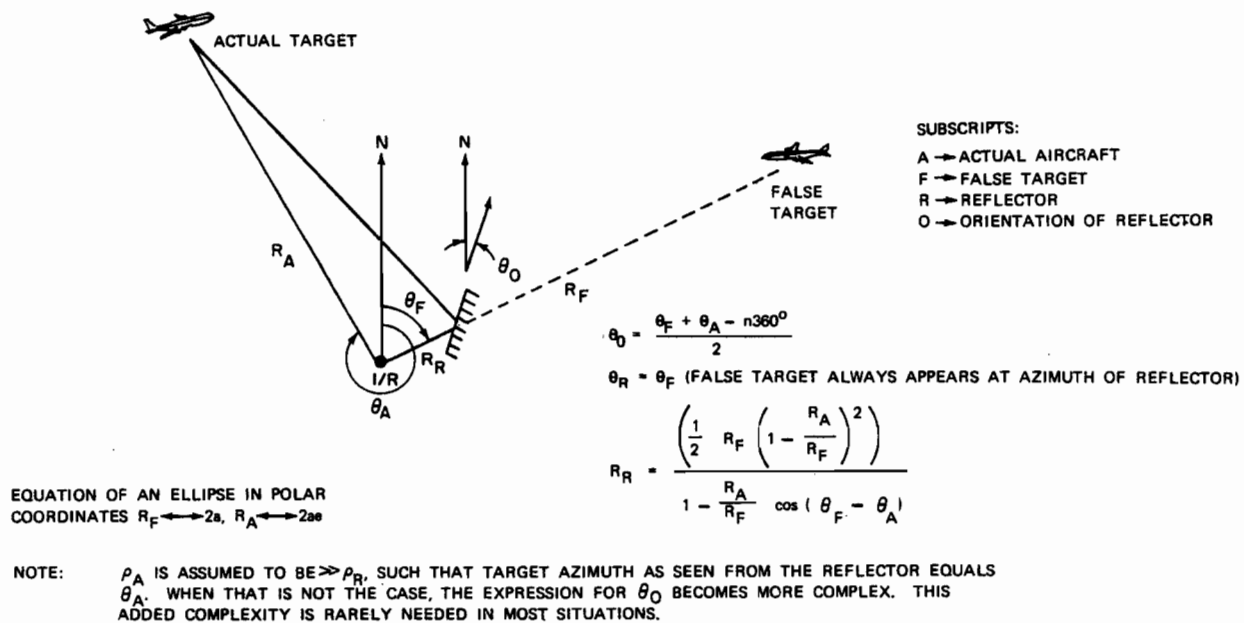
Fig. 20. Conventional flase target processing.

4. (Optional; not implemented in current program). Correlates like reflectors. Whenever multiple reflector solutions appear closely aligned in ρ_R , θ_R , and θ_O , they are probably due to a single reflector.

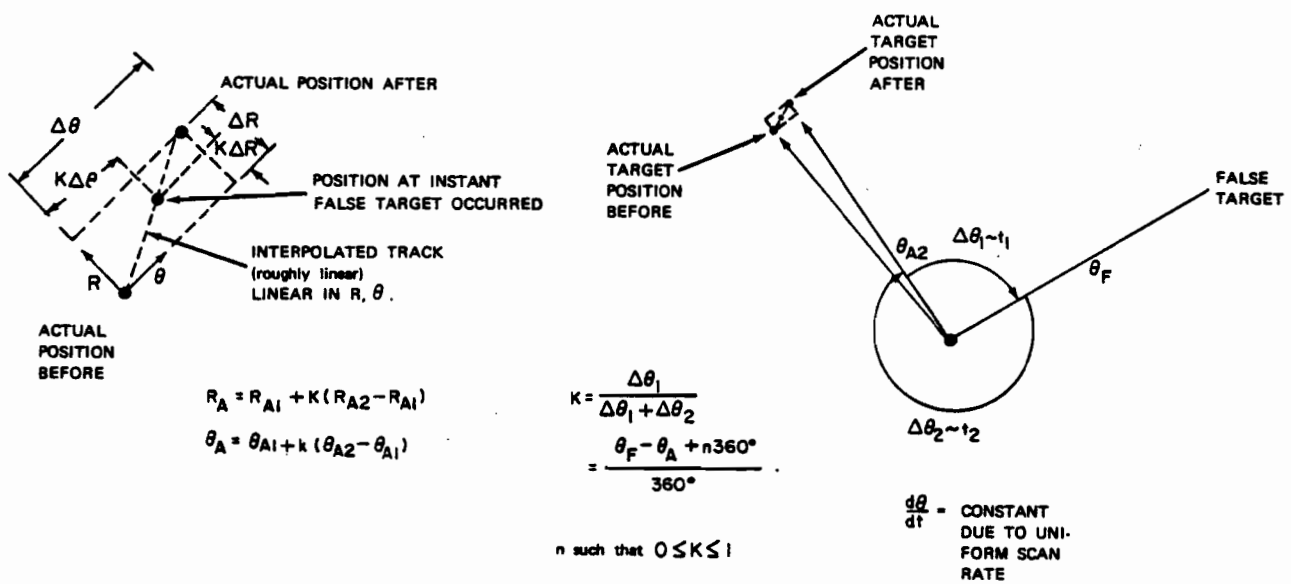
Fig. 21. Actual target position interpolation.

A highly precise estimate of that reflector's parameters could be obtained by averaging the parameters of the individual "samples". Accordingly, starting with the first reflector, ρ_R , θ_F , and θ_O are examined for each. If any are within $\pm 3^\circ$, ± 0.25 nmi, and 1° of the first reflector, a composite set of data are formed by averaging the parameters of the two. The length of the line representing the reflector could be modified by the amount of difference in θ_R , to account for building length (in cases where length is comparable to a Fresnel zone, such that different portions of the building illuminate the aircraft at different locations on adjacent scans); line length will then serve as a crude representation of reflector extent. The process would continue down the list, updating the composite data whenever a new sample is within $\pm 3^\circ$, ± 0.25 nmi. Note that this will require a running count of how many samples are included in the composite, in order to properly weigh new data.

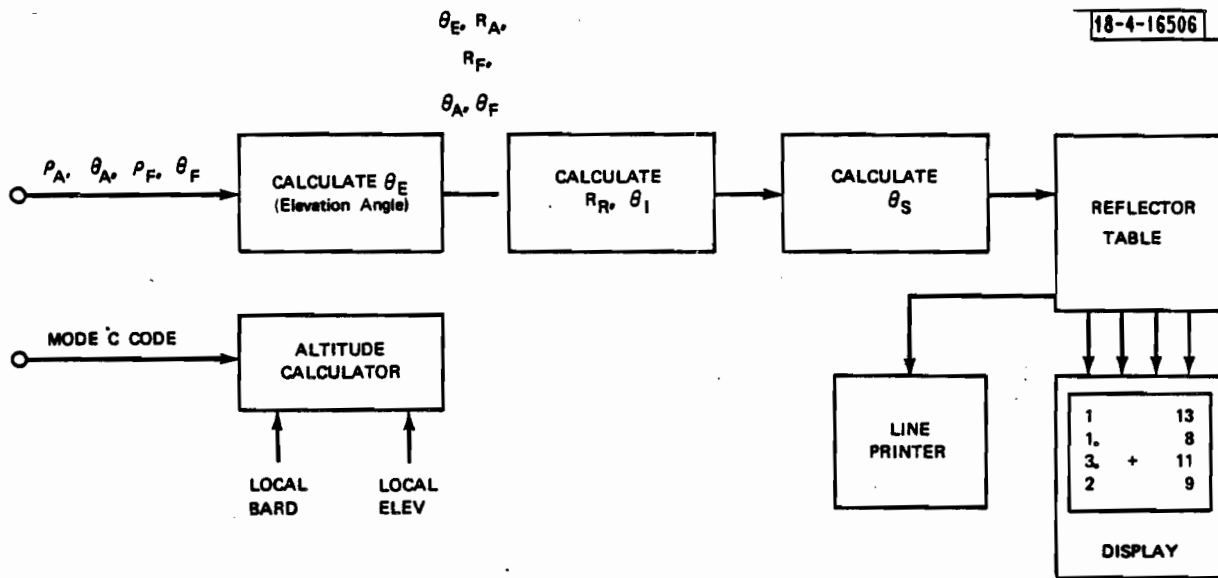
Fig. 23. Mainbeam reflection processing.

1. False target reports are examined to determine if two or more overlap in azimuth.

2. If so, then the report at greater range is treated as a conventional false target, and processed as such. The report at lesser range is treated as a sidelobe report (resulting from the geometry of Fig. 24), and should be ignored.
3. If only one false target report is noted at a particular azimuth, then it is not clear whether it is caused by one or the other mechanism. Both mechanisms are assumed, and reflector locations corresponding to both are determined. If one or the other correlates well with a reflector noted on other data, it can be combined with it, and the other can be dropped.
