Further Studies of ATCRBS Based on ARTS-III Derived Data

A. G. Cameron

13 December 1974

1. Report No. FAA-RD-74-145	2. Government Accession No.	3. Recipient's Catalog No.	
4. Title and Subtitle Further Studies of ATCRBS Based on ARTS-III Derived Data		5. Report Date 13 December 1974

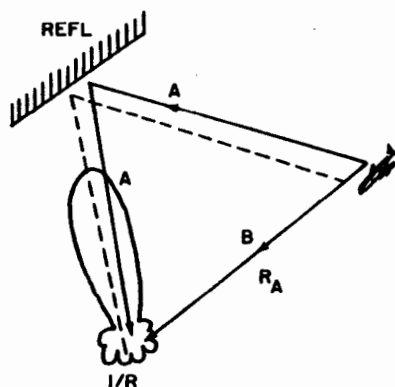
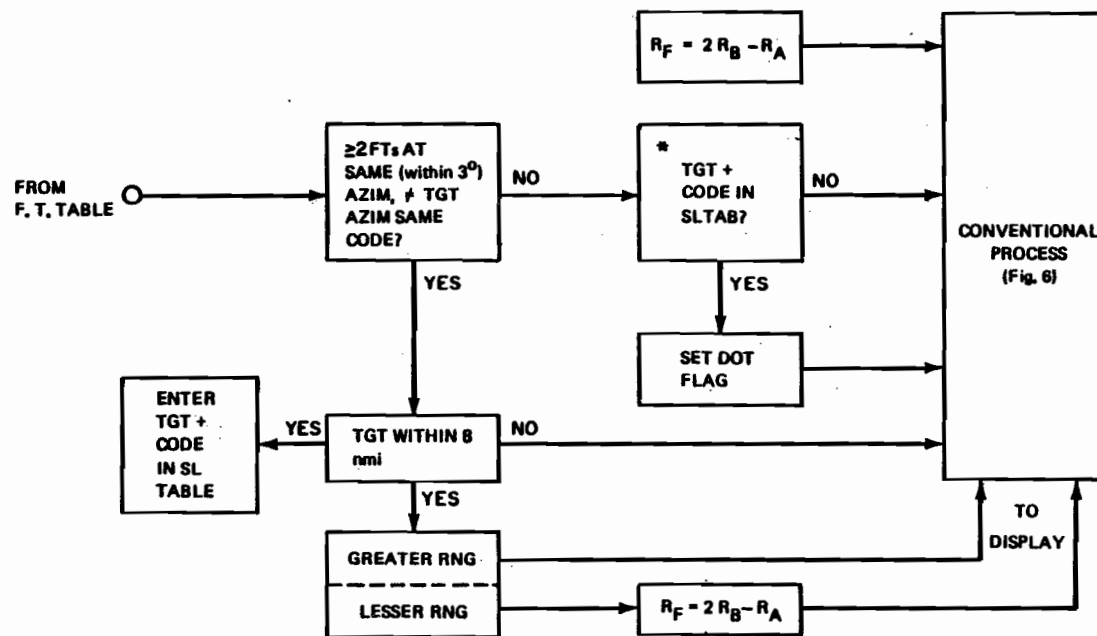
Fig. 24. Sidelobe reply processing.

FALSE TARGETS DUE TO RETURN PATH A CAN BE PROCESSED AS CONVENTIONAL

FALSE TARGETS DUE TO RETURN PATH B MUST FIRST HAVE APPARENT RANGE CORRECTED: $R_F = 2 R_B - R_A$
 WHERE R_B = MEASURED RANGE R_F = RANGE OF F. T. TO BE INPUT TO CONV. PROCESS

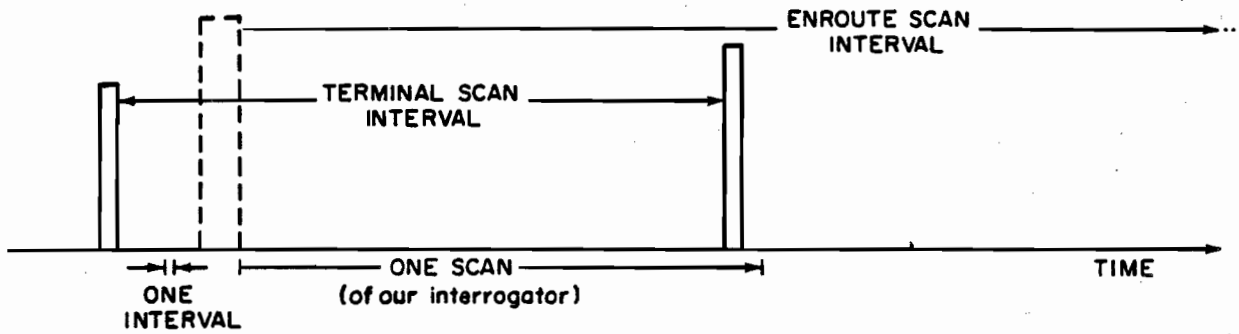
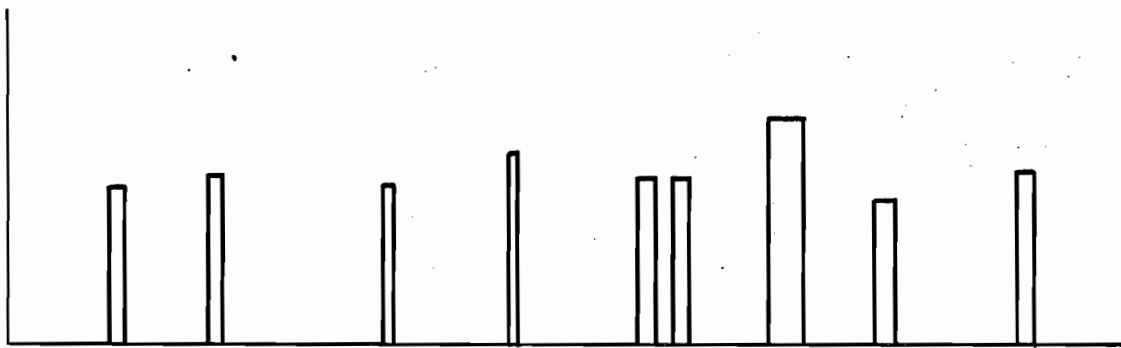
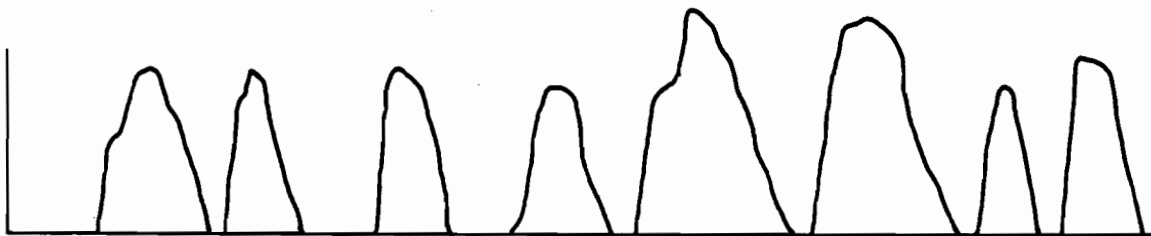
Fig. 28. Idealized fruit patterns.

(a) Fruit pattern due to a single Interrogator
(— terminal interrogator; ---- enroute interrogator)

(b) Composite pattern of fruit from one aircraft
due to several interrogators

(c) Total fruit count predicted from aircraft distribution,
assuming same interrogator environment as in (b)

The previous discussion concerned the fruit from a single aircraft. We would expect the total fruit to exhibit similar variations, but to be

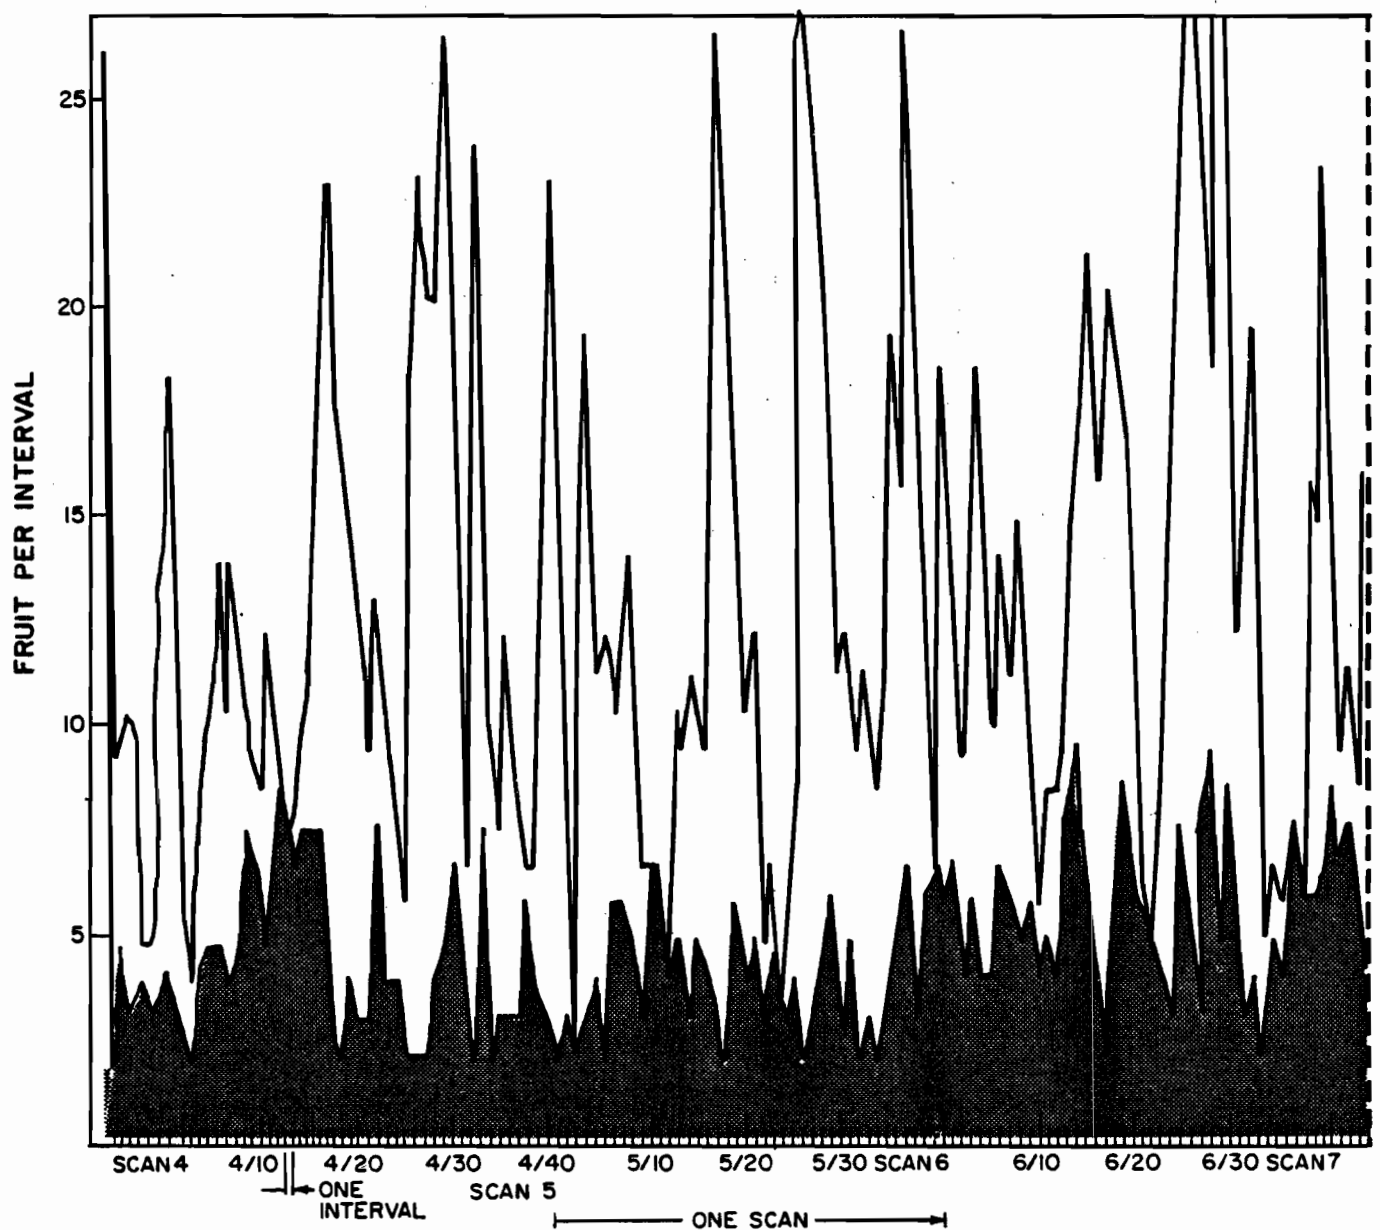
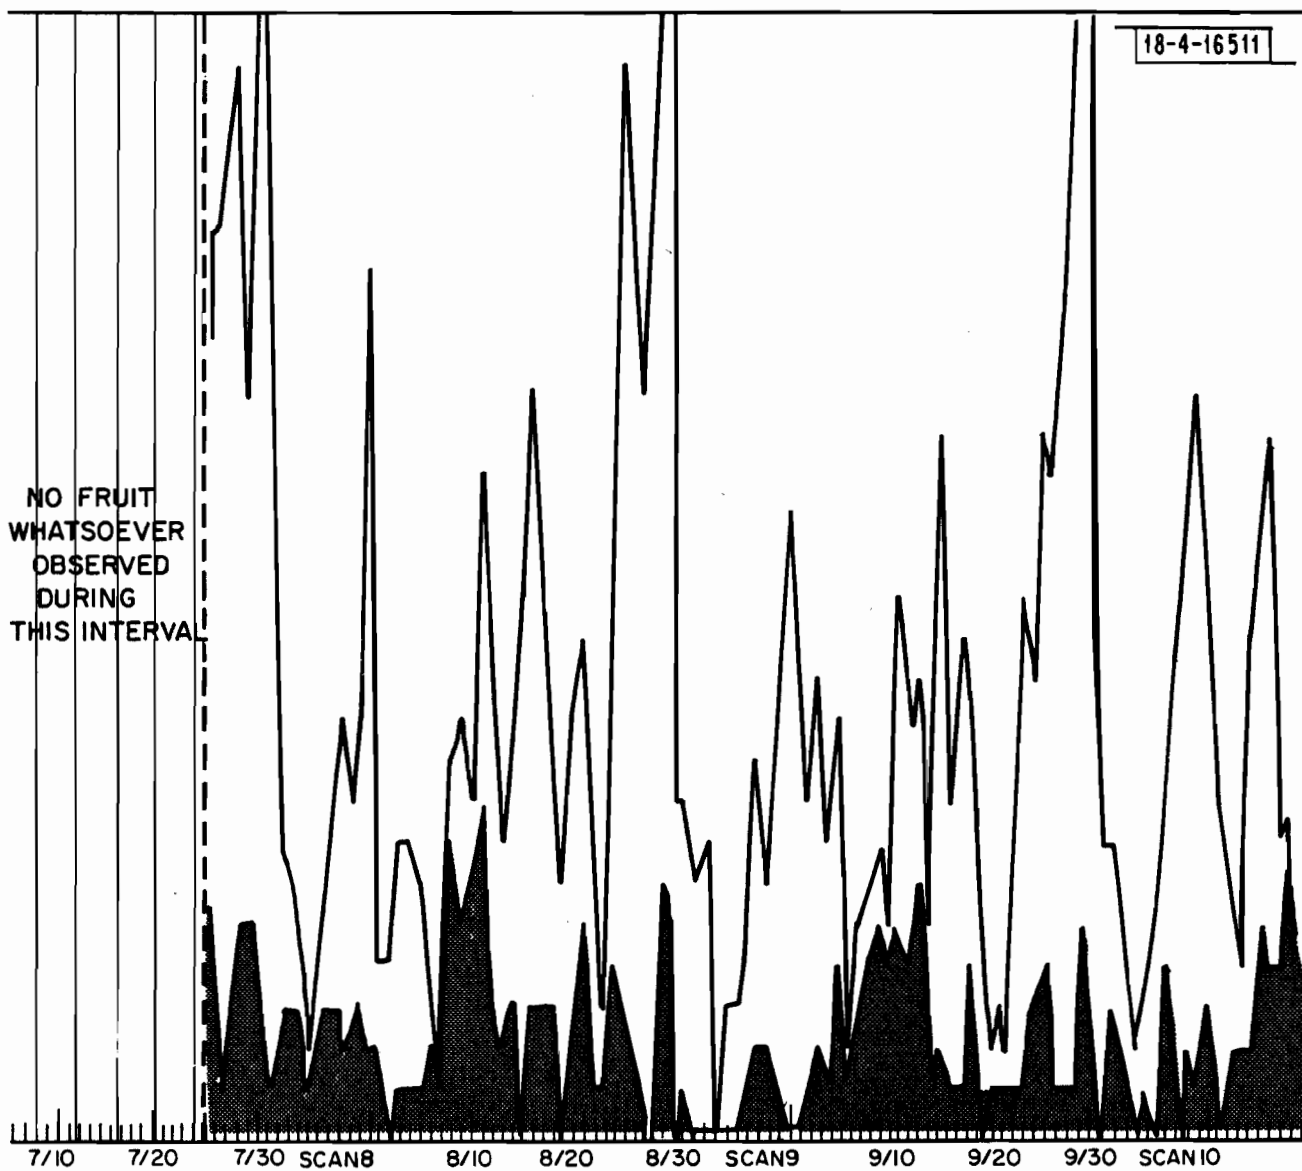
Fig. 29. Fruit arrival rates versus time.

Note that a substantial portion of scan 7 is devoid of any fruit whatsoever. This was originally assumed to be a result of the (assumed) low number of interrogators in the vicinity; no fruit was sensed simply because no other interrogators happened to be interrogating the aircraft within 10 nmi during

that period. Cursory examination of the data in Fig. 29 reveals that this is extremely unlikely; the dead time is probably due to inadvertent switching of the defruiter back into the system for a brief period. Note that it happened only twelve seconds after the defruiter was initially switched out (the technician at the radar site most likely still had his hands on it then).

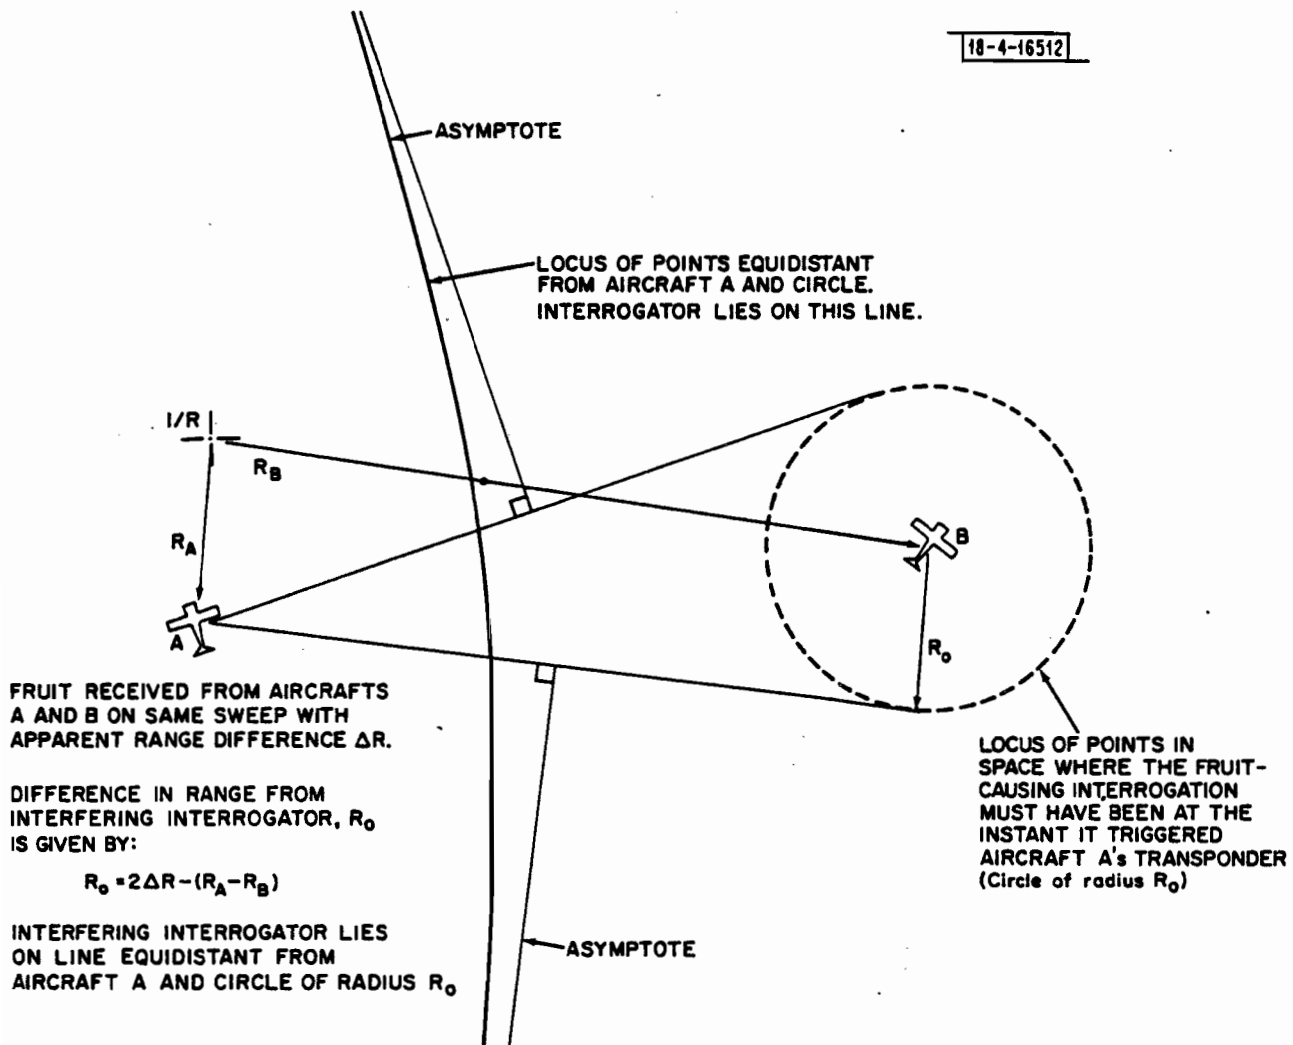
Fig. 30. Direction-finding from multiple fruit on a sweep.

Another approach was found, which is based on information derived from those occasions where several fruit replies from several different discrete-code aircraft occur on a single sweep. Whenever that occurs, in an environment where total fruit levels are moderate, it can be assumed that the several fruit result from a single interrogation. Since the positions of the aircraft are known, the information contained in apparent differences in ranges of the fruit from pairs of aircraft can be used to determine the relative timing of the interrogation as it arrived at the aircraft. This, in turn defines a pair of arrival angles (Fig. 30); this process, applied pairwise to three aircraft, resolves angular ambiguity, and results either in a bearing to the interfering interrogator or a fix of its position if it is closeby (Fig. 30).

Three attempts at locating interfering interrogators were made using Boston data. Each indicated a particular location, roughly consistent with known interrogator locations. Each was the result of a different interrogator; this is not surprising given the large number of interferors measured in the Boston data.

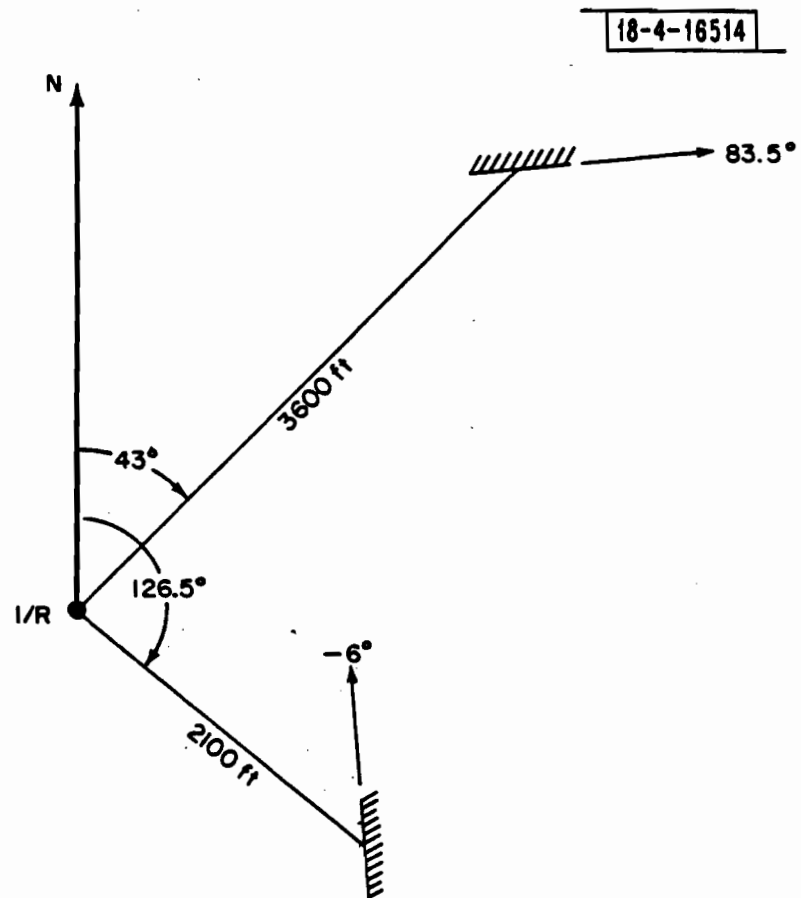
Fig. 32. Reflectors at MSP.

because of the excessively high SLS power; see Table 12); therefore, target reply sequences were tightly bunched and it was straightforward to note any replies at different ranges. All such replies, except those due to the false target mechanisms noted above and another exception which will be discussed later, were concluded to be fruit. Fruit replies were further classified as mainbeam or sidelobe fruit, depending on whether they agreed in code and/or altitude with target codes being received synchronously on the sweeps when the fruit was seen. Several fruit were observed with common codes (in particular, 1100, 1400, 2100 and 2300) which did not correspond to any codes of aircraft within the coverage. In each case, fruit of a particular code would occur consistently at a particular azimuth over a number of scans. These were concluded to be mainbeam fruit due to aircraft at ranges beyond the maximum range of the system. Whenever a fruit reply with a code the same as that of one of the aircraft within system coverage was noted, while that aircraft was not within the mainbeam, that fruit was counted as sidelobe fruit, despite the fact that it could have come from another aircraft with the same code in the mainbeam beyond the system maximum range. In only two cases were fruit replies with discrete codes matching those of aircraft in the system found in the "sidelobe" region; in both cases, they were at azimuths within three degrees of the target, and occurred just before or after the target legitimate reply sequence. No other fruit replies which could definitely be shown to be sidelobe fruit were noted in sixty scans.

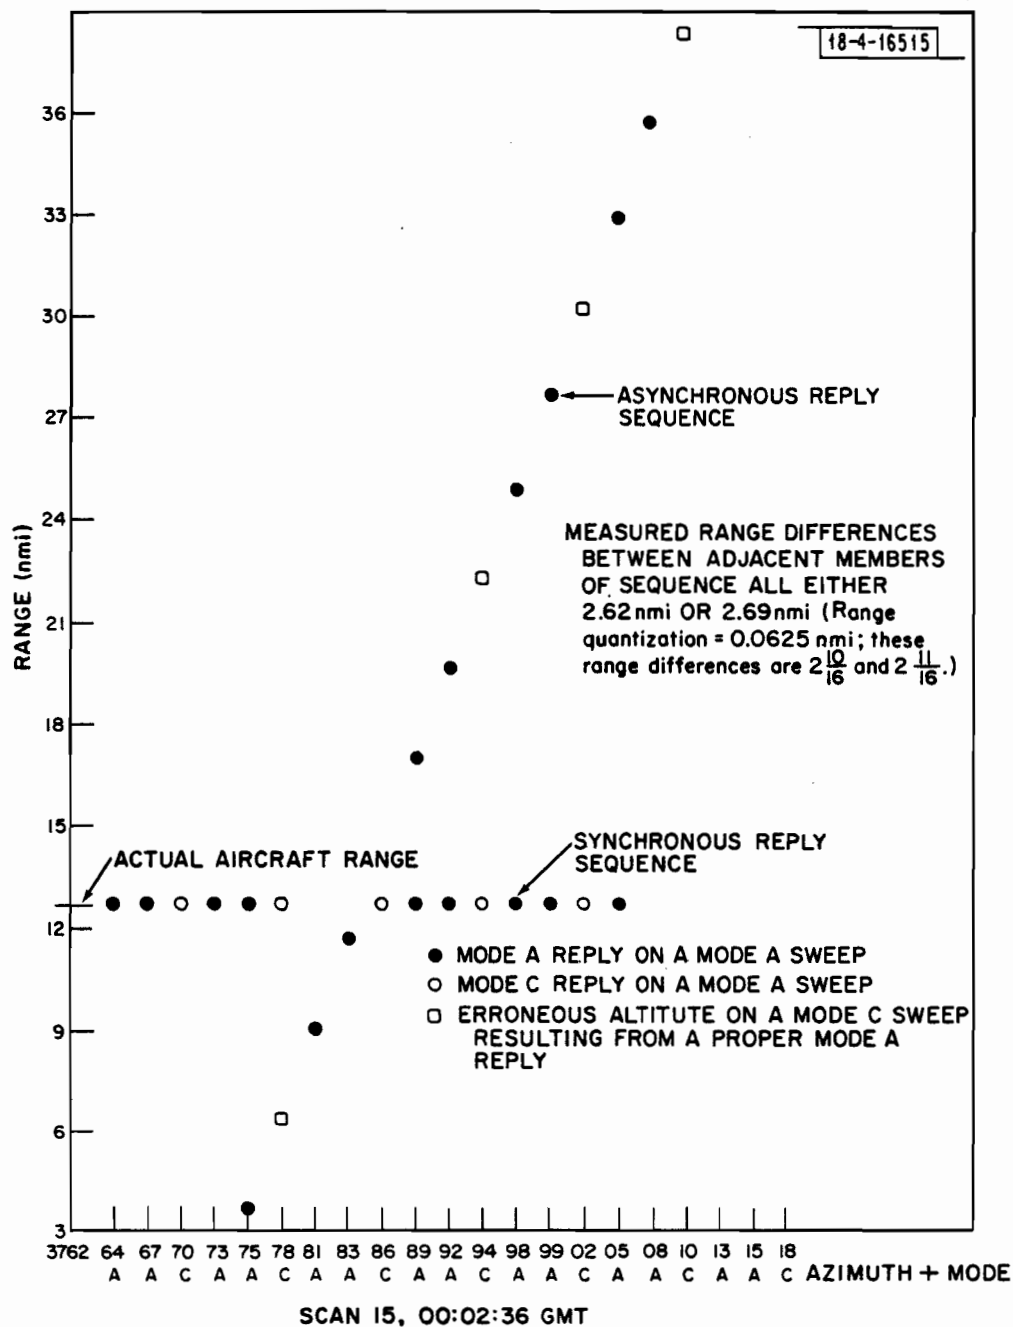
Fig. 33. Fruit pattern - MSP.

Another point which is evident from Fig. 33 is worth mention. Note that on sweeps 81 and 83 the synchronous reply is suppressed, because the synchronous interrogation follows too closely after the interrogation of the ARSR. Similarly, on sweep 86 the fruit reply is suppressed because it follows

Each tick denotes a sweep. Numbers are the last two digits of the ACP.

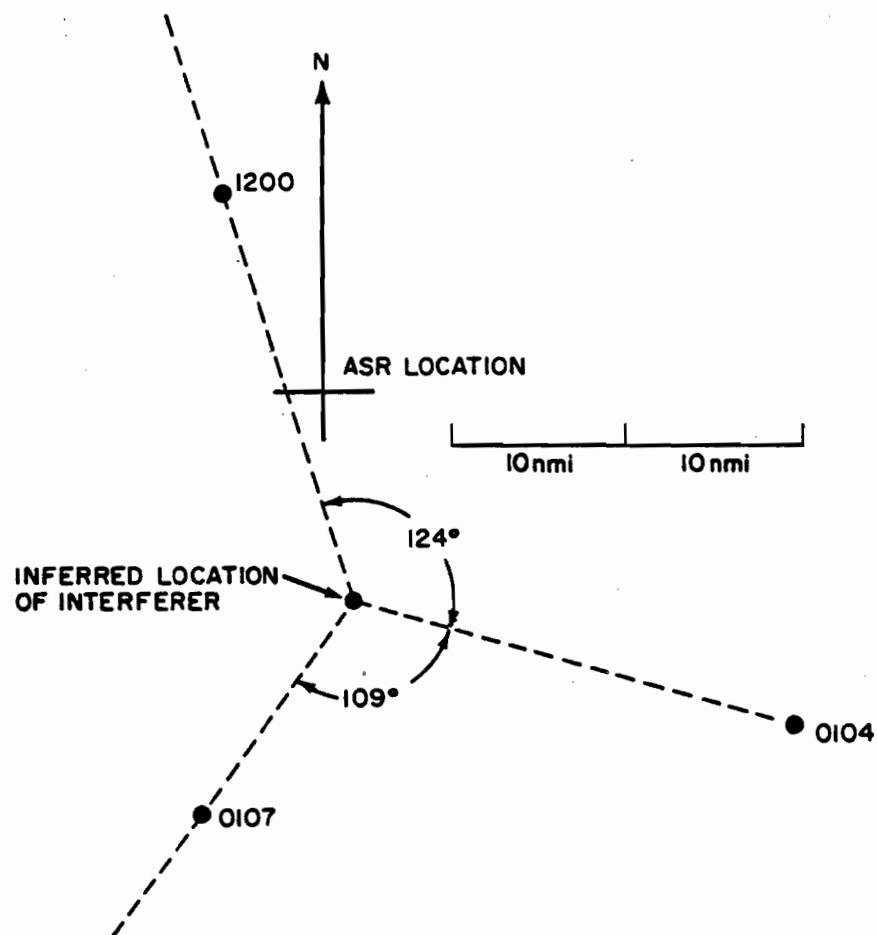
Fig. 34. Determination of interferer location.

the two situations account almost fully for the rate differences; the two results are not inconsistent. At Boston, twenty-six aircraft were within the coverage area, and the data suggested that perhaps fifteen interrogators were involved. Assuming that total fruit arrival rates are proportional to the aircraft-interrogator product would result in an expected difference factor of five (i.e., twice as many aircraft, two and one-half times as many interrogators at Boston).

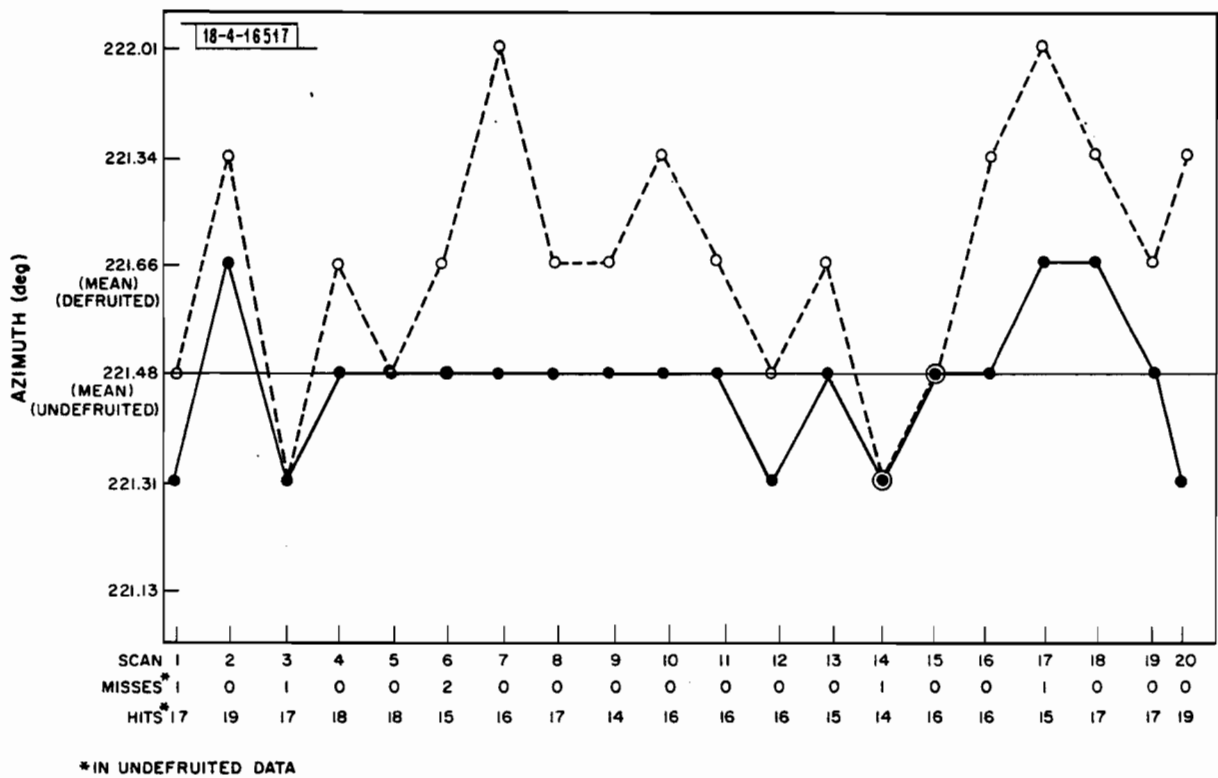
Fig. 35. Azimuthal accuracy.

A single target squawking both modes departing radially at relatively long range was tracked over twenty scans (from about 42 to 51 nmi). The target radial velocity held constant at 412.5 kt. Figure 35 plots the azimuth of the aircraft on each scan as determined by both systems. Making the somewhat questionable assumption that the aircraft actual azimuth remains constant at its average as seen in the undefruited data, we see that, for the data, the maximum azimuthal error in 20 scans is 0.175° (about 2 ACP's), and the rms error is 0.11° (about 1.25 ACP's). Corresponding values for the defruited data are 0.35° maximum (about 4 ACP's) and 0.192° rms (about 2.18 ACP's). These figures take into account the bias error introduced by leading reply suppression in the defruiter, and are worse for exactly the reasons one would expect: occasional missed initial mode C replies tended to make the leading edge "noisier," and holes in the reply sequence due to suppression were doubled in size by the defruiter. This latter phenomenon impacts on ARTS-III performance because of the center-of-gravity beamsplitting procedure employed. It should be noted that the reply probability of the aircraft in question was exceedingly high ($>98\%$ from Fig. 24) and a lower reply probability would tend to make both processes noisier, especially, in the defruited case.

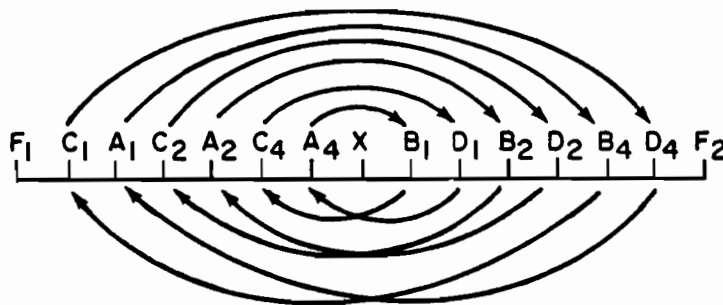
Fig. 36 Relationship between anomalous and legitimate reply pulses.

The pattern by which these pulses are related is shown in Fig. 36. The arrows point from the actual pulse which must be present in the original code to the incorrect pulse which it causes in the anomalous code; note that the relationship is non-reciprocal.

While the relationships among the pulses are certainly regular and consistent, it is apparent from the diagram that they cannot be explained by any simple mechanism which could be related to multipath phenomena such as a fixed delay, or a combination of delays. However, the manner in which a) D, A, B, and C pulses, respectively, cause anomalous A, B, C, and D pulses and, b) pulses 1, 2, and 4 cause anomalous pulses 4, 2, and 1 strikes a familiar note.

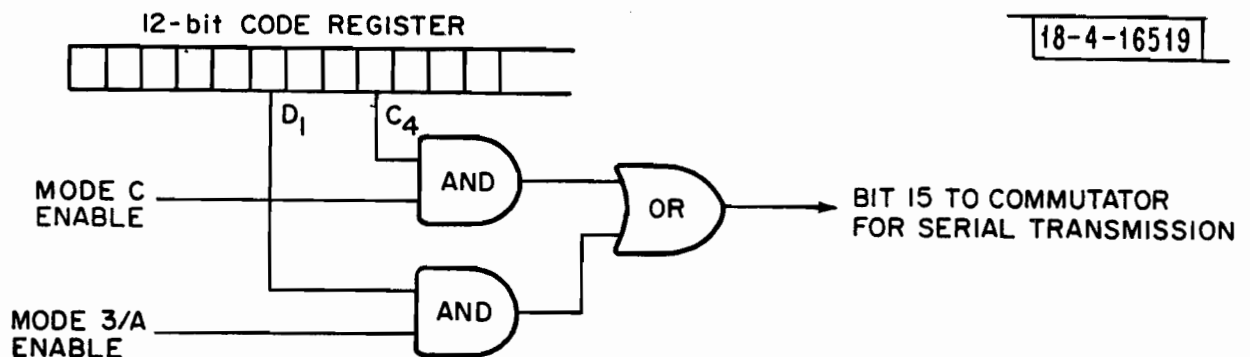
Fig. 37 ARTS III Reply Code Readout Circuitry

Given this fact, one can speculate with reasonable soundness on what is causing the anomalous codes in the Logan ARTS-III. The System Description manual [12] does not present detailed logic diagrams of the entire DAS, but does indicate in the DAS detailed block diagram (Fig. 3. 2-7) a functional unit (called the "Code Transformation Gates") which formats DAS reply words. That unit is hard-wired to read out the code bits in either of the above formats. Telephone conversations with Burroughs personnel reveal that circuitry of the sort shown in Fig. 37 (a simple "toggle") is employed (only the circuitry for bit #15 is shown for clarity):

The enable lines are driven by a set of flip-flops, which are set at the beginning of each sweep, and reset by the maximum range pulses. Any improper enabling signal on the wrong enable line would allow the C_4 bit (if present) to pass the and-gate, and appear in bit position 15 (where the D_1 pulse would be expected in a mode 3/A data word). Intermittent existence of such an enabling signal would cause intermittent presence of an anomalous pulse in the D_1 (or any other) position of a mode 3/A reply word whenever the C_4 pulse (or whatever pulse in the mode C line of the above table corresponded to that particular position) was present. This is precisely the behaviour that was displayed in the data.
