**Project Report
ATC-270**

An Evaluation of the ASR-9 Weather Channel Based on Observations from the ITWS Prototypes

23 September 1999

Lincoln Laboratory
MASSACHUSETTS INSTITUTE OF TECHNOLOGY
LEXINGTON, MASSACHUSETTS

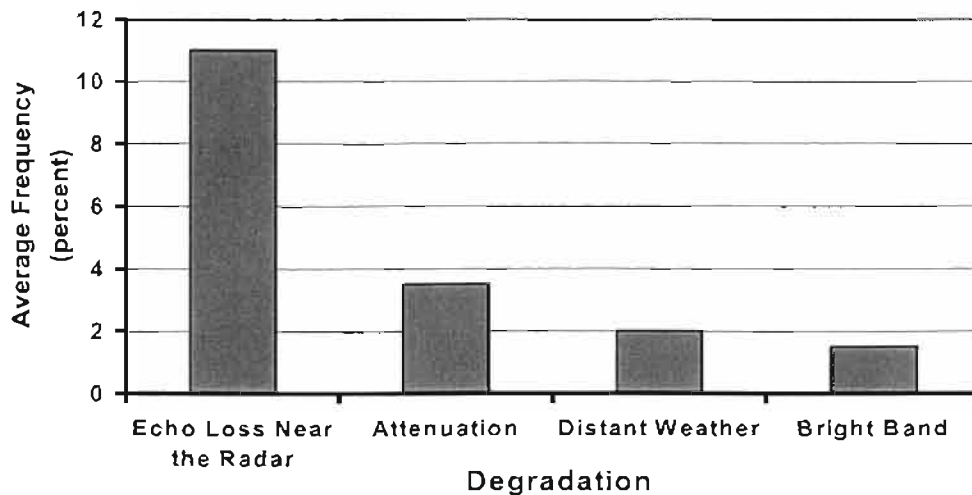
Figure 1. The fraction of ITWS site operational reports listing degradations based on over 400 weather days over a two-year period from both MEM and DFW.

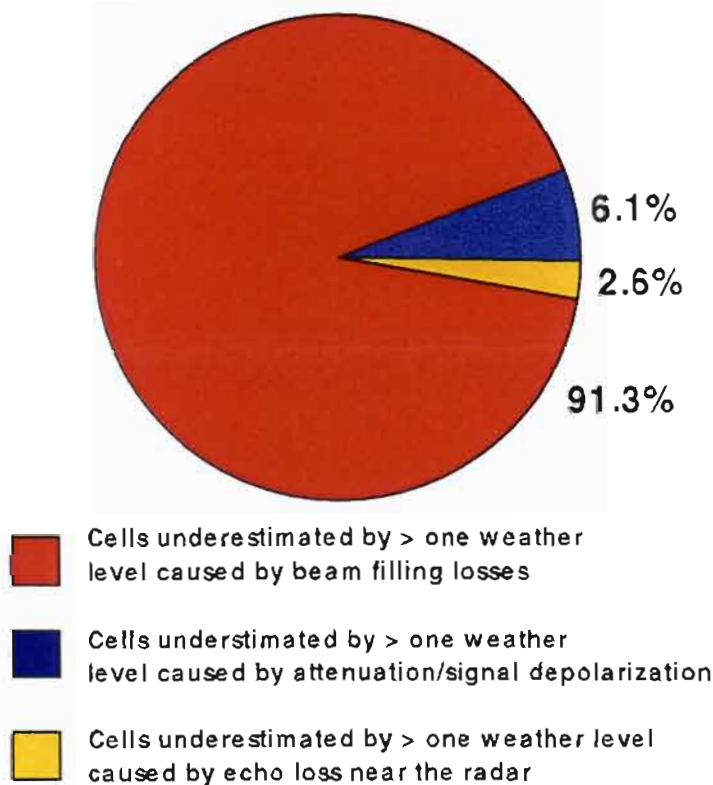
Figure 2. These data show the distribution of degradation causes on a cell-by-cell basis based on seven MEM cases examined in the Crowe, et al. (1997) study.

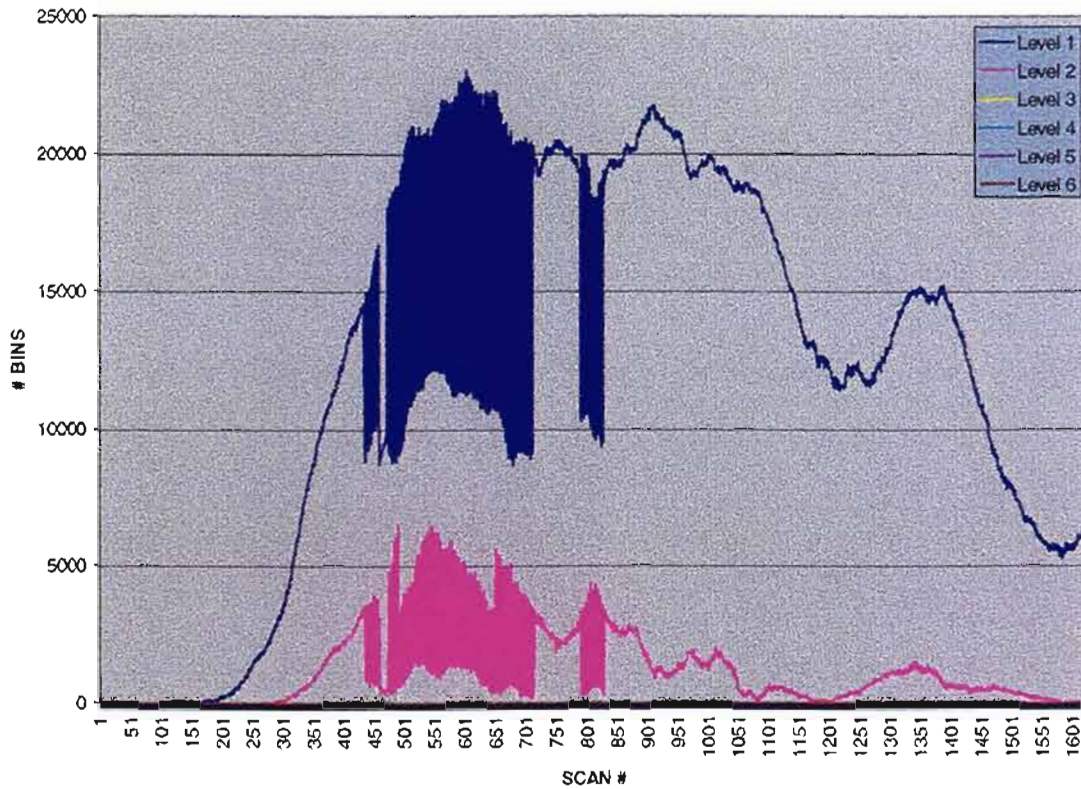
Figure 3. Number of radar resolution cells showing various weather levels versus time. From the SWF ASR-9 on 990228. Notice how the distribution varies widely between scan numbers 440 and 830 due to the radar changing polarization repeatedly over this time frame.

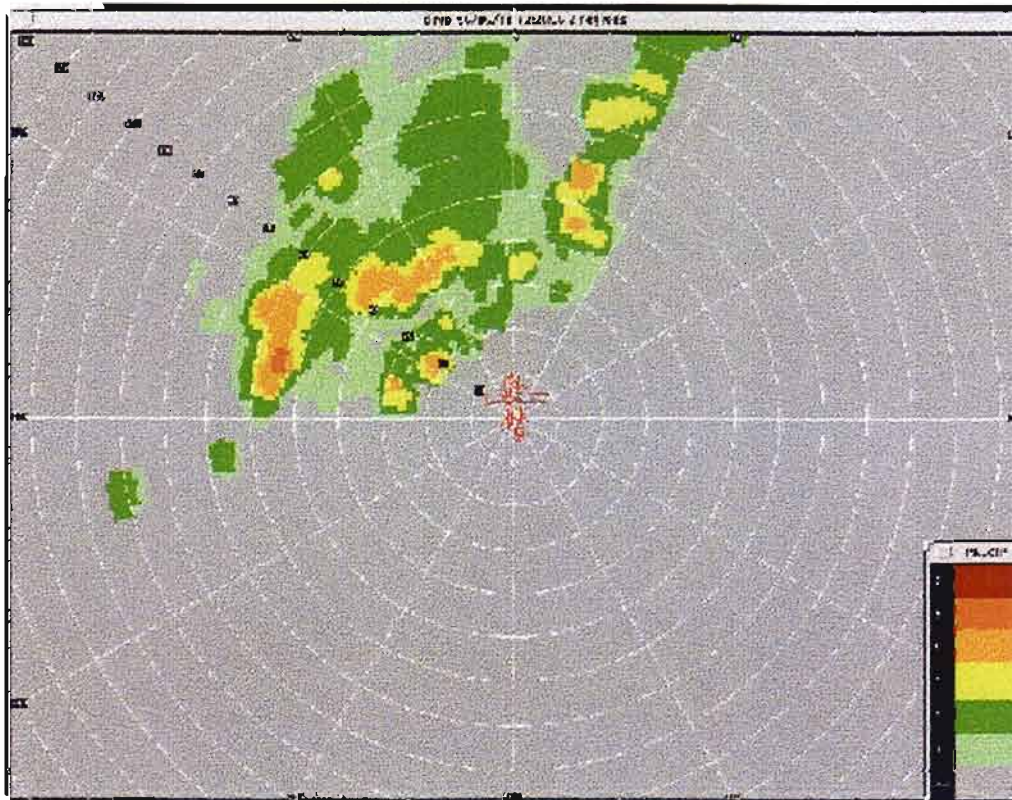
Figure 4. ASR-9 weather channel data for the Memphis case on 960618. The weather echoes are represented in the standard NWS six weather levels. The red polygons in the center of the image are the MEM Areas Noted for Attention (ARENAs). Note the echoes between 50 and 60 km northwest of the airport to compare with the NEXRAD composite and VIL products shown in the next two figures.

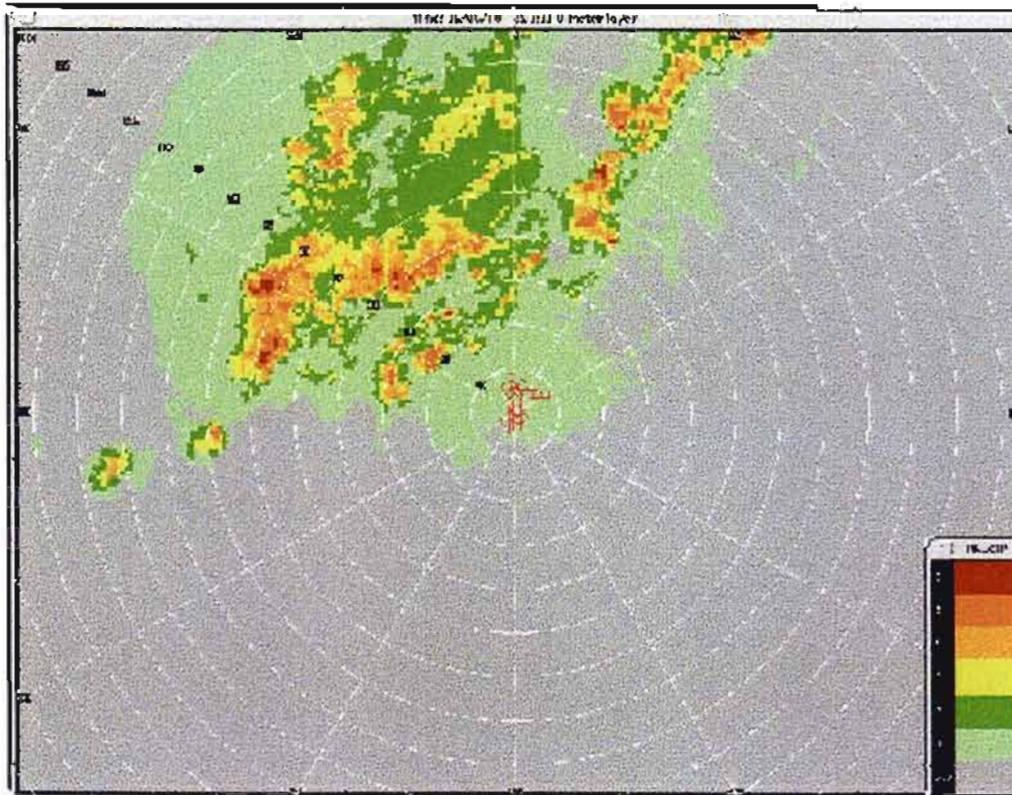
Figure 5. NEXRAD composite reflectivity product data for the Memphis case in Figure 4. The time difference in the two images is due to the time required to complete a NEXRAD volume scan. Therefore, the time stamp on the ASR-9 product is about five minutes earlier than the NEXRAD. The echoes are represented in the standard NWS six weather levels. Note again the area 50 to 60 km northwest of MEM airport.

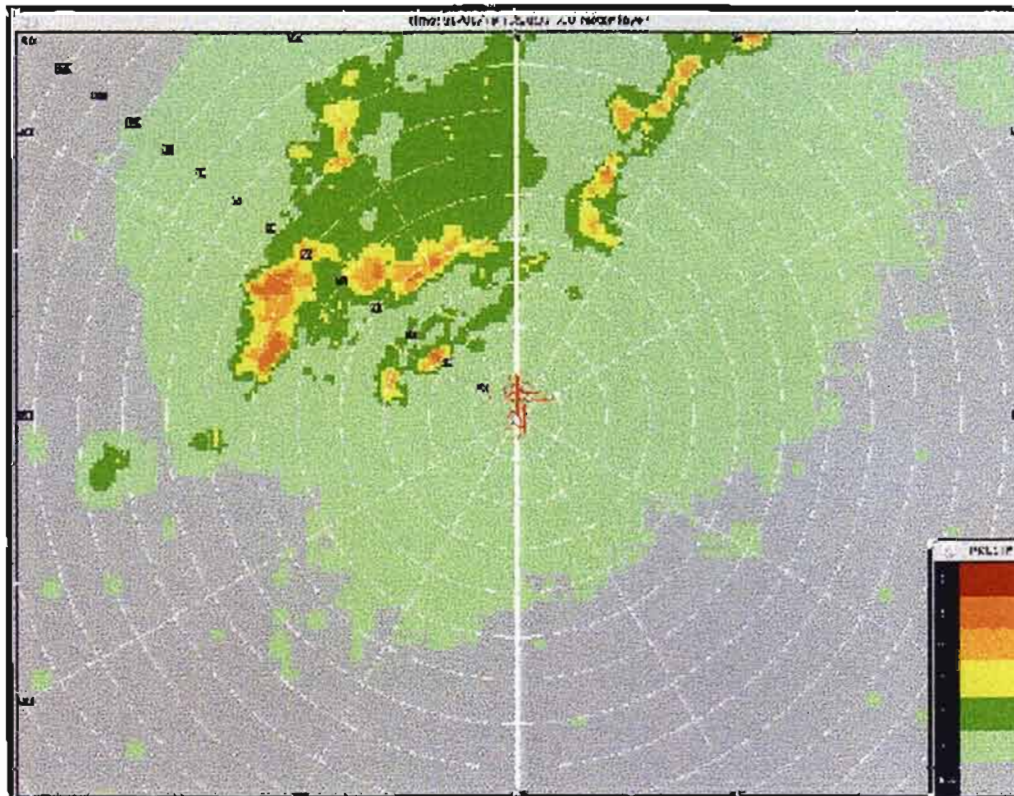
Figure 6. The NEXRAD derived VIL for the MEM case on 960618. The data are presented in the standard NWS six weather levels as in Figures 4 and 5. This was accomplished by applying the conversions from Table 1. Notice that there is at least a one weather level difference between many of the echoes presented here and the composite reflectivity echoes in Figure 5.

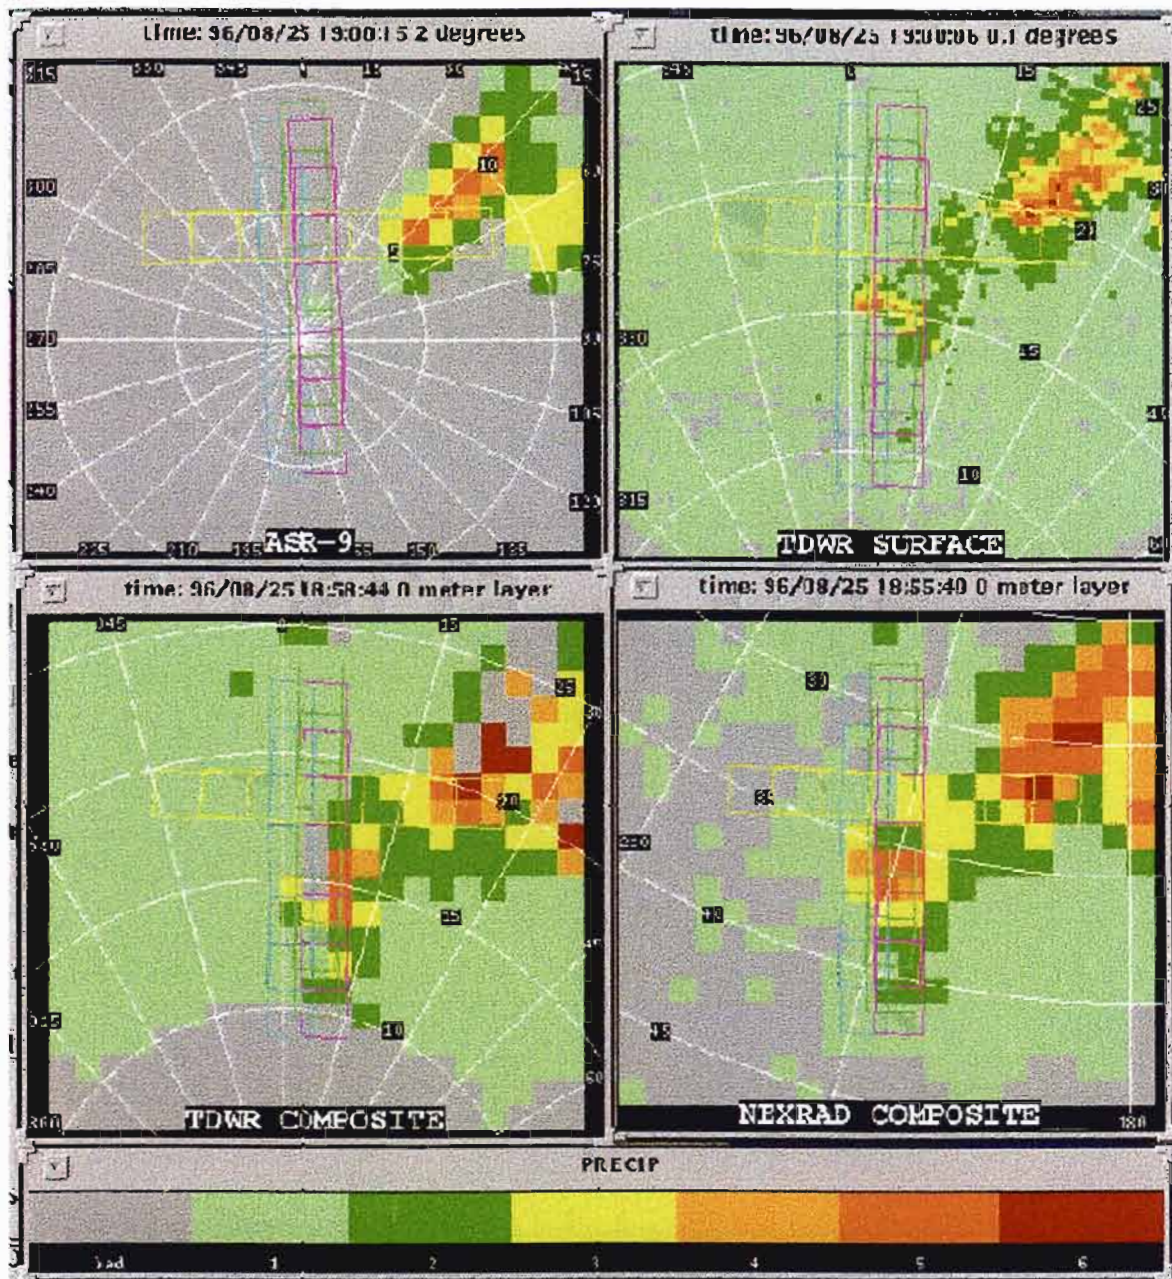
Figure 7. The ASR-9, TDWR and NEXRAD data for a MEM event on 960825. The colored polygons represent the MEM ARENAS. The range rings are spaced at 5 km intervals. The ASR-9 data are oriented to magnetic north, while the TDWR and NEXRAD data are in true coordinates. The time in each panel is for the beginning of the scan. Notice the echo located near the center of the ARENAS is completely missed by the ASR-9. The gray pixels in the TDWR composite represent attenuation flagging.

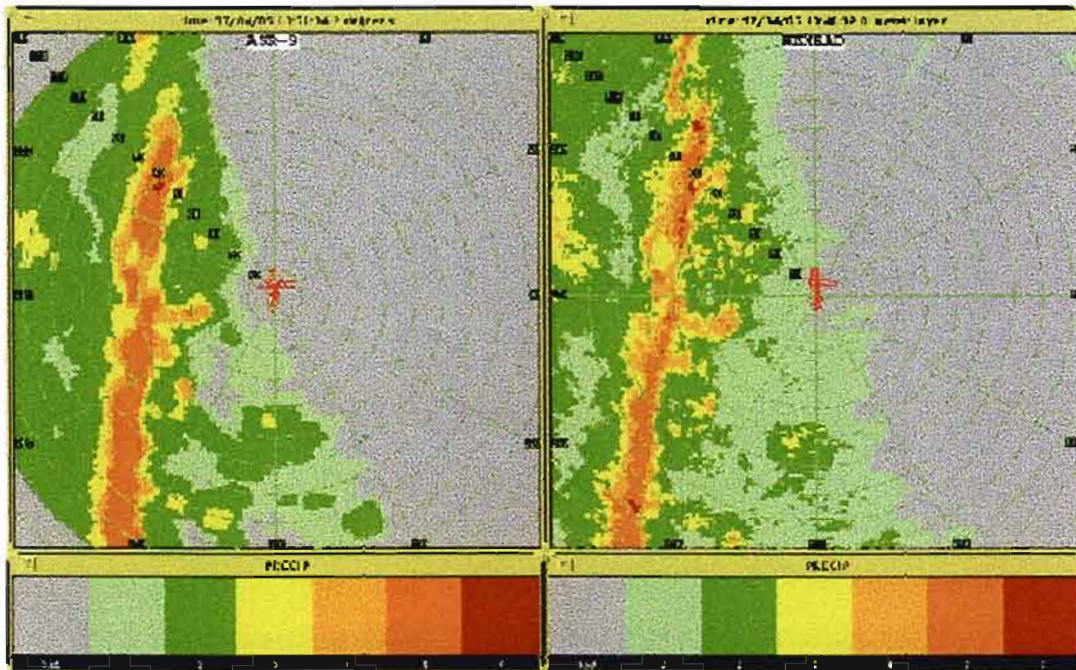
Figure 8. A squall line bearing down on the MEM airport on 970405 at 1351 UT. The red polygons in the center of the images are the MEM ARENAS and the range rings are in 10 km increments. The panel on the left is the ASR-9 data, while the panel on the right is the composite reflectivity product from the NEXRAD.

The first case study illustrates that significant reflectivity losses can occur when a line of heavy precipitation tracks over the radar platform. Figures 8, 9, and 10 are from a MEM event on 970405. The radar was operating in CP during the time period, which was analyzed. In this case, the sensor was impacted by level 6 precipitation. Figure 8 shows both the ASR-9 and the NEXRAD composite products prior to the impact. The heavy precipitation within the line extends well to the north and south of the airport. Figure 9 shows the line crossing the ASR-9 site (left panel). The corresponding NEXRAD data are shown in the right panel. An examination of the ASR-9 data reveal gaps and lower intensities in the squall line between 25-40 km north and 20-30 km south. In fact, a level 3 echo in the ASR-9 reflectivity field between 40-60 km to the north-northwest is actually a level 5 to 6 cell in the NEXRAD composite reflectivity data. Figure 10 shows the same line after it cleared the ASR-9 site and both sensors were once again detecting the full length of the squall line. Therefore, the line did not decay as it passed over the radar site, but rather the weather channel suffered significant reflectivity losses.

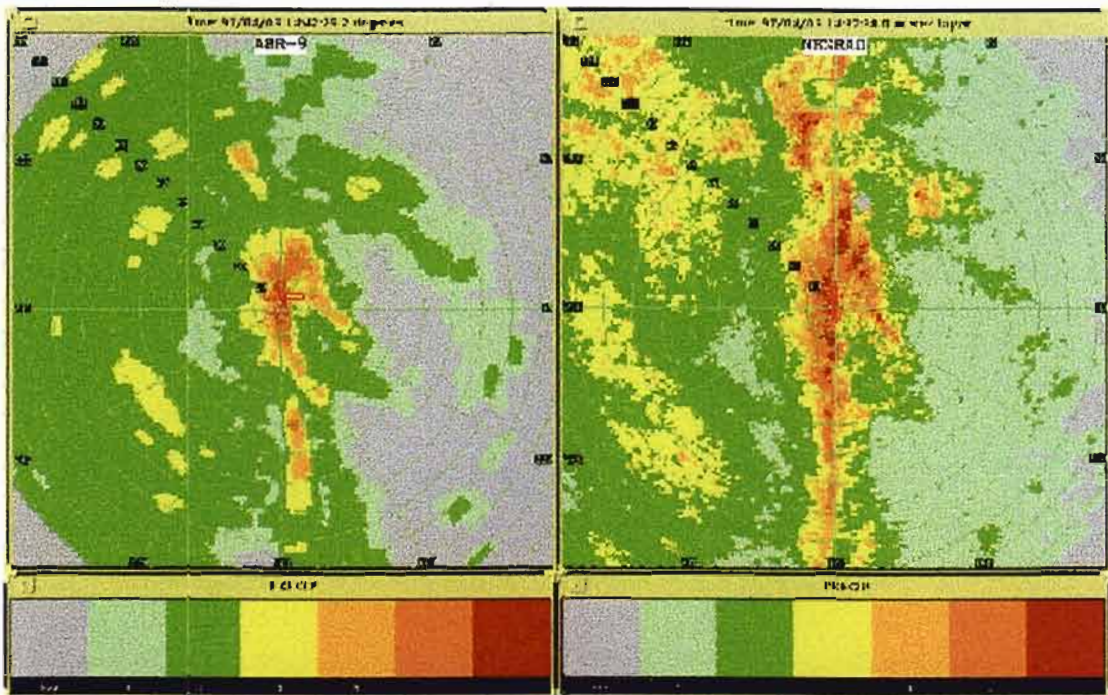
Figure 9. The same as Figure 8, only 40 minutes later as the squall line is impacting the MEM radar site. Notice that the NEXRAD composite product (right) still shows a continuous line of heavy precipitation, while the ASR-9 shows only the level 5 out to 20 km.

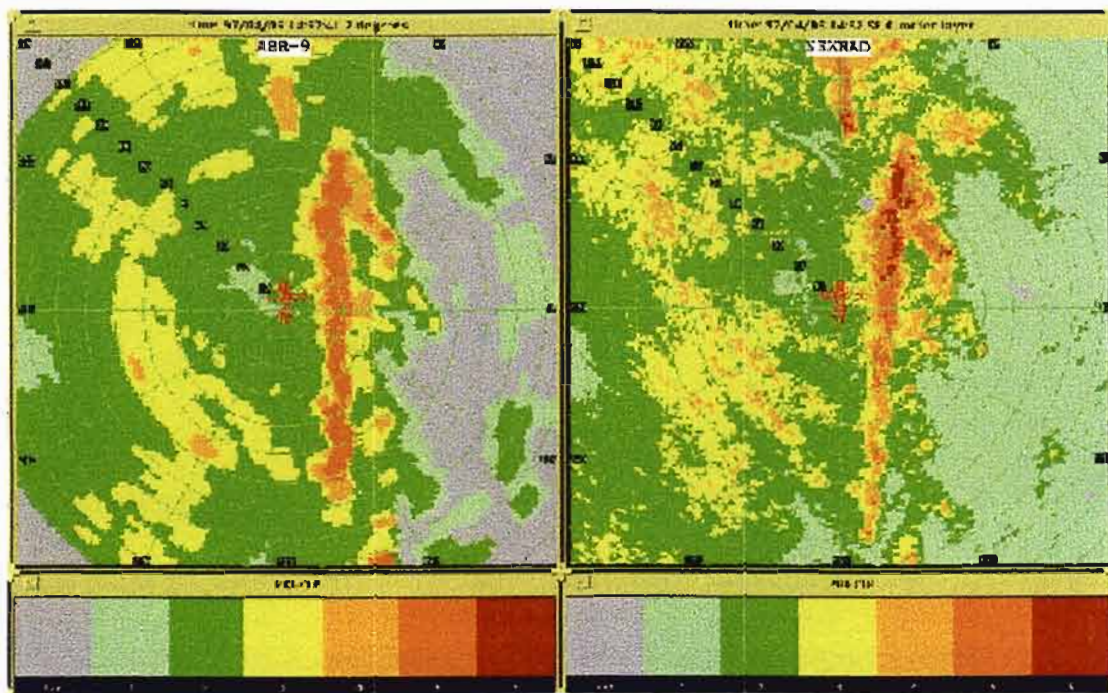
Figure 10. The squall line 15 minutes after Figure 9. The strongest precipitation is now east of the site and the ASR-9 (left) is again detecting the full length of the squall line.

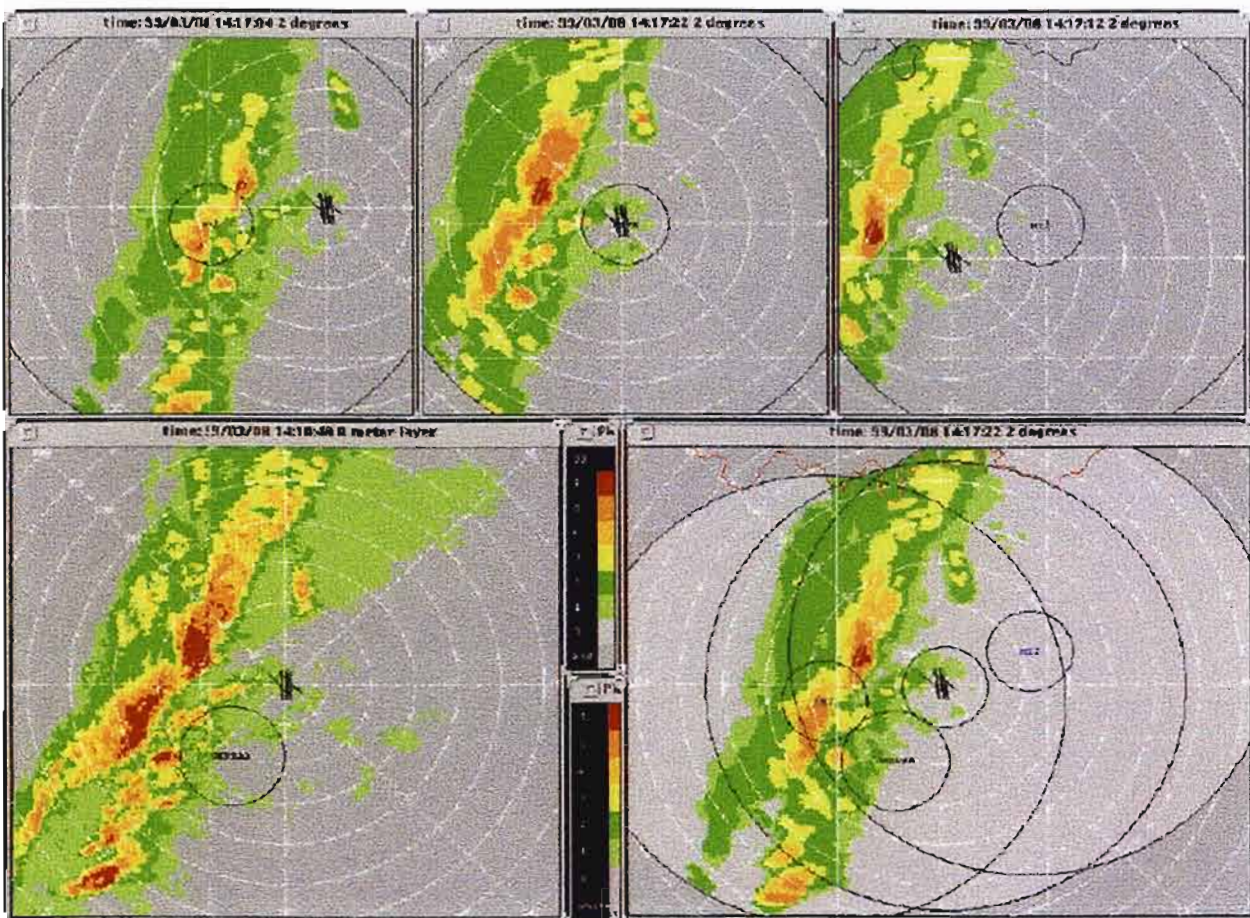
Figure 11. This is a multi-window display showing the impact of a squall line on the PA2 ASR-9 in DFW on 990308. The three upper panels, from left to right, are PA2, DFWE, and Sachse (MI2). Below are the NEXRAD composite product (left) and the ASR-9 mosaicked product (right). The small circles indicate the radar location and the larger circles show each radar's coverage. The black shape in each panel is the DFW airport and all range rings are 10 km apart.

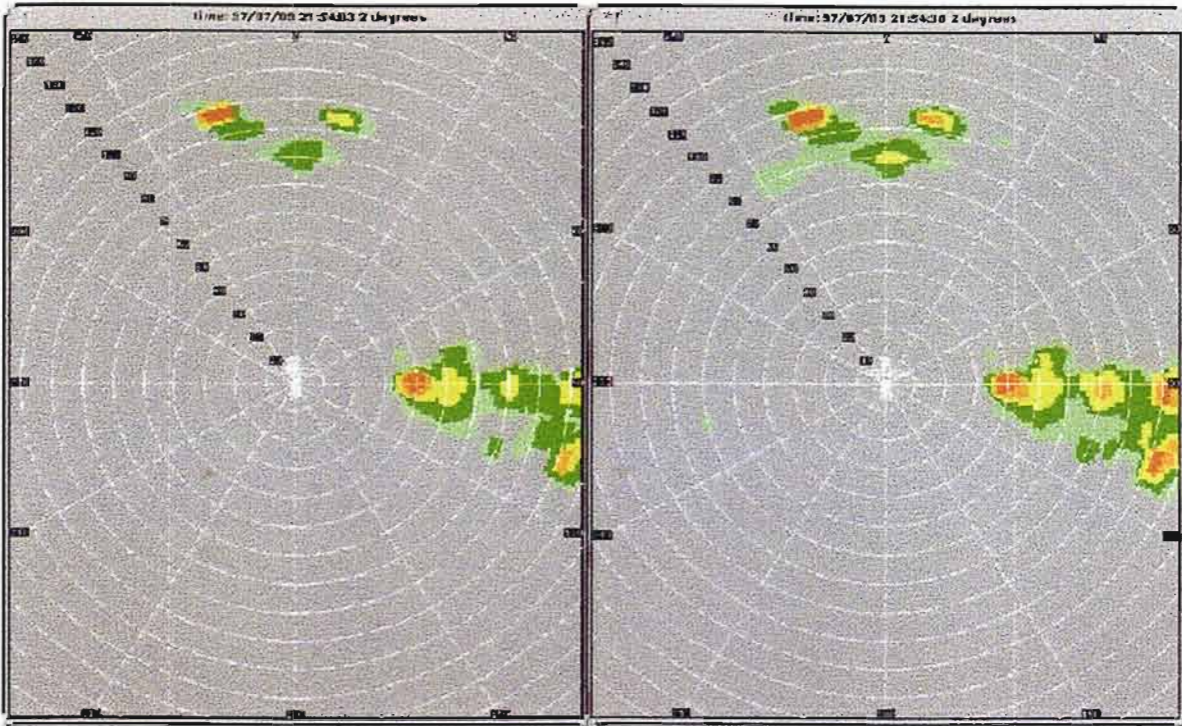
Figure 12. This is an image from MEM on 970709 showing slight calibration differences between LP and CP. The white set of polygons in the center of the image is the MEM ARENAS and the image is centered on the ASR-9. The range rings are at 10 km intervals. The image on the left shows the weather echoes in CP, while the image on the right is 30 seconds later, after the radar was switched into LP.

By comparison, there was a significant difference in precipitation intensity when switching between LP and CP in MEM. An example of the data before and after the change is shown in Figure 12. There was an increase of approximately one weather level in each cell's intensity after the switch. In fact, one cell located 90 km east increased from level 3 to 5. Another level 5 cell located 40 km east changed very little. So, in the MEM case, the indicated intensity of strong precipitation remained the same or increased when switching polarization. There was also a tendency for the weaker weather echoes to disappear in CP. According to Weber (1986), the detection of level 1 weather is both range and polarization dependent because different STC curves and level 1 data collection schemes are used between LP and CP. We believe calibration differences between the radar and weather channel could very easily account for the precipitation discrepancies shown in Figure 12.

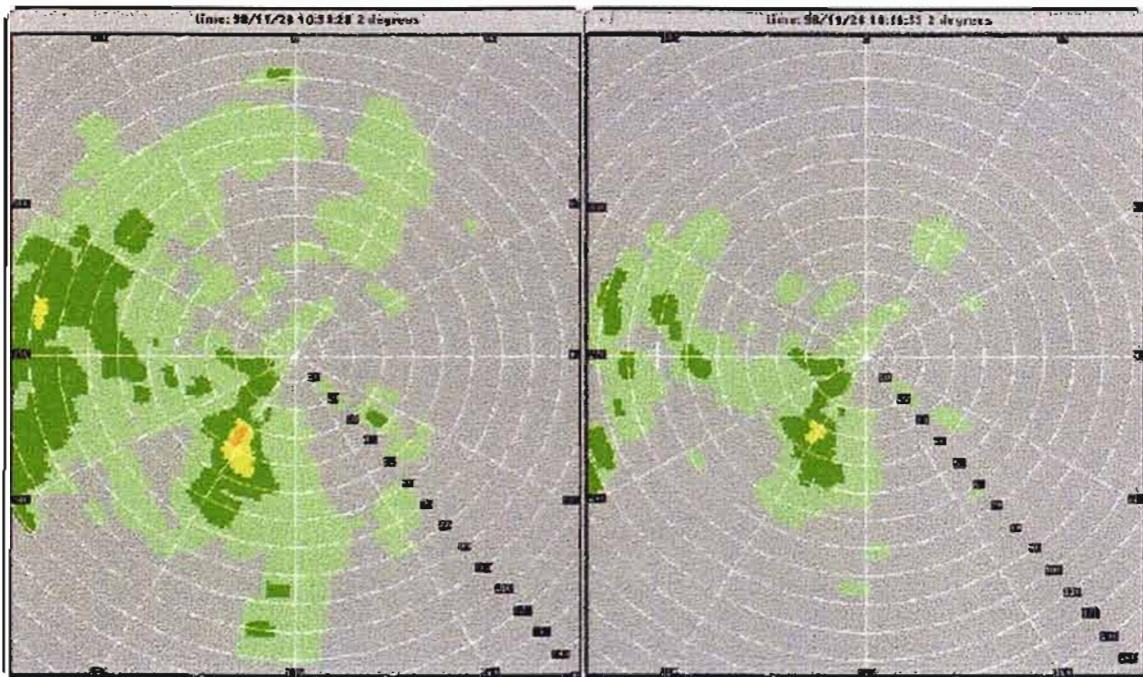
Figure 13. Data from the SWF radar, showing the effect of polarization switching on weather echoes. The image on the left is in LP, while the one on the right (30 seconds later) is in CP.

There have been a number of other cases documented where the precipitation returns varied between LP and CP due to possible calibration differences. An example of this scenario is presented in Figure 13. The panel on the left shows the echo coverage from the SWF radar in LP, while the panel on the right shows the weather returns after the radar has automatically switched to CP. An inspection of these images shows a reduction of approximately one weather level after the switch. One area where this reduction is most evident is located between a range of 30-40 km and an azimuth of approximately 210 degrees. A level 4 echo in this locale has decreased to level 3. As with the MEM case discussed previously, the underreporting of level 1 returns in CP is also evident with this event. Based on the data analyzed so far, precipitation underestimation during polarization changes is most likely on the MEM, SWF, and PHL radars. The other radar platforms only show smaller differences in the precipitation intensity when changing polarization.

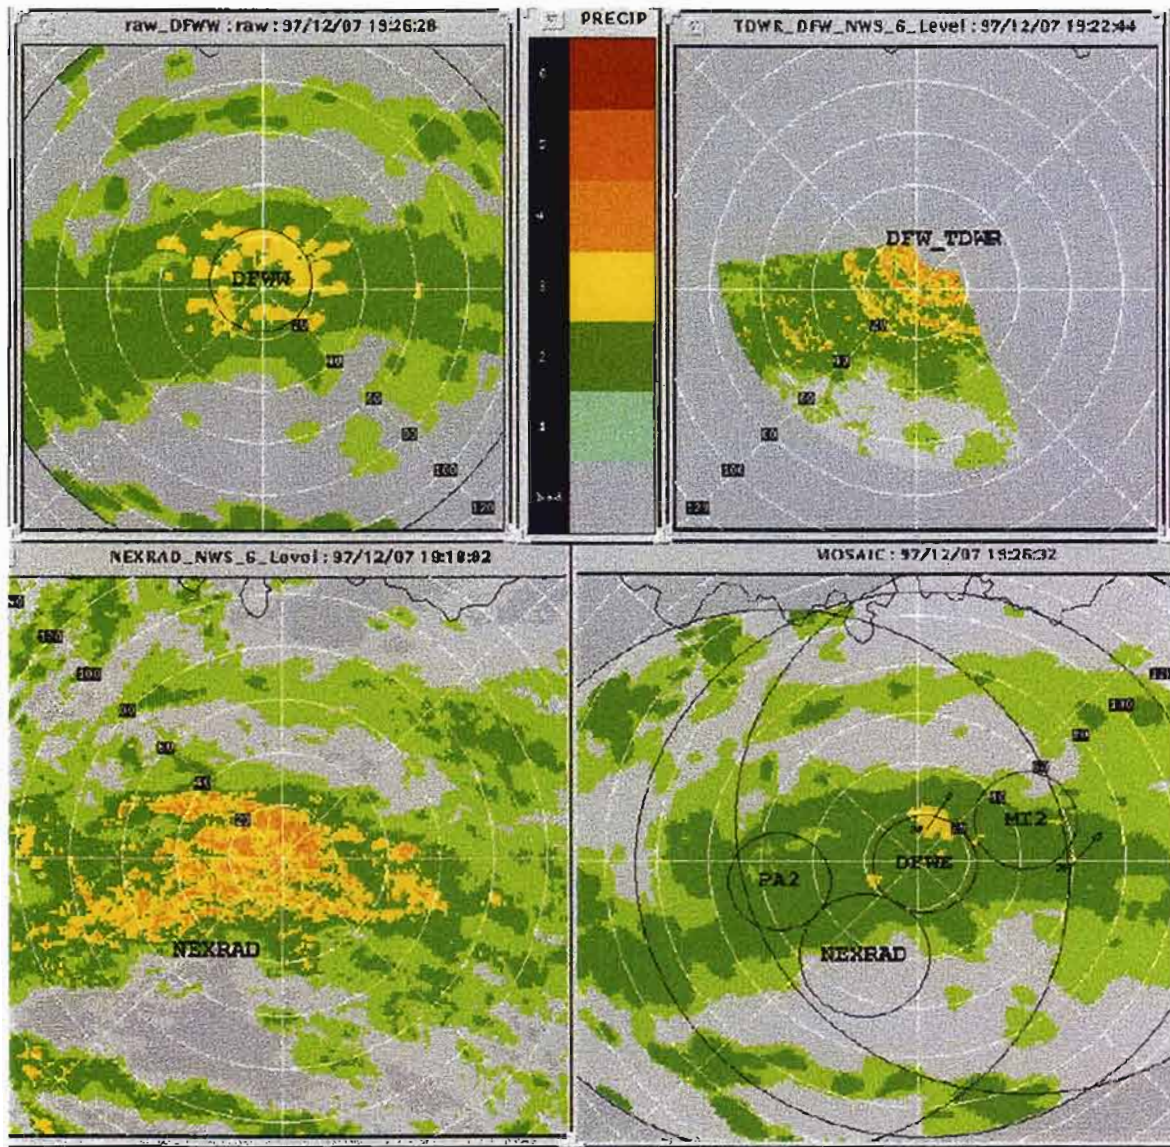
Figure 14. This is an example of bright band contamination from DFW. The DFW ASR-9 is in the upper left panel, the DFW TDWR is in the upper center panel, the NEXRAD composite product is in the lower left panel, and the ASR-9 mosaicked product is in the lower right panel. The circles in each image are the same as in Figure 11.

An example of ASR-9 bright-band contamination can be seen in Figure 14. This image shows a band of precipitation tracking over the DFW airport on 971207. The upper left-hand image is from DFW West ASR-9 (DFWW). Notice the band of level 3 around the site. The top center image is the DFW TDWR data, and although the system is in hazardous mode, a portion of the rings can be seen around the radar site. Partial rings also can be seen in the NEXRAD composite reflectivity data (bottom left). The mosaic image (bottom right) does not have the bright-band contamination seen in the single ASR-9 radar image (upper left). This is because the mosaic algorithm typically outputs the median value for each data bin. Since this problem is range dependent, using the median would generally eliminate the data contamination from the mosaic. While this approach would work effectively at ITWS sites with at least three ASR-9s, this type of data contamination would still be a minor problem at those sites with only two radars.

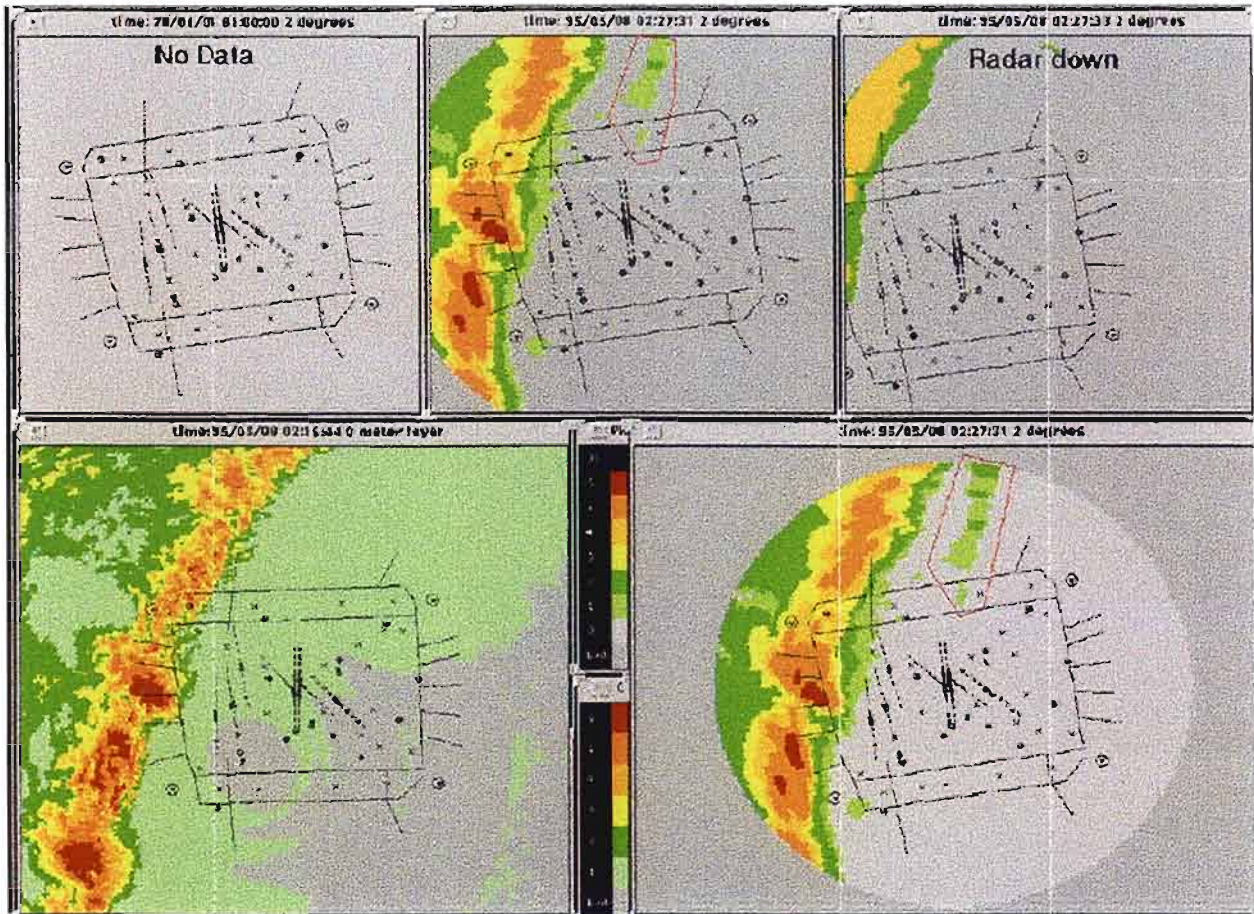
Figure 15. A five-panel display showing an area of distant weather contamination in DFW at 0227 UT on 950508. The large black rectangle in each panel is the "old" DFW TRACON, with the black lines in the center representing the DFW airport. The three upper panels show the ASR-9s (left to right: PA2, DFWE, and MI2), while the lower panels are the NEXRAD composite product (left) and the ASR-9 mosaicked product (right). The level 1 and 2 echoes within the red polygons are the distant weather contamination.

Echoes outside of the ASR-9s first-trip region (111 km) can, under certain conditions, be displayed within the first-trip region. For the most part, the ASR-9 does a very good job of removing the range ambiguities. However, if a strong weather echo extends over a range interval greater than the difference in unambiguous range between the ASR-9s two PRIs (about 34 km), distant weather echoes can contaminate the data. This causes false weather echoes to appear in the radar data, much like AP. Figures 15 and 16 show a DFW case from 950508 where a strong line of thunderstorms tracked into the coverage region. As shown in the NEXRAD composite data (lower left panel), the line extends well beyond the DFW East ASR-9 (DFWE) detection range (upper center image) and well past the 34 km unambiguous range. In Figure 15, the upper center image is from the DFWE ASR-9. Notice the thin band of level 1 and

2 echo north of the airport. This echo does not exist in the NEXRAD composite reflectivity data. At this time there is no data from either PA2 (upper left) or MI2 (upper right), which is contributing to the mosaic (lower right). Figure 16 shows the same event three minutes later, after MI2 became operational. The level 1 and 2 echoes to the north of the airport are no longer prevalent (lower right panel) because the mosaic process edited the distant weather. We should mention that the MI2 radar was in two-level mode and thus the data would not be used under this condition in the production ITWS. In this case, the two-level data has been incorporated into the mosaic on the northern end of the line, resulting in the removal of the distant weather. [The software to ignore two-level data was not operational in DFW during this event.] This is yet another example of the advantage of using a mosaicked precipitation product. Therefore, distant weather contamination may be more significant at airports with only a single ASR-9.

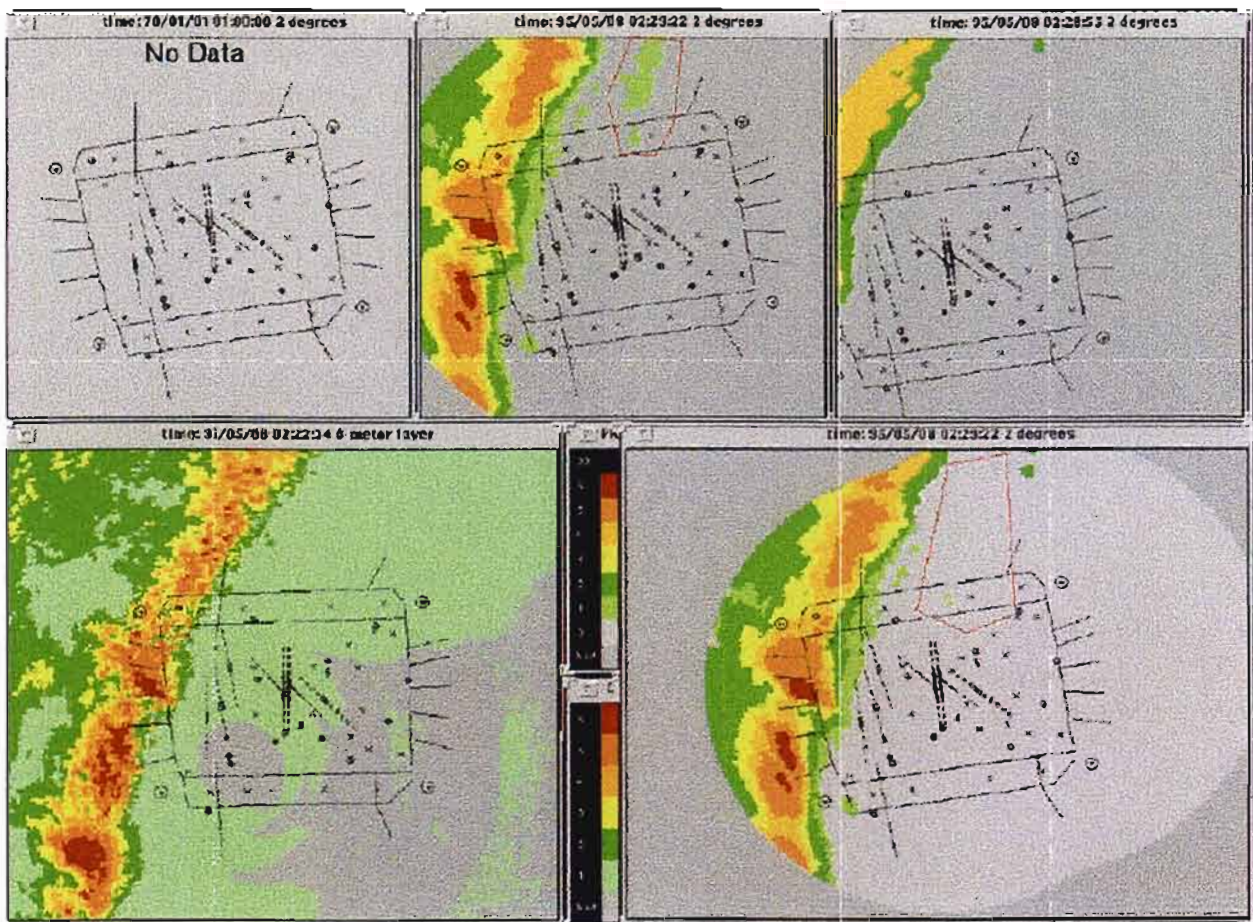
Figure 16. The same as Figure 15, but a few minutes later when the MI2 (upper right) radar came back on line. Notice that the area of distant weather contamination (area within the red polygons) has been edited from the mosaicked (lower right) product.

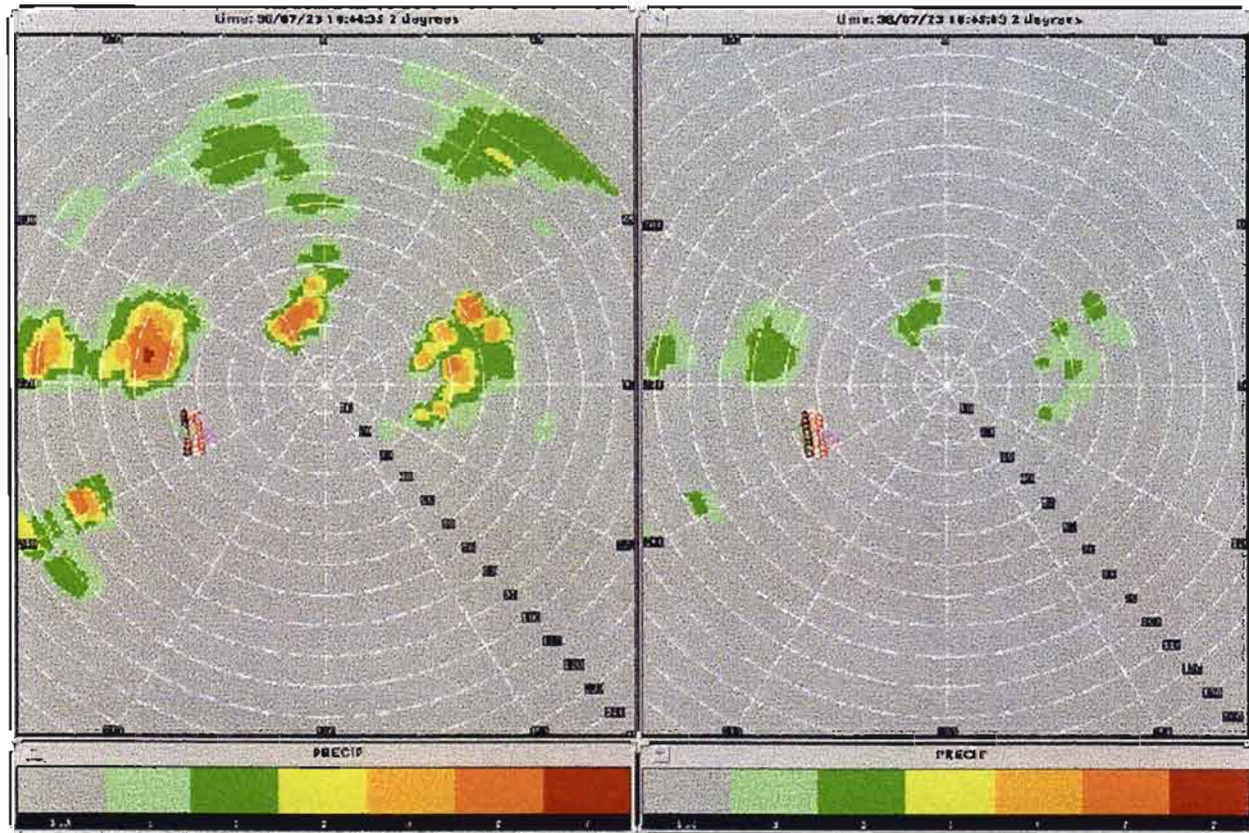
Figure 17. The MI2 ASR-9 when the radar switched between LP and CP (LP on the left and CP on the right). The multi-colored polygons are the DFW ARENAS, and range rings are at 10 km intervals. This figure illustrates the loss of reflectivity due to a stuck polarizer vane.

The polarizer in the ASR-9 consists of a “vane” which physically rotates between two positions to receive LP or CP radar returns. Due to excessive wear, the vane polarizer can occasionally stick mid-way during polarization changes. When this happens, the result is a significant decrease in the precipitation intensity. An example of this problem from 960723 in DFW is shown in Figure 17. In this case, the MI2 precipitation intensity and areal coverage decreased dramatically for a one-hour period shortly after the radar attempted a transition from LP to CP. The panel on the left shows there were a number of high reflectivity cells located in all quadrants prior to the vane sticking. After the attempted polarization change (right panel), the maximum echo intensity within the coverage region dropped to level 2. There were also several level 2 and 3 echoes, which disappeared entirely. A sudden decrease in precipitation intensity and areal coverage can be a strong indication that the polarizer vane is stuck, especially if it is correlated with an antenna alarm or failed polarization status message. Performance

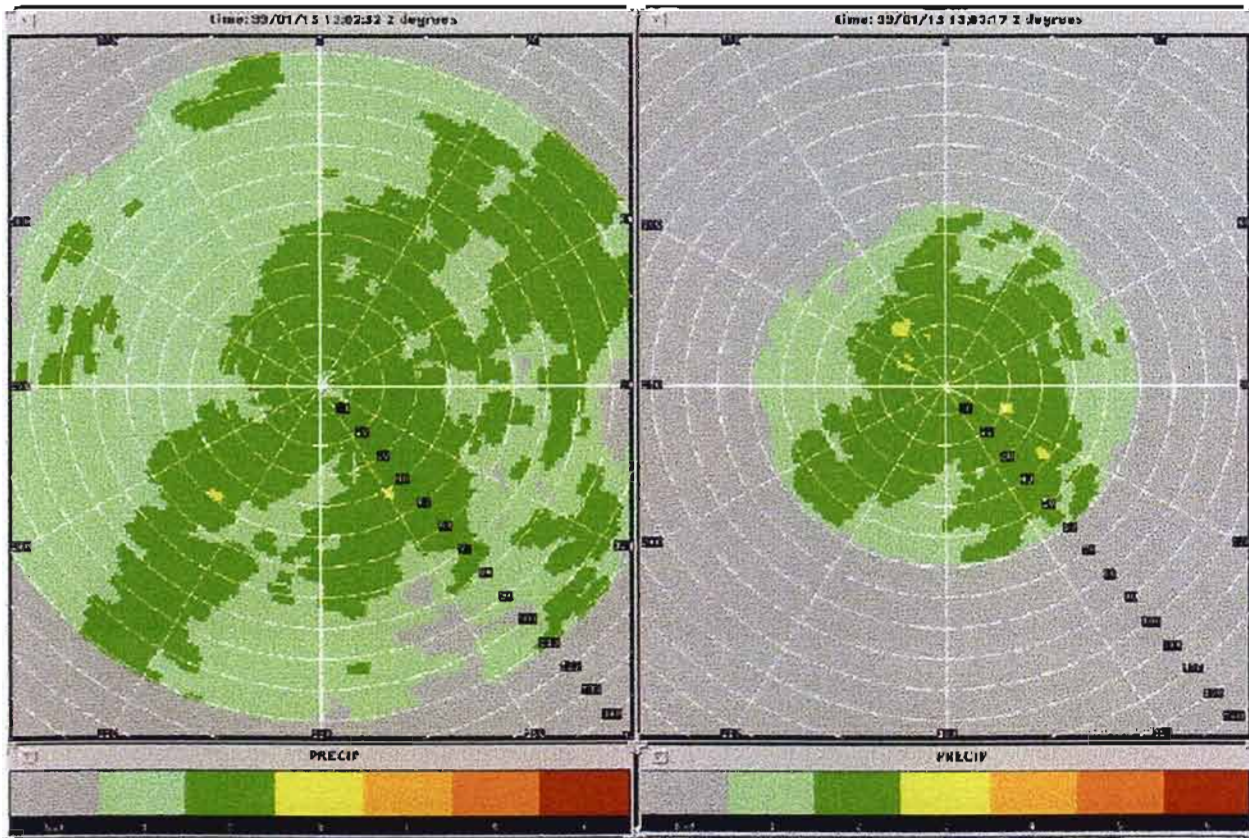
Figure 18. Data from the PHL ASR-9 on 990115 before and after it switched into CP. The panel on the left shows the reflectivity data in LP and the right panel is in CP. Notice that the reflectivity levels stay nearly the same, but all data beyond 60 km are lost.

- It is characterized by missing data beyond 60 km from the radar. If the echoes beyond 60 km are strong enough, they will be displayed, but at a lower reflectivity level.
- The precipitation intensity inside 60 km generally remains the same. This is in contrast to the cases where the polarizer vane sticks, since this impacts all echoes, regardless of their range.

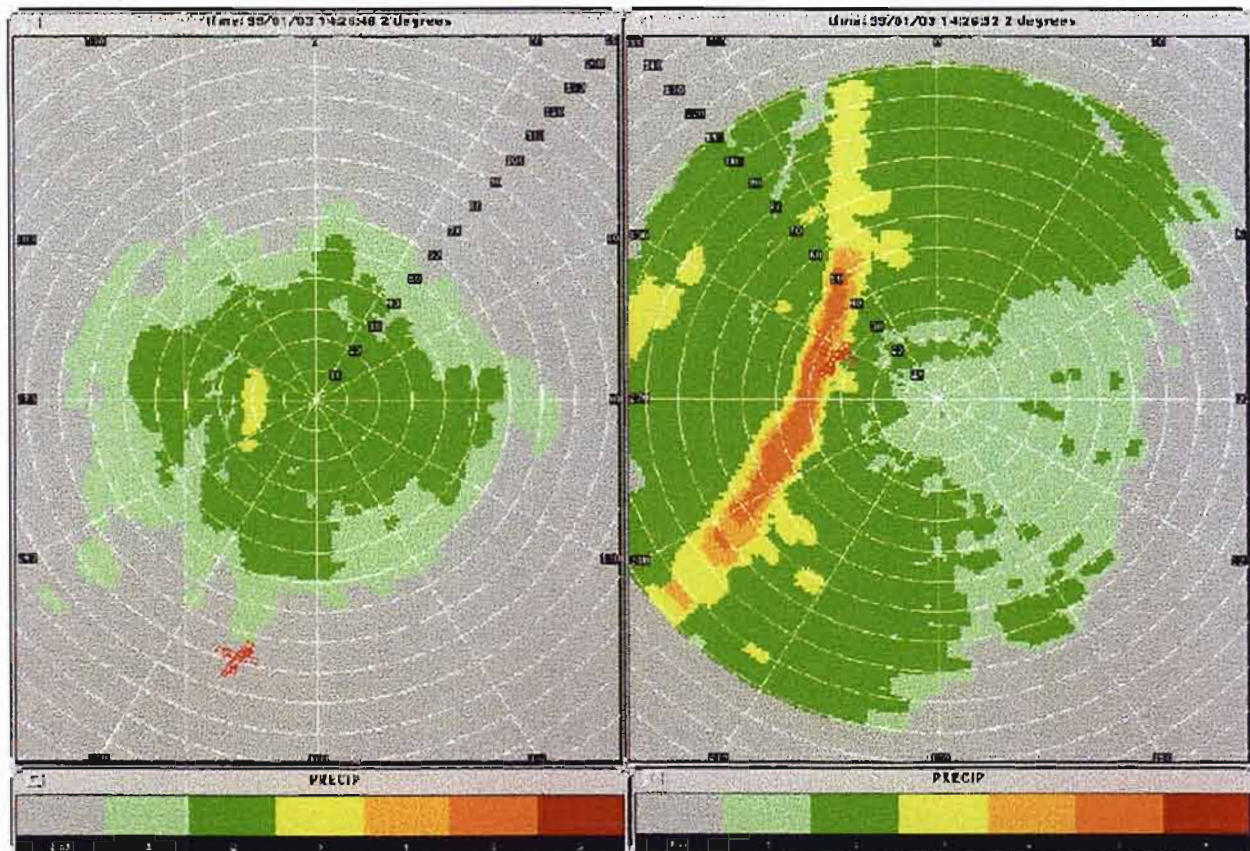
Figure 19. This is an example of a more complex ASR-9 hardware-related failure from the SWF ASR-9 on 990103. The image on the left is from the SWF radar, while weather data from the JFK radar are on the right. The red polygons on both images are the ARENAS for Newark and are added for reference.

Another, more complex hardware-related failure from the SWF radar on 990103 is presented in Figure 19. In this case, there was an area of weaker precipitation located ahead of a squall line, which tracked through the NYC domain. The data from SWF are shown in the left panel, while the John F. Kennedy (JFK) data are on the right. There are several discrepancies in the SWF echo intensity and areal coverage, which are of concern. First, there are no level 2 returns beyond 60 km range (similar to the PHL case). The JFK data show that the SWF system is not detecting the level 1-3 stratiform precipitation very effectively. Even more significant, though, is the comparison of the squall line precipitation between the two sensors. The JFK data show a well-pronounced squall line (Level 3-5) aligned north-northeast to south-southwest across the Newark (EWR) ARENAS (red polygons). The SWF radar is reporting a maximum intensity of level 3 for this weather episode and is not detecting the storms over the EWR airport at all. So, this case shows evidence of reduced range coverage and an underestimation of the precipitation intensity within the squall line. Thus, it is likely the radar suffered from both a stuck polarizer vane and a failure of the high-to-low beam microwave switch. This combination of hardware-related failures produced a significant degradation of the data for this event.
