**Project Report
ATC-270**

An Evaluation of the ASR-9 Weather Channel Based on Observations from the ITWS Prototypes

23 September 1999

Lincoln Laboratory
MASSACHUSETTS INSTITUTE OF TECHNOLOGY
LEXINGTON, MASSACHUSETTS

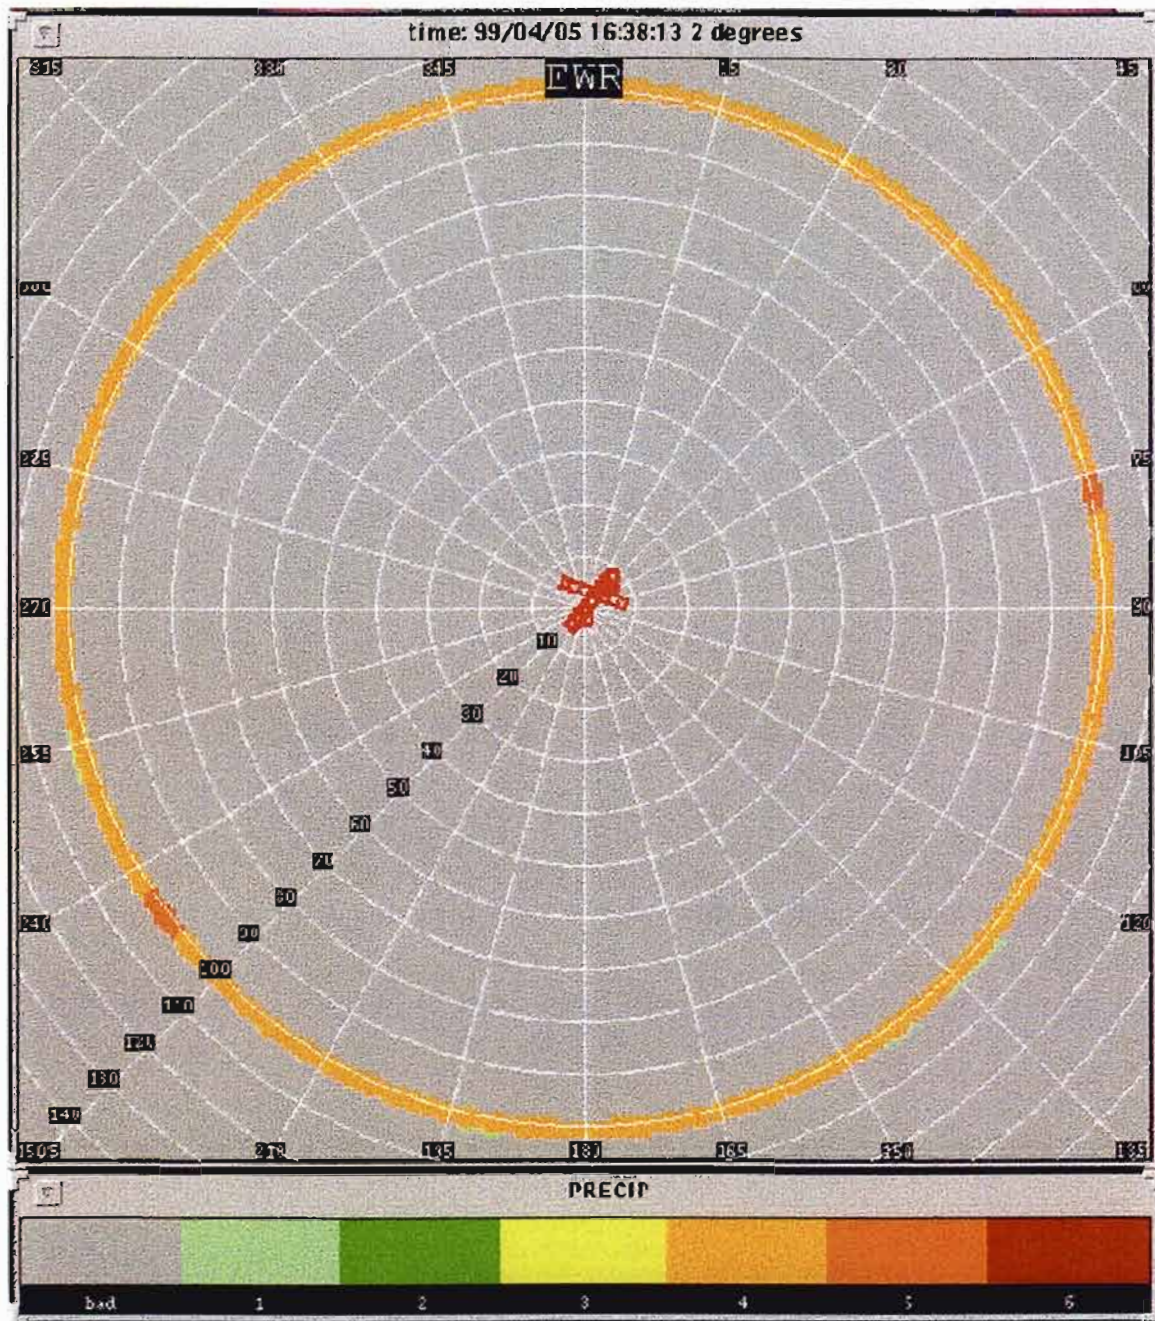
Figure 20. A ring of bad data at ~100 km from the EWR ASR-9 on 990405. Both the radar and antenna system experienced alarms during this time period.

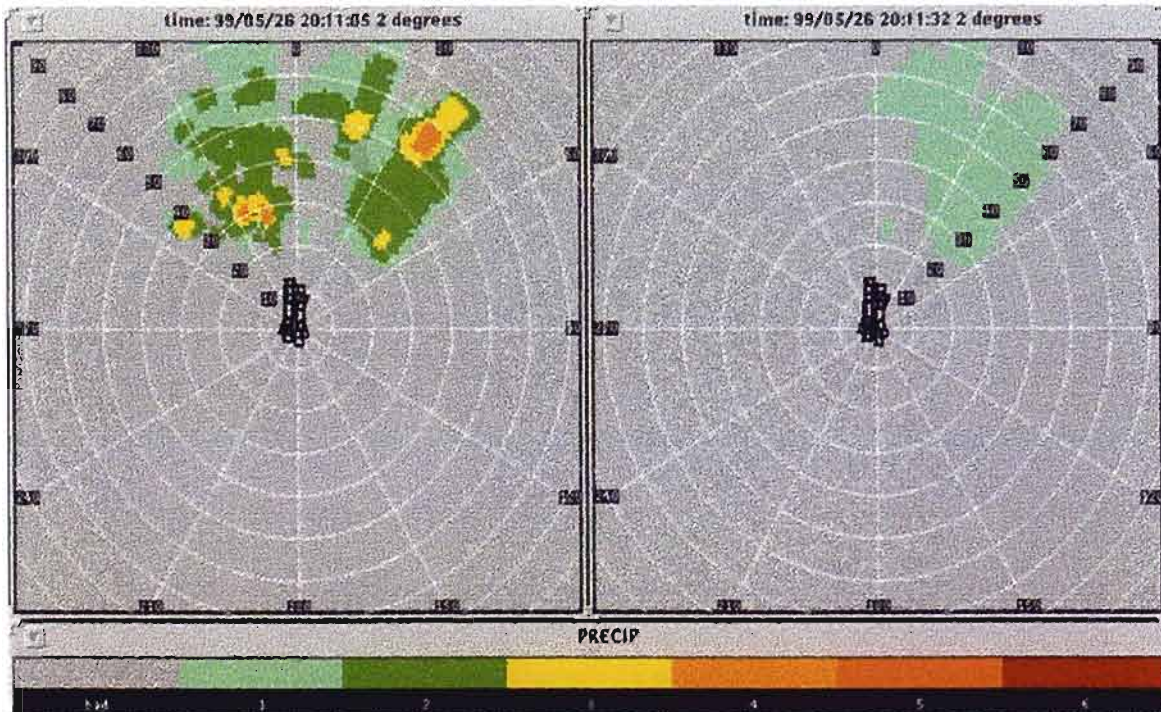
Figure 21. This is an image from MCO on 990526 showing the impact a radar channel failure can have on the data quality. The data on the left is before the radar alarm, while the data on the right shows the product degradation after the alarm.

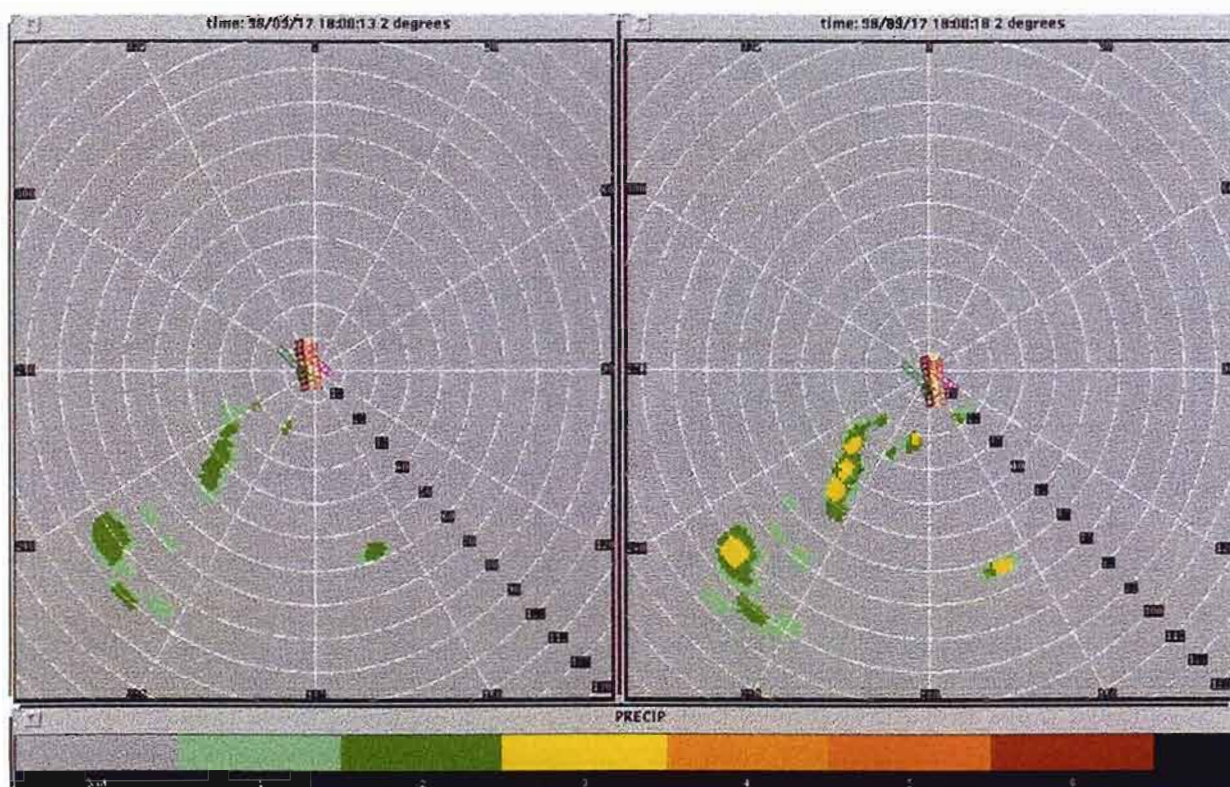
Figure 22. Comparison of co-located ASR-9s at DFW to illustrate calibration issues. The data on the left is from DFWE, while the data on the right is from DFWW.
